2021 [REDACTED] Roof Review

Main Mall Building

Office Tower

Roof Review [REDACTED]

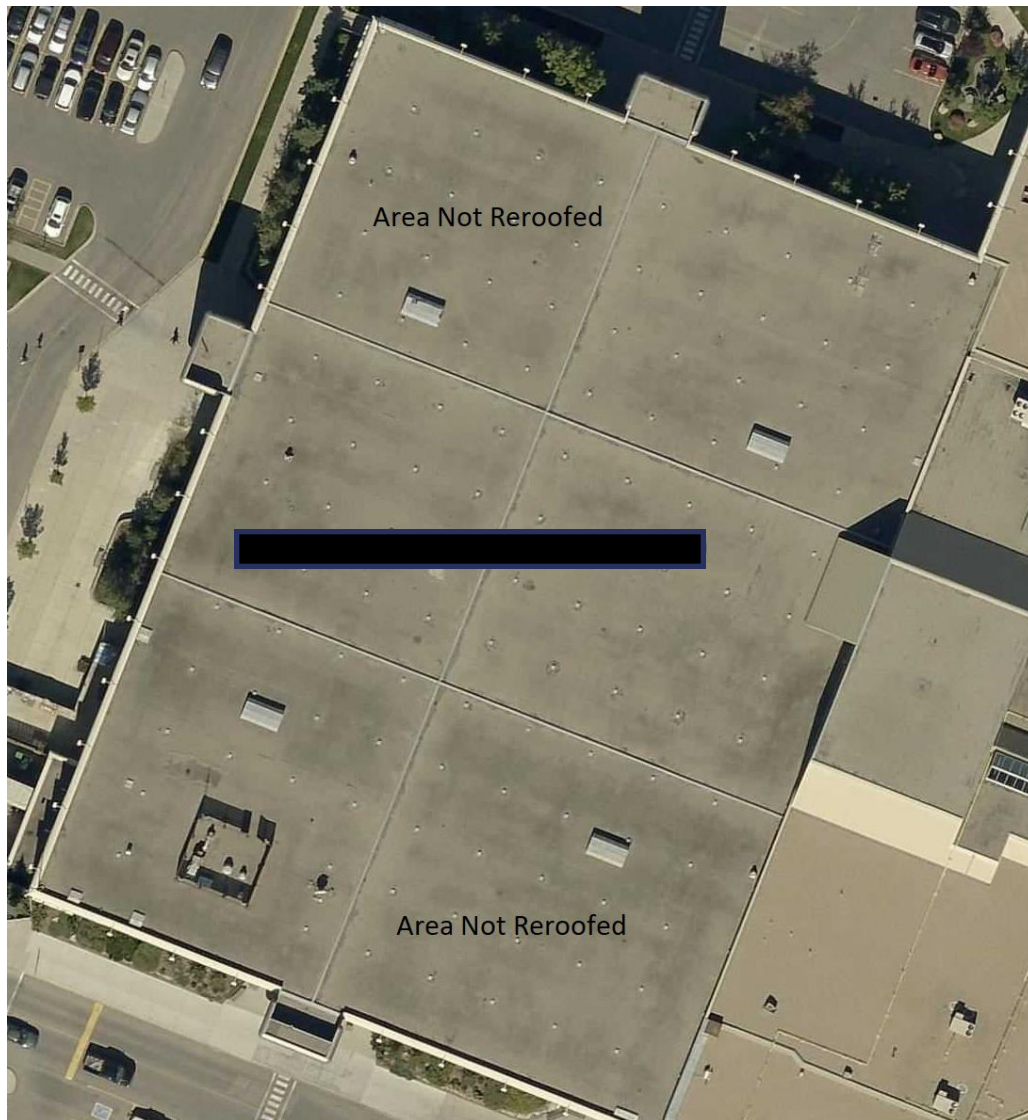
This roof is for the most part in the same condition throughout and is showing sign of failure, interply blistering, ridging and exposed felts are on all sections of the roof. Repairs could extend the life of this roof but would only be a temporary fix, in my opinion money would be best spent on a reroofing program.

Update: 2/3 of [REDACTED] roof was reroofed about a year ago, the areas not reroofed are shown on the picture below. They have substantial moisture in the system detected by our thermal scan recently and should be reroofed soon.

The parapet on this roof area is not a standard roof parapet type and could cause some issues and difficulty when reroofing. My recommendation would be to remove it if possible and replace it with a more conventional roof edge detail.

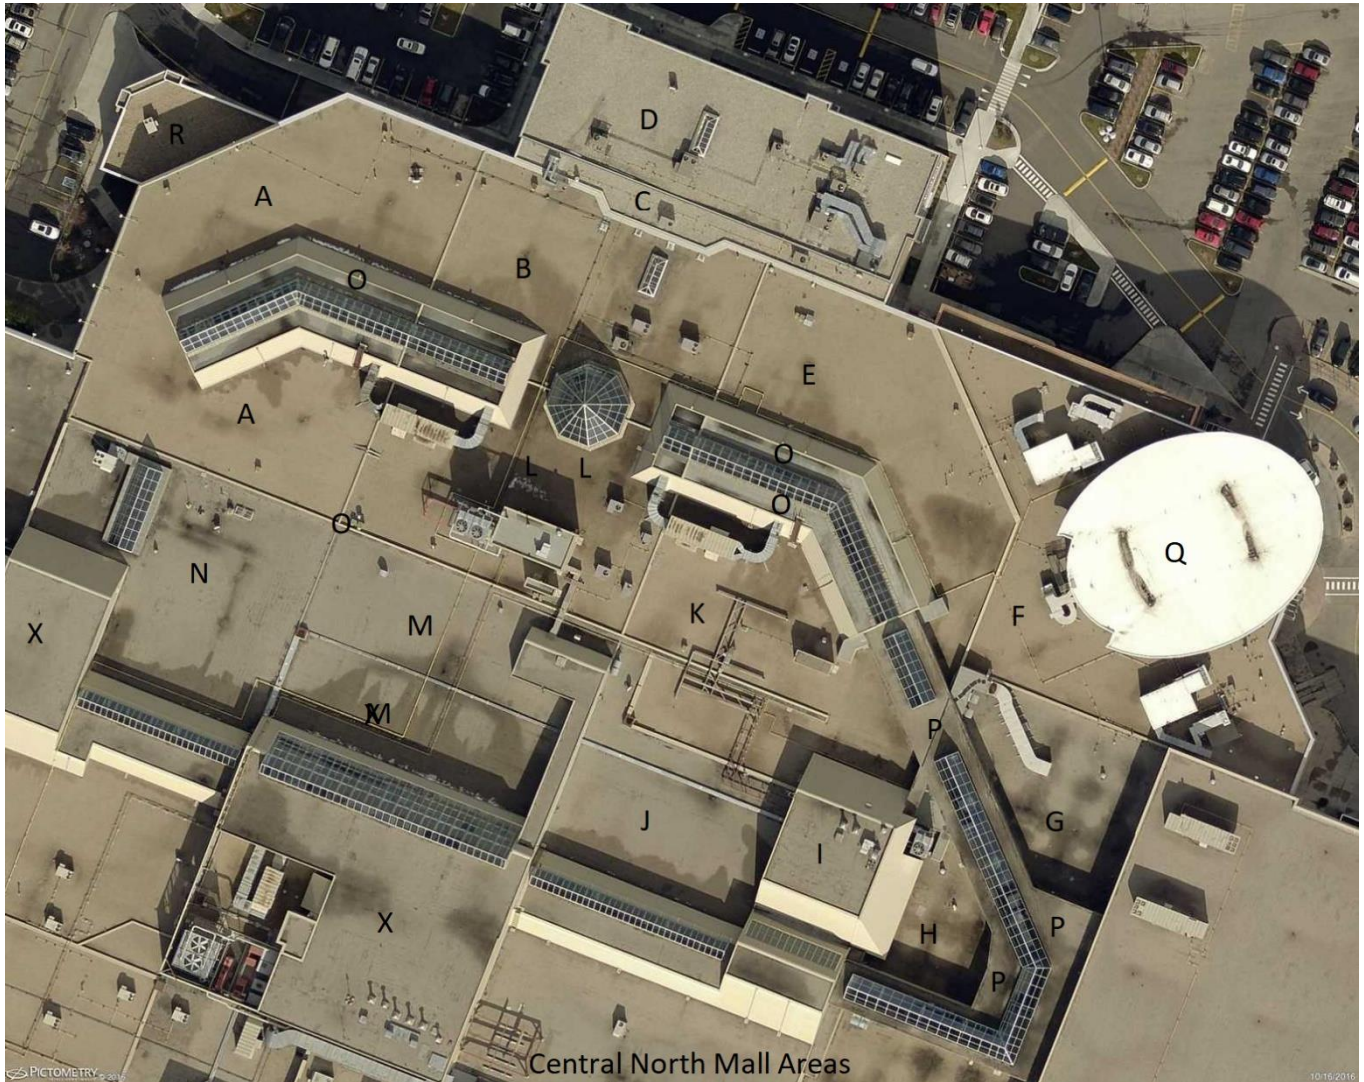
[REDACTED] BUILDING NORTH CENTRAL

Areas A, B, E, F, I, L, and K; Good Condition. These areas are all BUR membrane with SBS perimeter stripping, they are in good shape and should provide years of additional service. They should be walked yearly and maintained when necessary. There is one open tall cone on area A with no plumbing pipe through it, this should be sealed to prevent water from entering the building during a rain. Update: These roof areas will require reroofing within 15 years.

Areas G, H, M, N, and P; Poor Condition. These areas are obviously older roof areas and are showing their age, there are numerous ridges blisters, blueberries and exposed felt on these roof areas and although not facing imminent failure they should be scheduled for replacement in the next few years. These roof areas should be monitored yearly. Update: Areas N and P have been reroofed and should last at least 25 years. Areas H & G are the top priority for reroofing and should be done next year. They have substantial moisture in the system.

Area Q; Good Condition. This is a relatively new PVC single ply roof system and is in good shape and should provide years of service, it should be walked yearly to monitor any changes.

Area C, D, and R; Good Condition. These are relatively new EPDM ballasted single ply roof system and is in good shape and should provide years of service, it should be walked yearly to monitor any changes. One plumbing vent detail on area C was not completed during installation and should be completed to ensure there is no infiltration of water.

Areas X; Fair Condition These roof areas were not accessible although I had a look at them at a distance from other roof areas, these are similar to the older roof areas above and it would be prudent to schedule them in for reroof in the next few years. Update: These roof areas are very old and should be reroofed in the next few years.

Update: Area N and P are reroofed. Areas H and G have substantial water in the system and should be prioritized for reroofing.

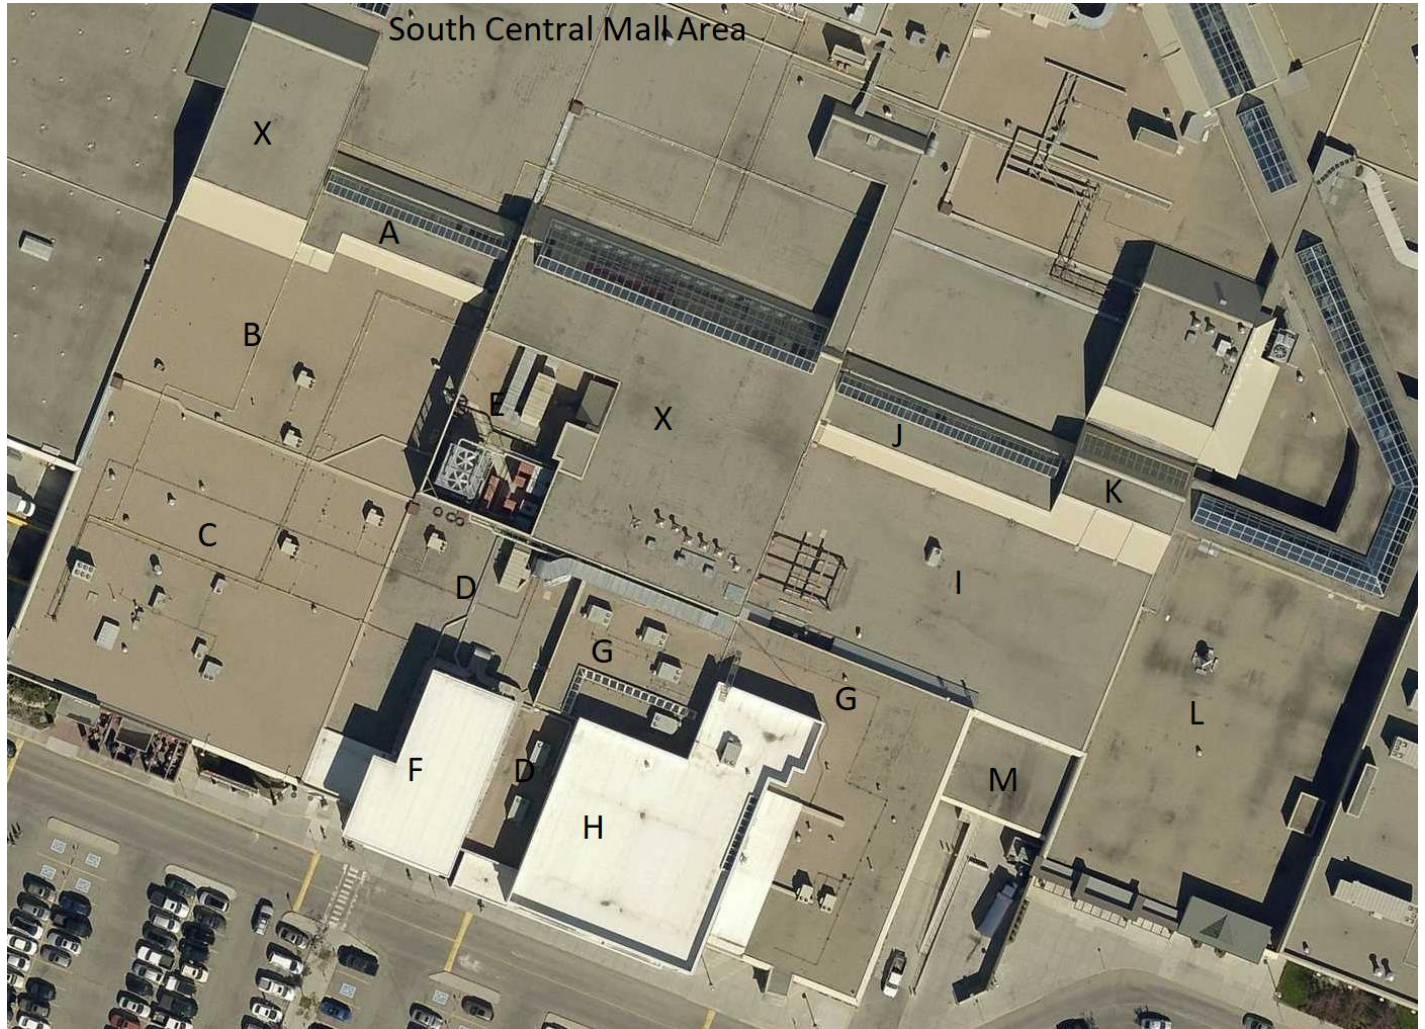
MAIN MALL BUILDING SOUTH CENTRAL

Areas B and C; Good Condition. These areas are all BUR membrane with SBS perimeter stripping, they are in good shape and should provide years of additional service. They should be walked yearly and maintained when necessary. There is one open tall cone on area A with no plumbing pipe through it, this should be sealed to prevent water from entering the building during a rain. Update: These roof areas should be reroofed in the next 15 years

Areas A, J, K and G; Fair Condition. These areas are obviously older roof areas and are showing their age, there are numerous ridges blisters, blueberries and exposed felt on these roof areas and although not facing imminent failure they should be scheduled for replacement in the next few years. These roof areas should be monitored yearly. Area G had a roof area removed and temporarily sealed with vapour retarder membrane, this will not provide adequate protection from water egress and could compromise the roof system. The roof should only be removed when they are ready to install the curb. Update: Reroofed other than the west side of area G which has moisture in the system and should be reroofed soon. Area K has not been reroofed and is not accessible to evaluate.

Areas I, L, D and M; Poor Condition. These areas are obviously older roof areas and are showing their age, there are numerous ridges blisters, blueberries and exposed felt on these roof areas and although not facing imminent failure they should be scheduled for replacement in the next few years. These roof areas should be monitored yearly.

Area F and H; Good Condition. This is a relatively new PVC single ply roof system and is in good shape and should provide years of service, it should be walked yearly to monitor any changes.

Areas X; Fair to Poor Condition These roof areas were not accessible although I had a look at them at a distance from other roof areas, these are like the older roof areas and it would be prudent to schedule them in for reroof in the next few years. Update: These roof areas should be reroofed in the next few years as they have not been touched in the last 25 years and drone photos show deterioration.

Update: Area D and most of G to the east have been reroofed, the area of G not reroofed has moisture in the system and should be reroofed soon. Area B has a small amount of moisture in the system just west of the cooling tower.

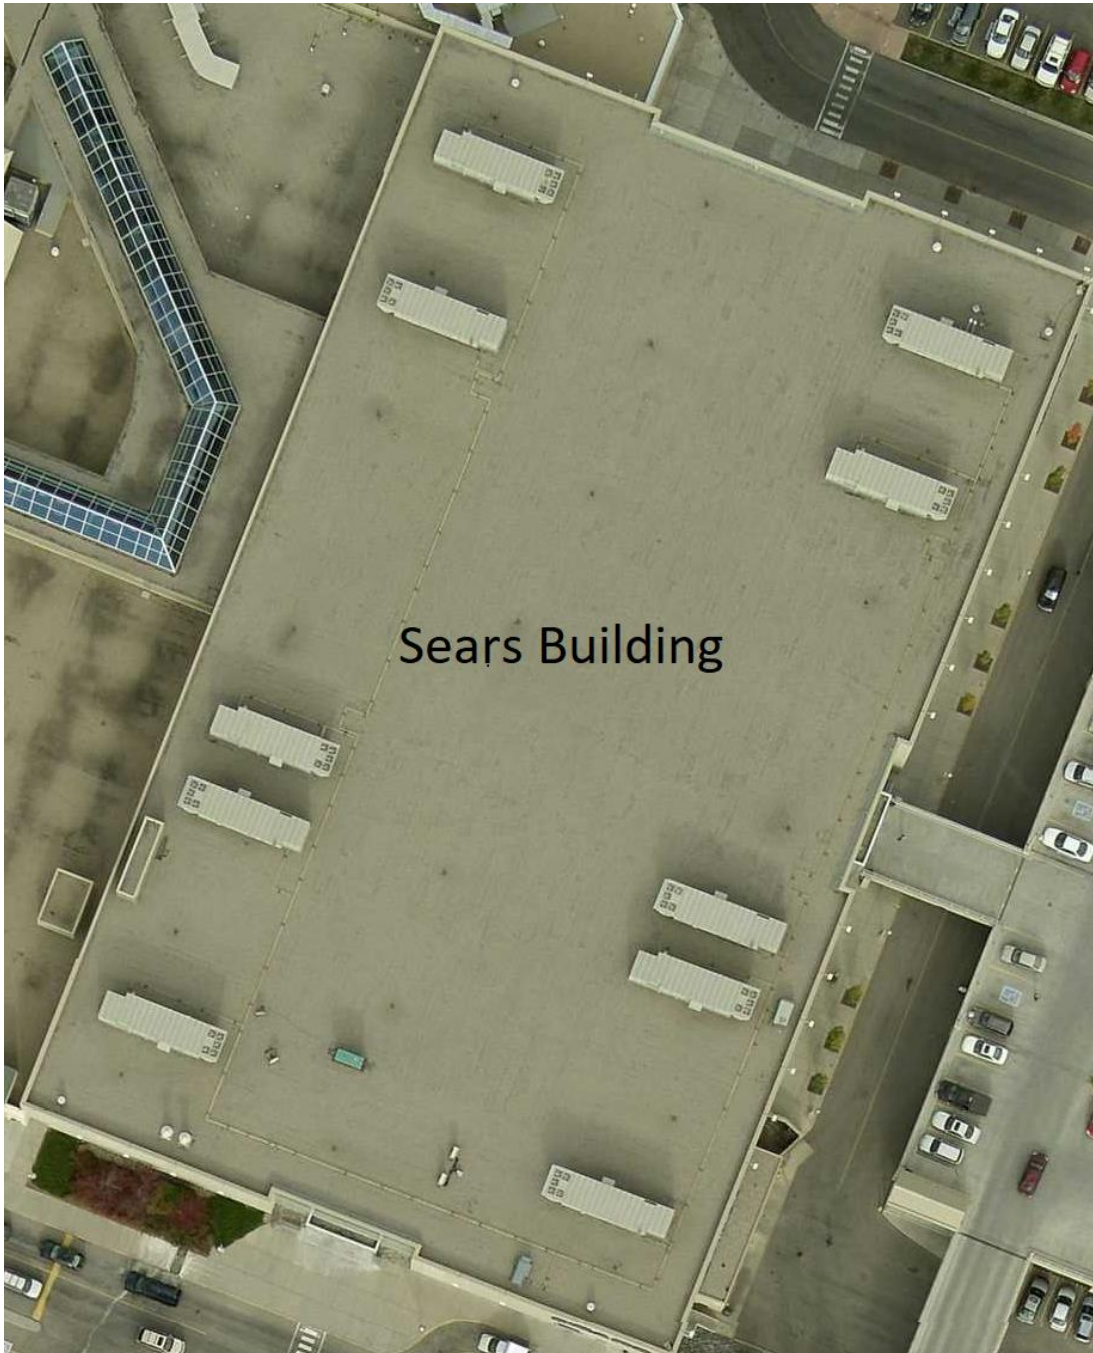
MAIN MALL BUILDING EAST (SEARS)

This roof is for the most part in the same condition throughout and is in good shape, I found only 2 interply blisters located in the northeast corner, this roof should provide years of additional service if maintained properly.

Update: This roof was installed in 2007 so it will reach its lifespan in the next 15 years.

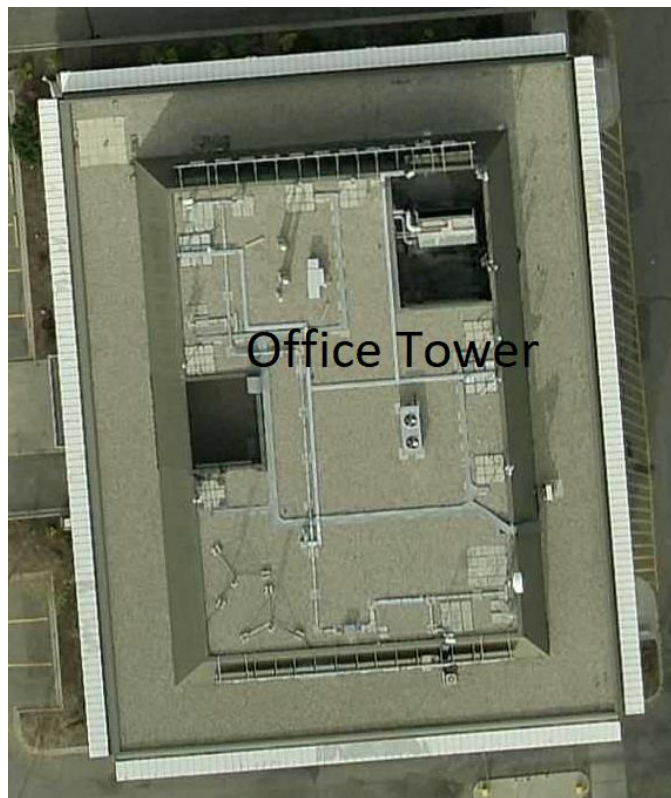
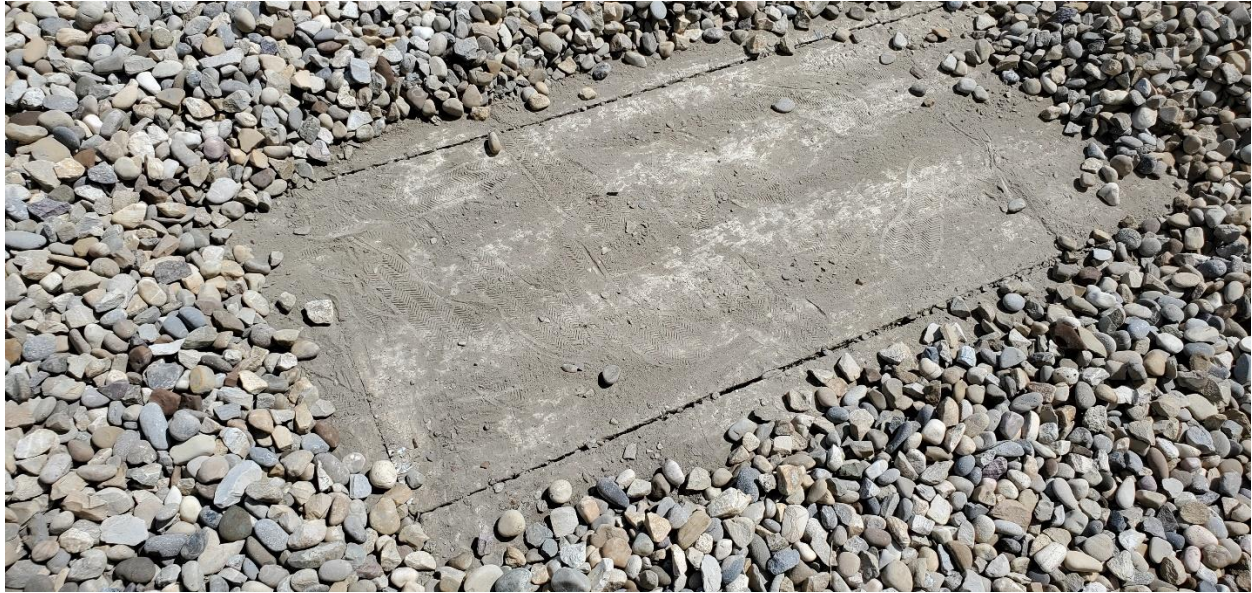
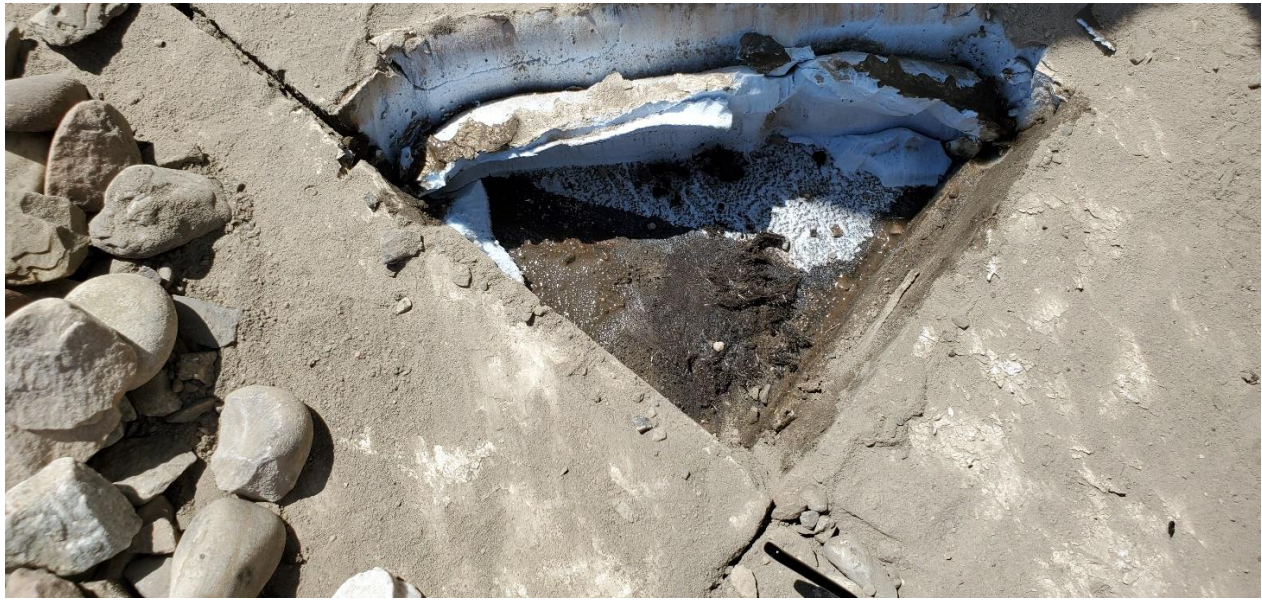
OFFICE TOWER

The building is a multi storey building with a low slope roofing system. All roof areas are IRMA (inverted roof membrane assemblies). Generally, this type of roof system has an excellent service life as the roof membrane is protected from UV and heat. My suspicions are this membrane is a four ply BUR just going on the age of the building although it is not visible. These types of roofs are not that common any more as they are very expensive and not very energy efficient. There is no evidence of failure on this roof. Update: The roof system is confirmed to be a BUR membrane system with the extruded polystyrene insulation bonded to the surface, this makes it very difficult to inspect but we did manage to remove a small piece of insulation and confirm the membrane. The membrane is in very good condition. This type of roof is known to have a very long service life. See photos below.

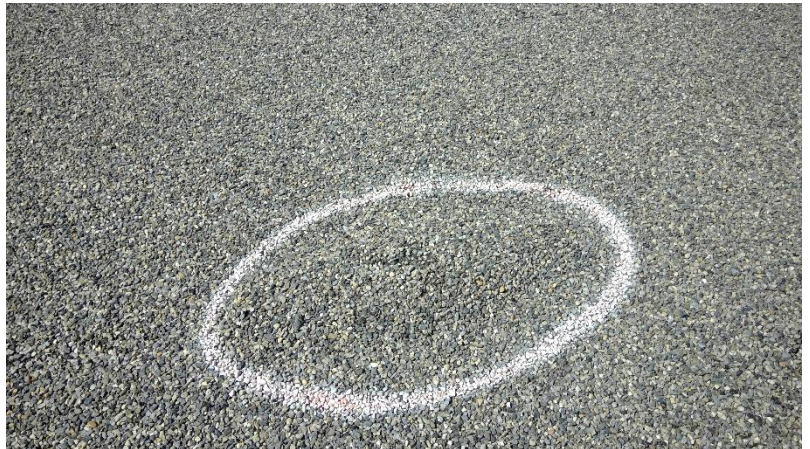
2) The Bay – Typical interply blister, they are numerous in all areas.

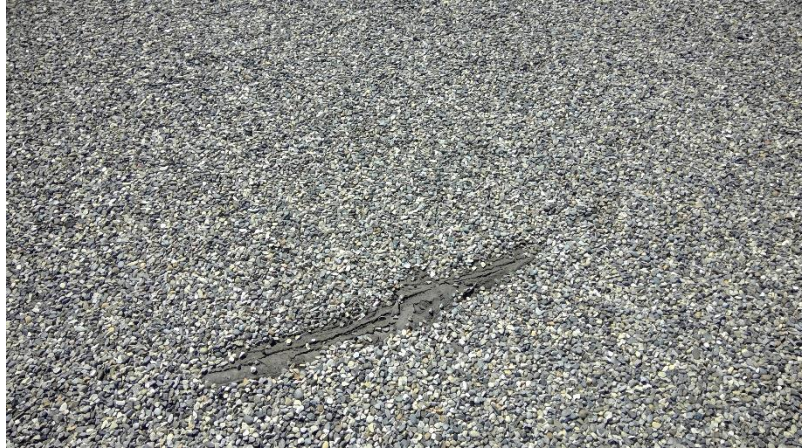
3) The Bay – Typical exposed felts

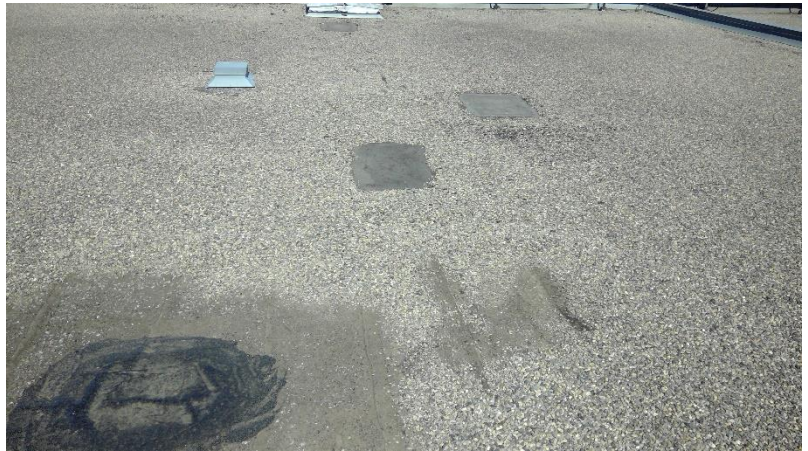
4) The Bay – Repairs undertaken.

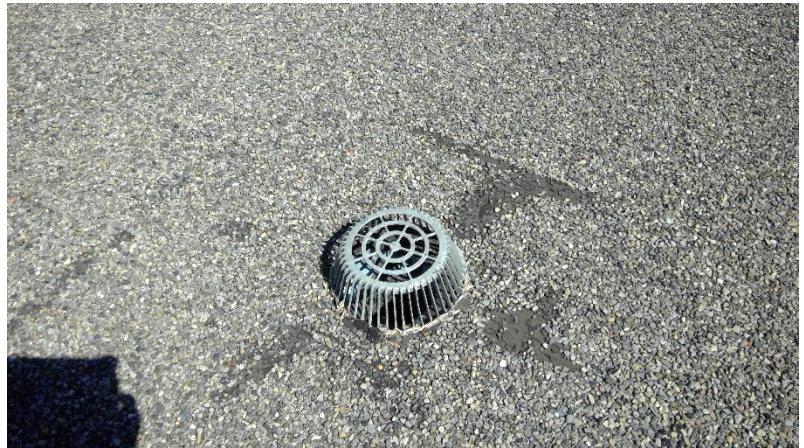
- 5) The Bay – Exposed felts around the drain.

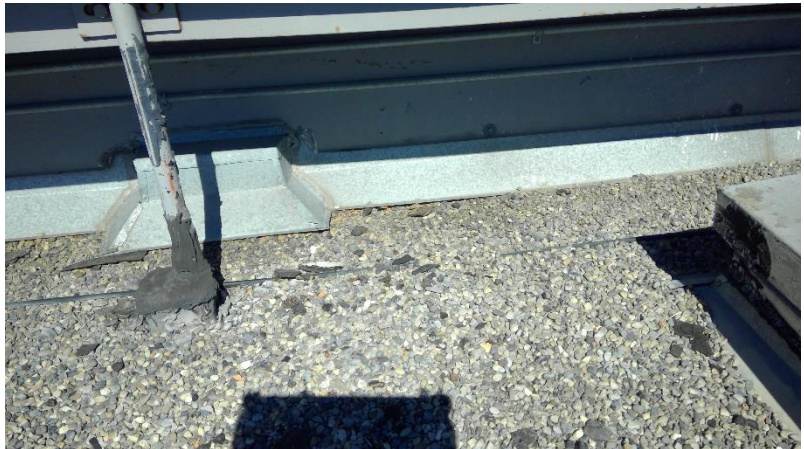
- 6) The Bay – Parapet Wall.

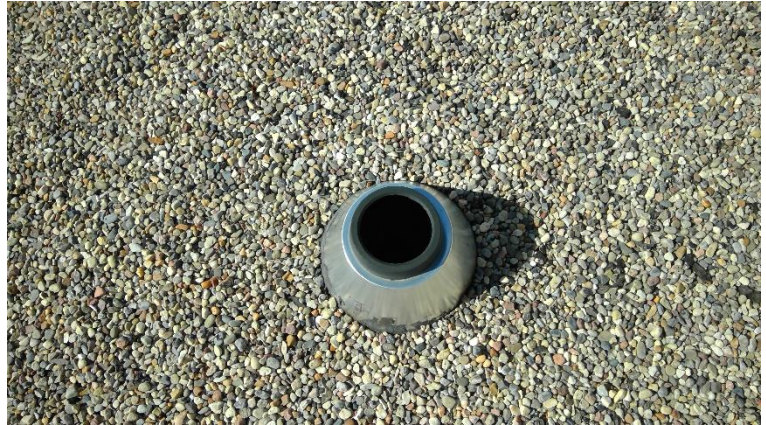
- 7) North Central Mall - Area A Tall cone with no pipe should be capped to keep the water out of the building.

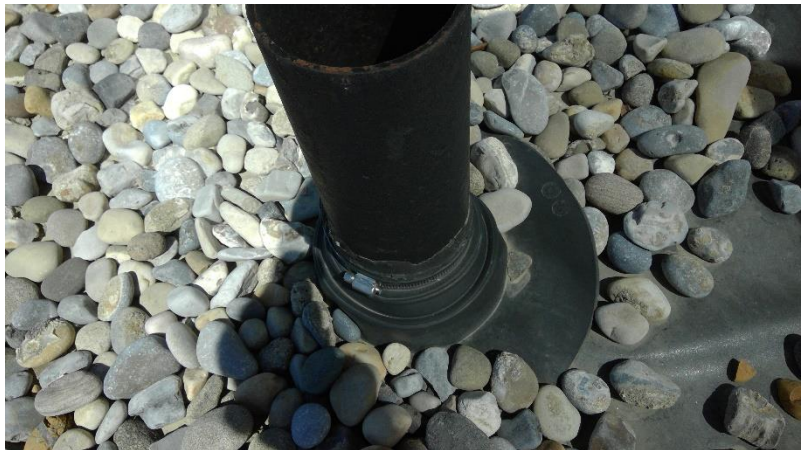
- 8) North Central Mall – Area C Plumbing detail not complete.

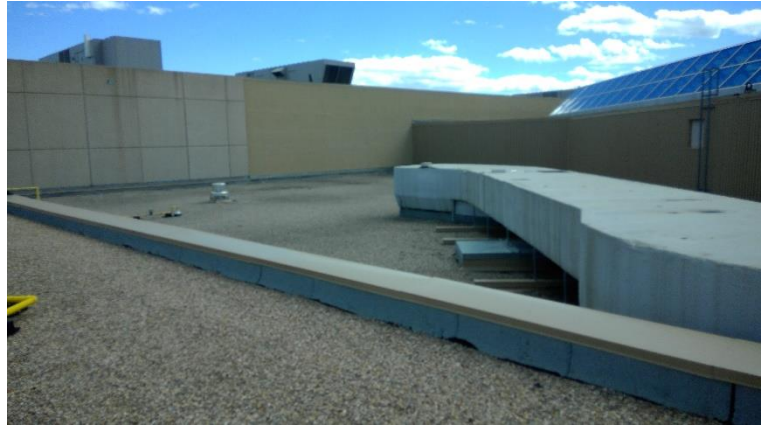
- 9) North Central Mall – Area G overview, this area has some ridging, blisters and blueberries, it is not a high priority but will require reroofing in the next few years.

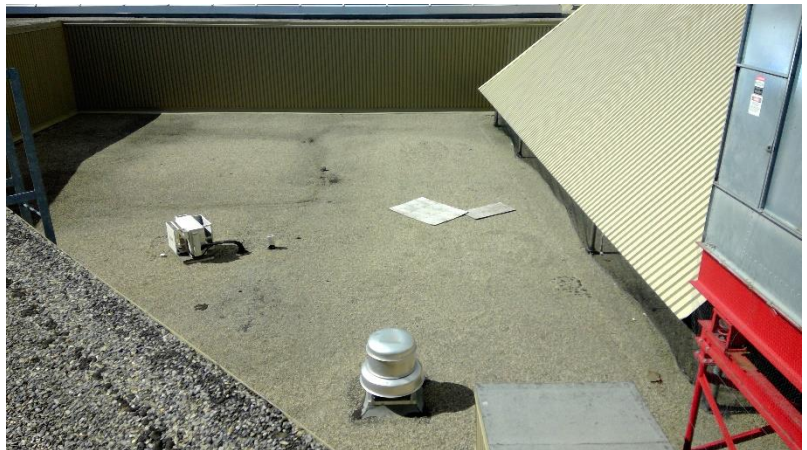
- 10) North Central Mall – Area H overview, this area has some ridging, blisters and blueberries, it is not a high priority but will require reroofing in the next few years.

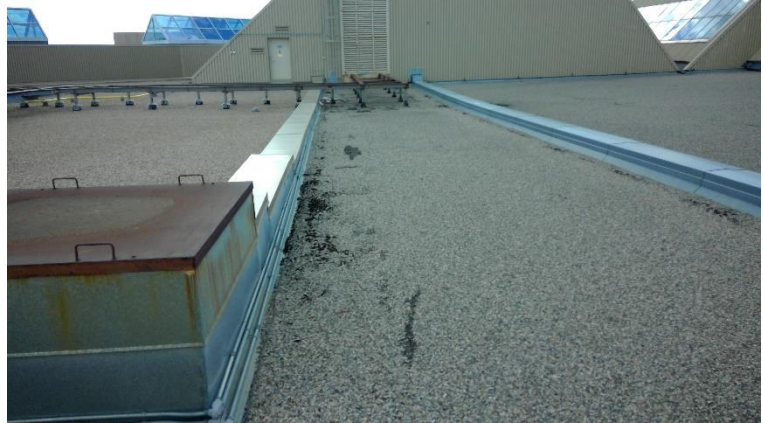
- 11) North Central Mall – Area J overview, this area has some ridging, blisters and blueberries, it is not a high priority but will require reroofing in the next few years.

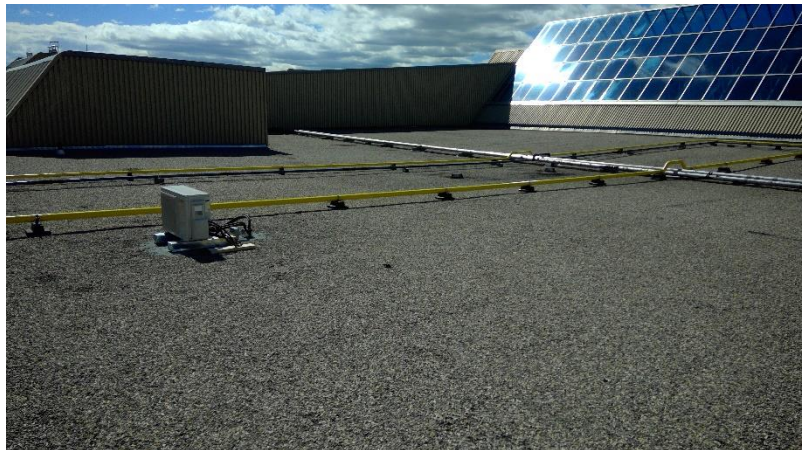
- 12) North Central Mall – Area M overview, this area has some ridging, blisters and blueberries, it is not a high priority but will require reroofing in the next few years.

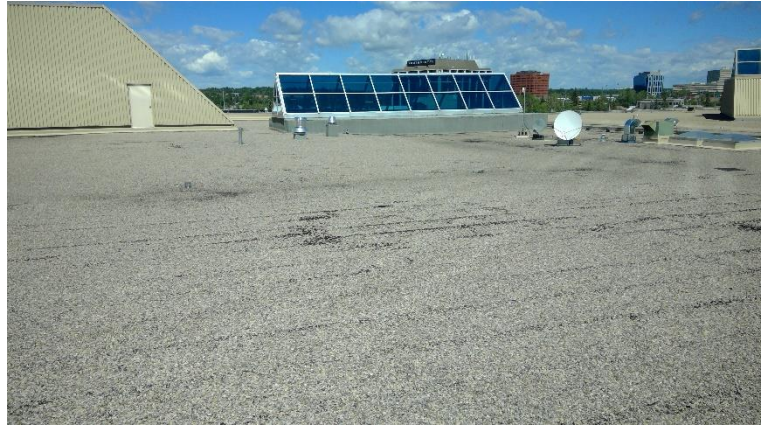
- 13) North Central Mall – Area N overview, this area has some ridging, blisters and blueberries, it is not a high priority but will require reroofing in the next few years.

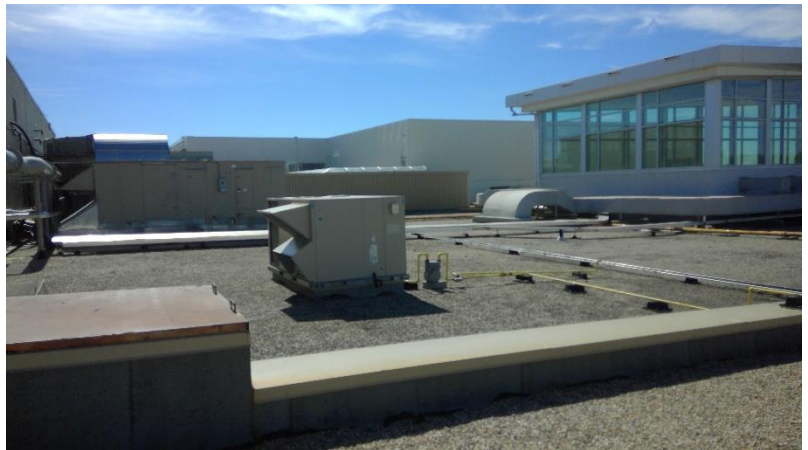
- 14) South Central Mall – Area D overview, this area has some ridging, blisters and blueberries, it also has been leaking frequently and has many repairs. This area is a high priority for reroof.

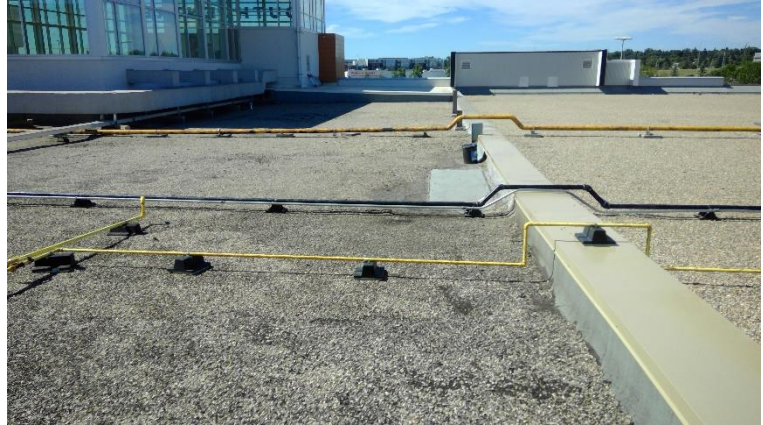
- 15) South Central Mall - Area D recent repairs.

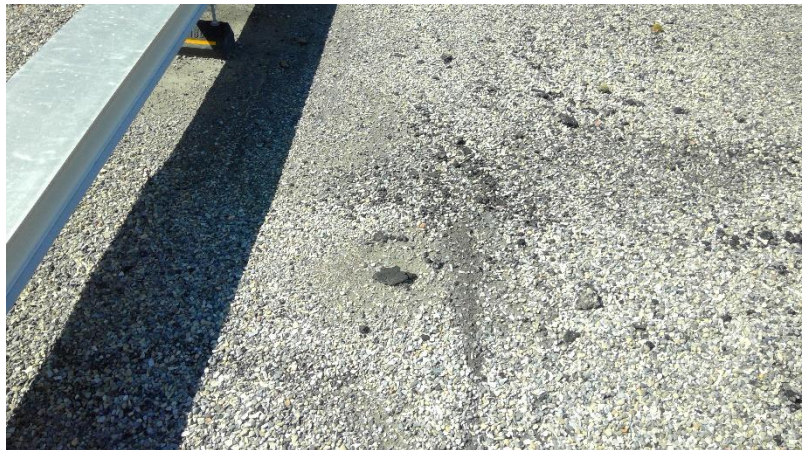
- 16) South Central Mall - Area D Ridging and exposed felts.

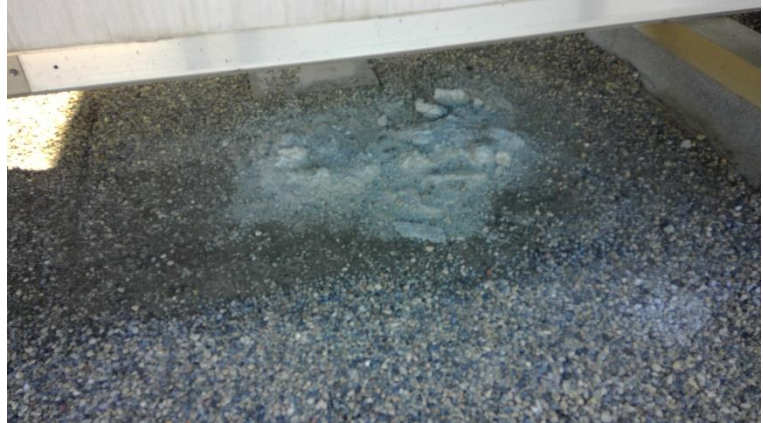
- 17) South Central Mall - Area D
Temporary leak repair.

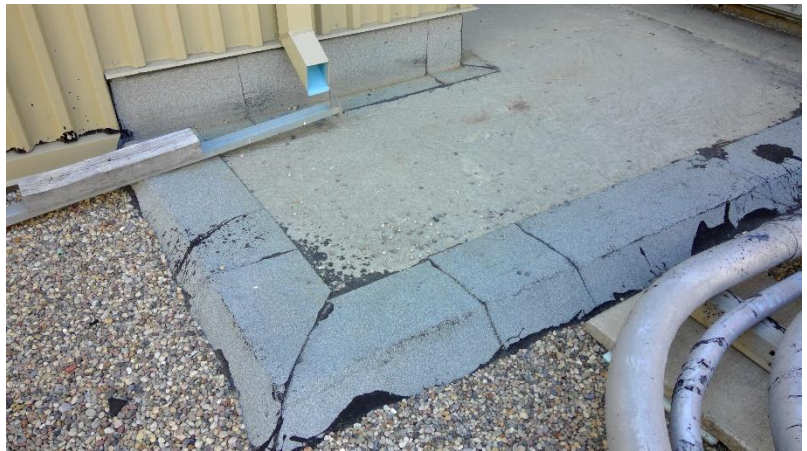
- 18) South Central Mall - Area E, unusual detail, concrete not waterproofed but stripped in at the edges to the roof system. Cracks in the concrete could cause leaks.

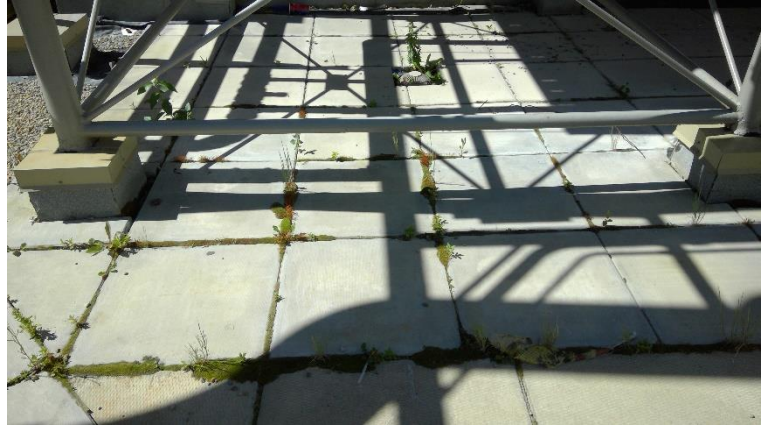
- 19) South Central Mall - Area E vegetize growth between pavers .

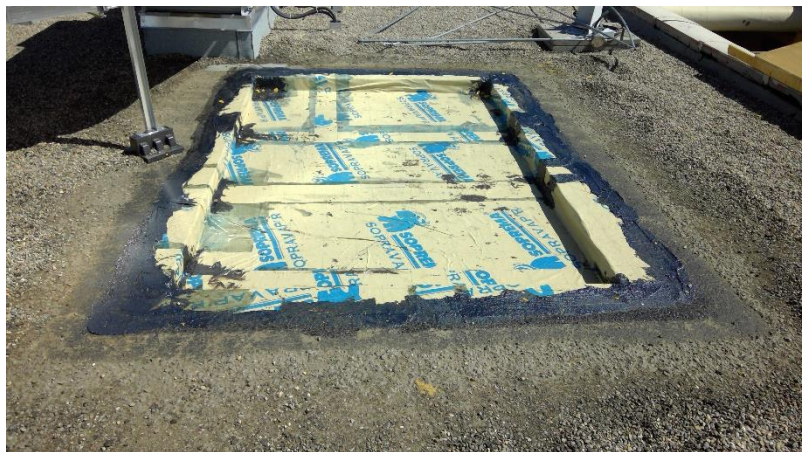
- 20) South Central Mall - Area G , temporary seal for unit install is not adequate for longer term. This should only be used for an overnight seal with little rain expected.

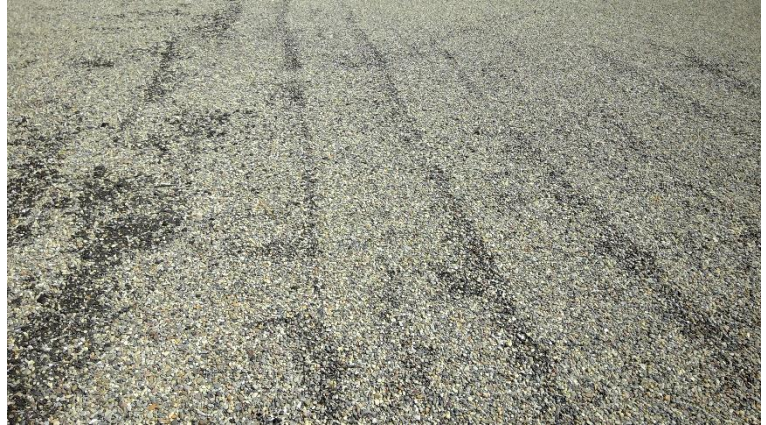
- 21) South Central Mall - Area G Evidence of "sweep prime and repour".

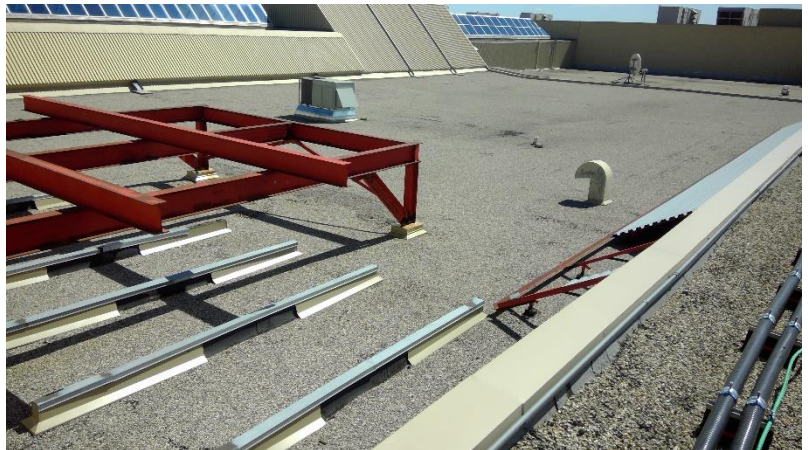
- 22) South Central Mall - Area L Overview. You can see the areas that are starting to rig

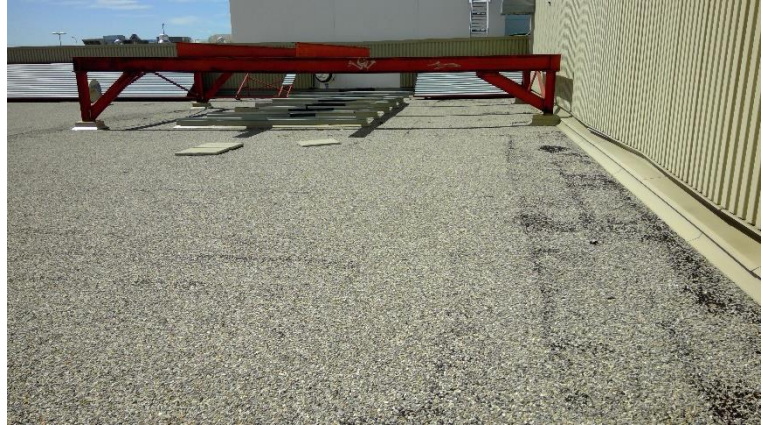
- 23) South Central Mall - Area I Ridges and blisters.

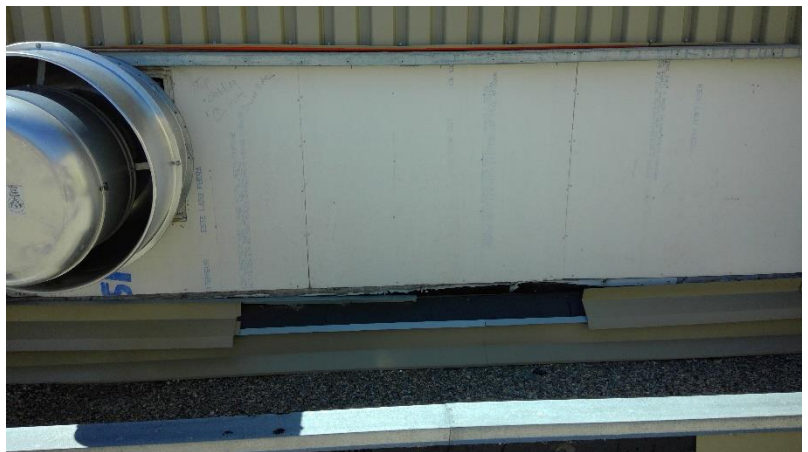
- 24) South Central Mall - Area I Proper cladding should be installed on this detail, wind driven rain can get in the building.

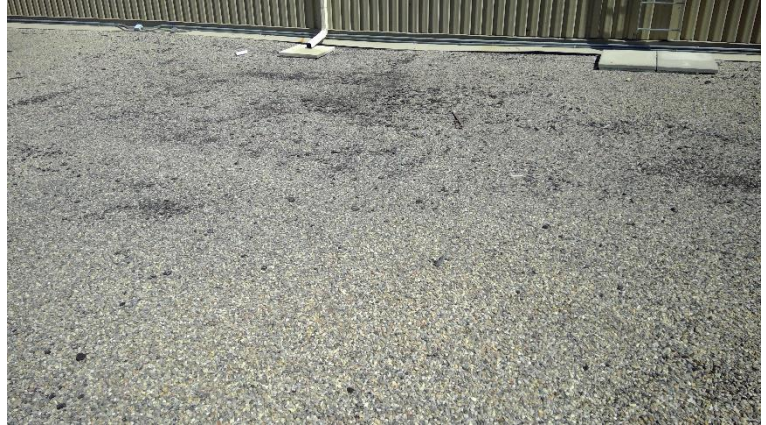
- 25) South Central Mall - Area L Ridging
exposed felts.

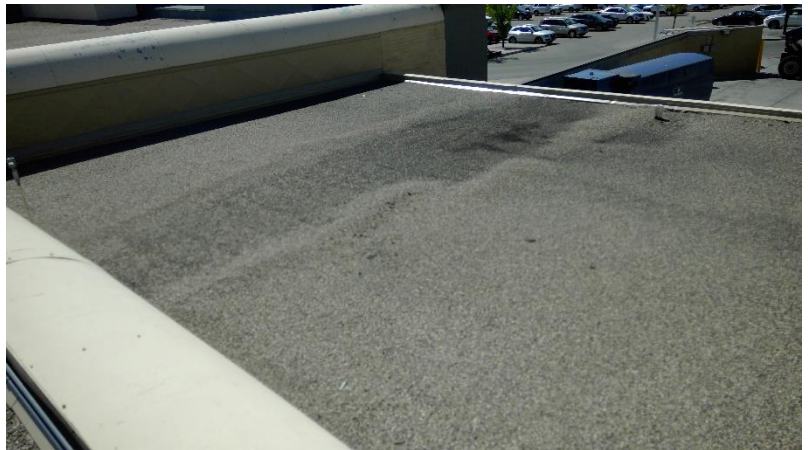
- 26) South Central Mall - Area M evidence
of repairs.

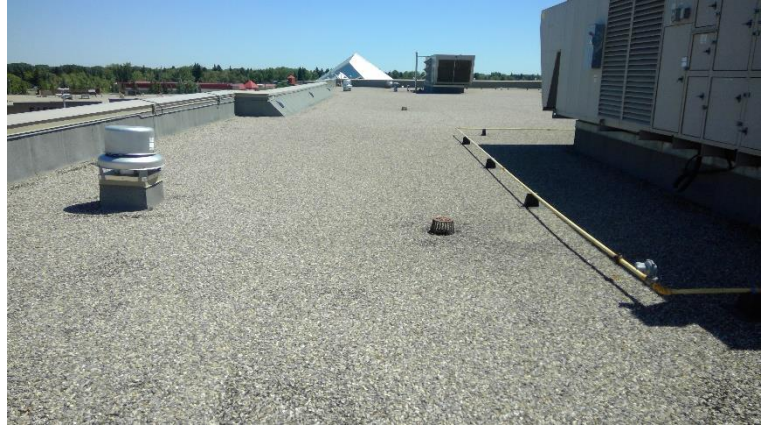
- 27) Sears, north parapet, 2 blisters near the north-east corner.

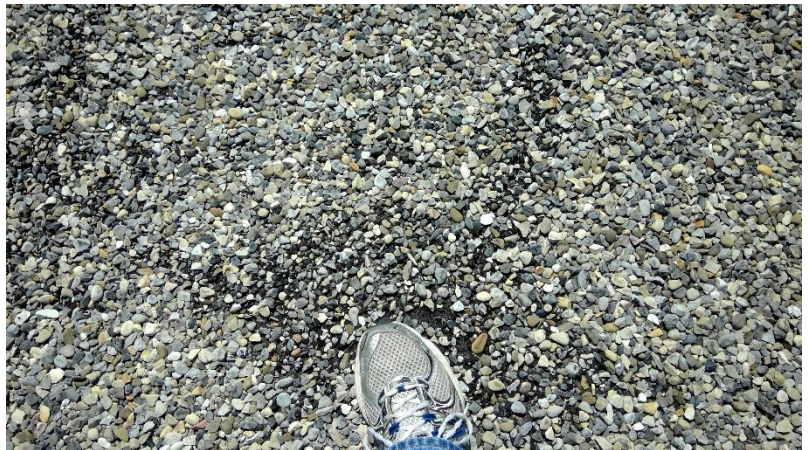
- 28) Sears, blisters near the north-east corner.

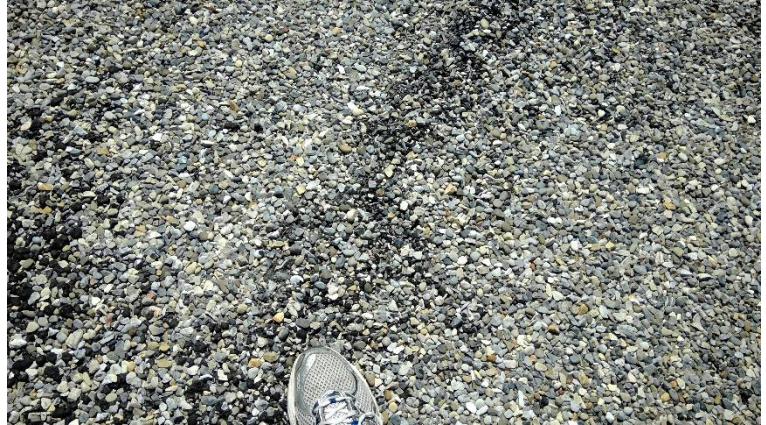
- 29) Sears, 2nd blisters near the north-east corner.

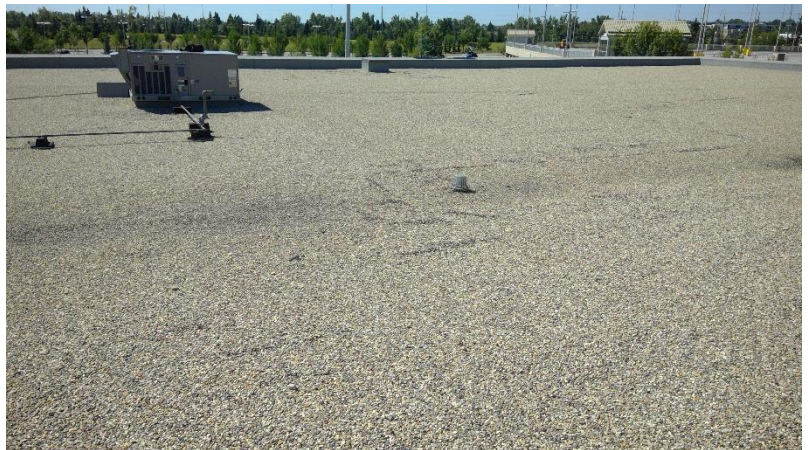
- 30) Safeway, the south 1/3 of the roof is in very poor shape blisters and ridging is everywhere.

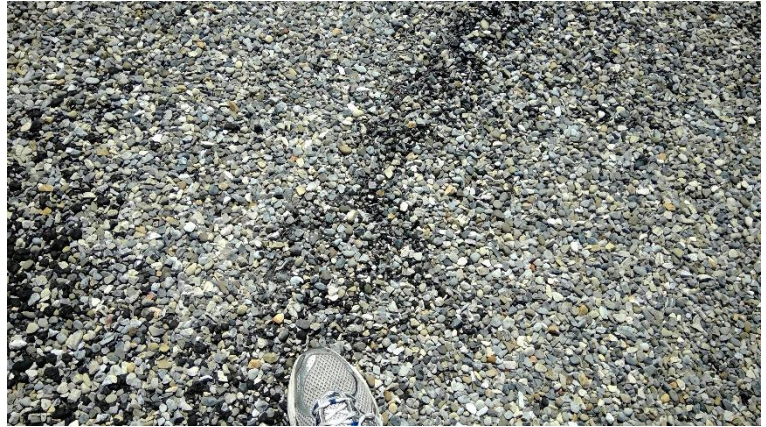
- 31) Sears, 2nd blisters near the north-east corner.

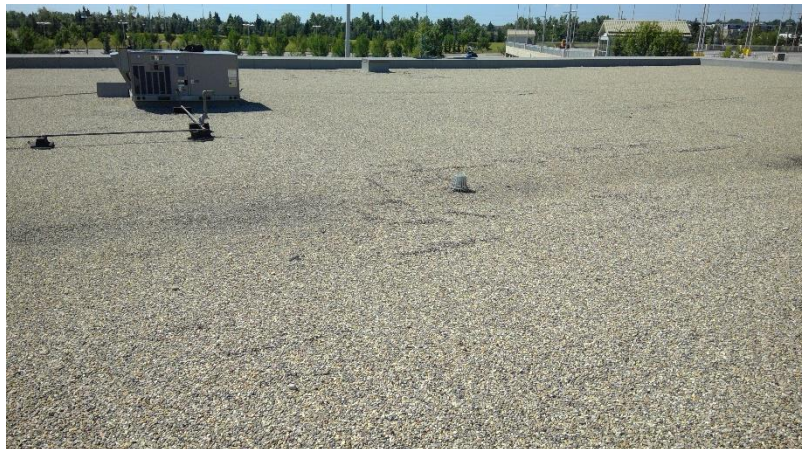
- 32) Safeway, the south 1/3 of the roof is in very poor shape blisters and ridging is everywhere.

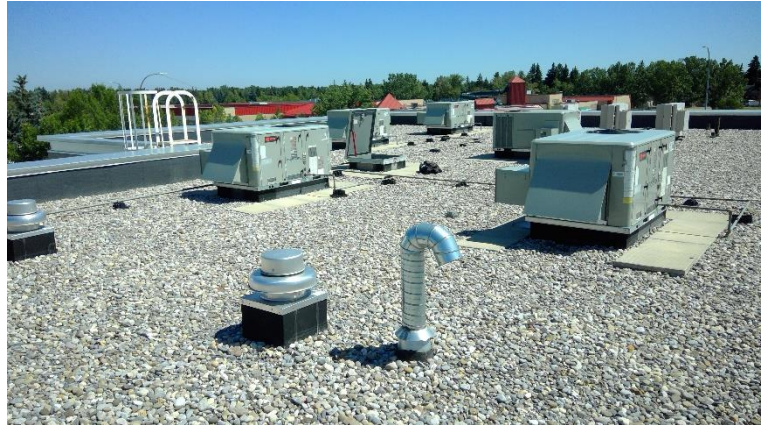
CIBC – This roof is in good shape and I found no issues.

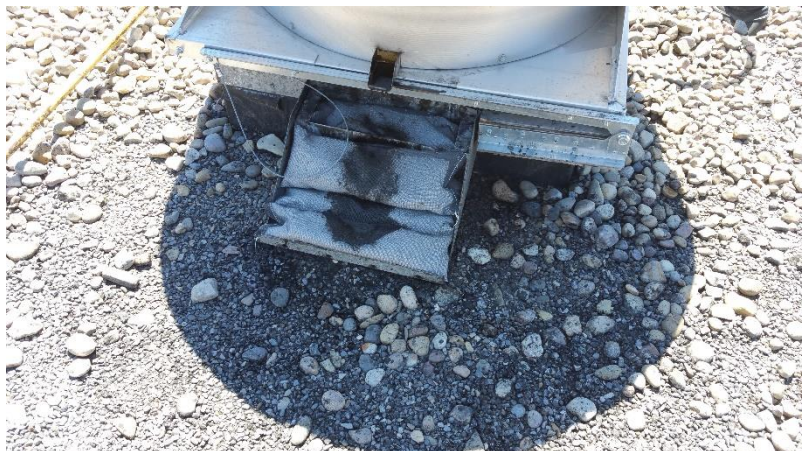
- 33) Milestones – This grease collector is not working properly and allowing grease onto the roof. This could damage the roof over time.

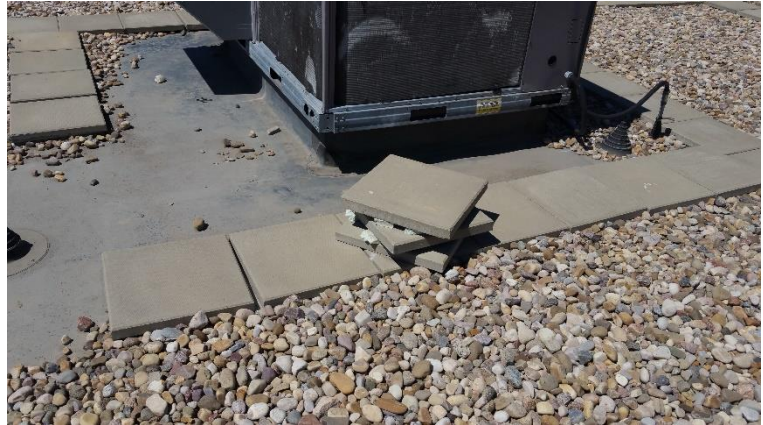
- 34) Milestones – Displaced pavers and gravel should be replaced.

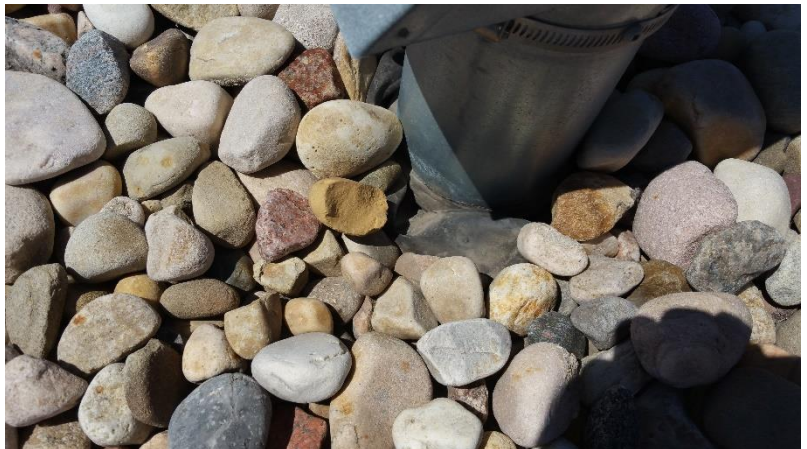
- 35) Milestones – 2 vents look like they were pulled down after they were sealed, these should be resealed as the seal is almost at the membrane surface.

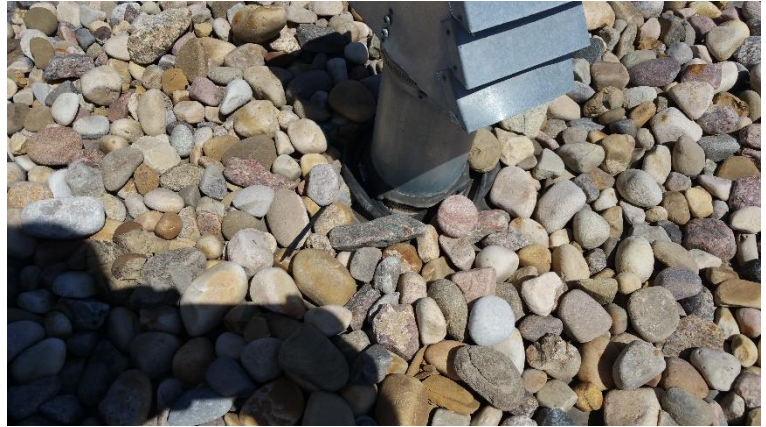
36) Milestones – Seal to low at vent.
