2021 [REDACTED] Roof Review

Main Mall Building

Office Tower

Roof Review [REDACTED]

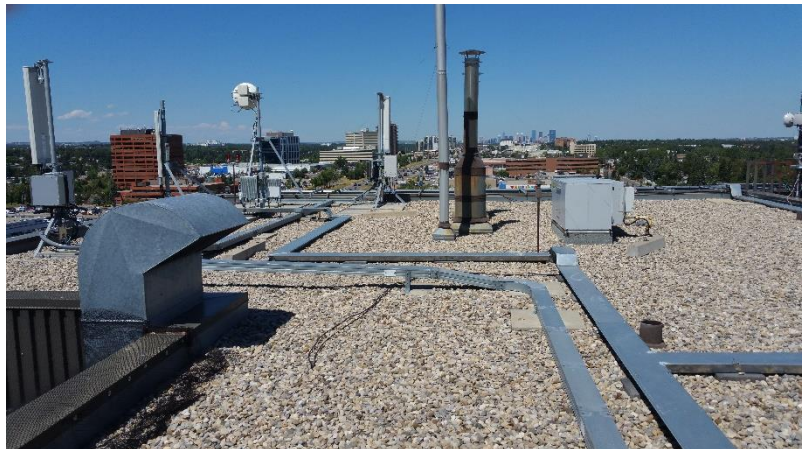
37) Office Tower – No issues.
