## 2019 Schools Roofing Review

**O'Neil Consulting**

December 31, 2019

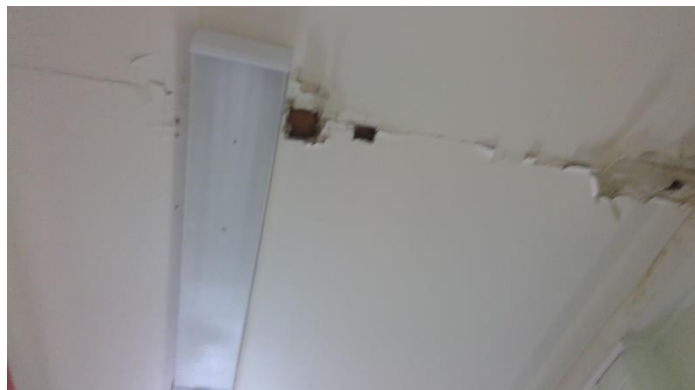
### 2) Ceiling damage at the transition from the sloped metal to the SBS roof, east end.

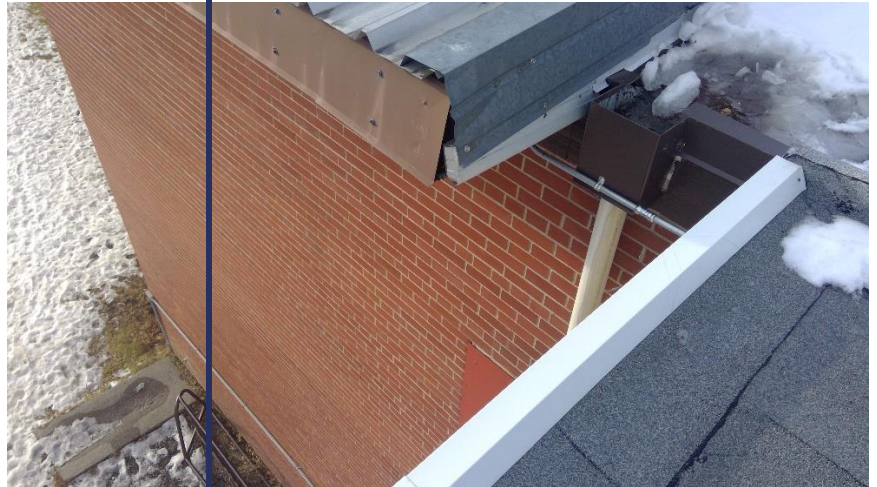
- 3) Area over the ceiling damage, the transition area is coming apart and should be taken apart and redone.

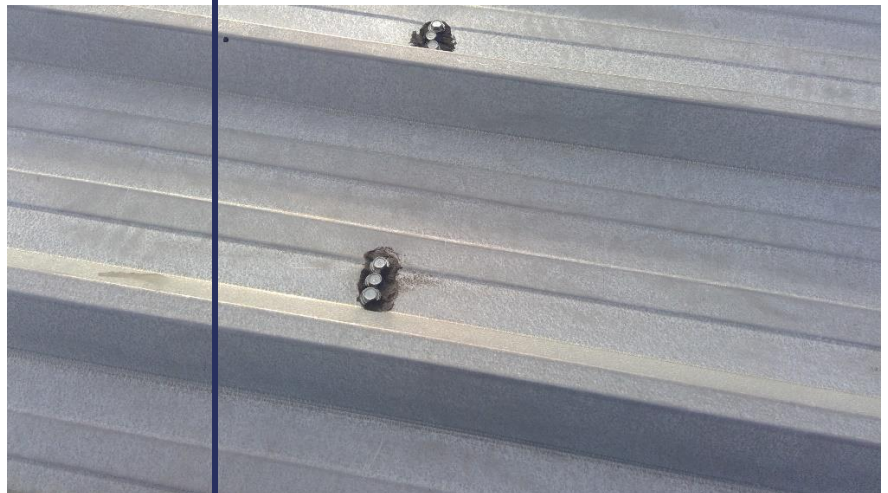
- 4) Neoprene fastener repairs on the sloped metal roof, the condition of these fasteners should be monitored and replaced before leakage occurs. The neoprene becomes brittle due to UV exposure and can cause leaks into the fastening layer, this can cause rotting and fastener failure.

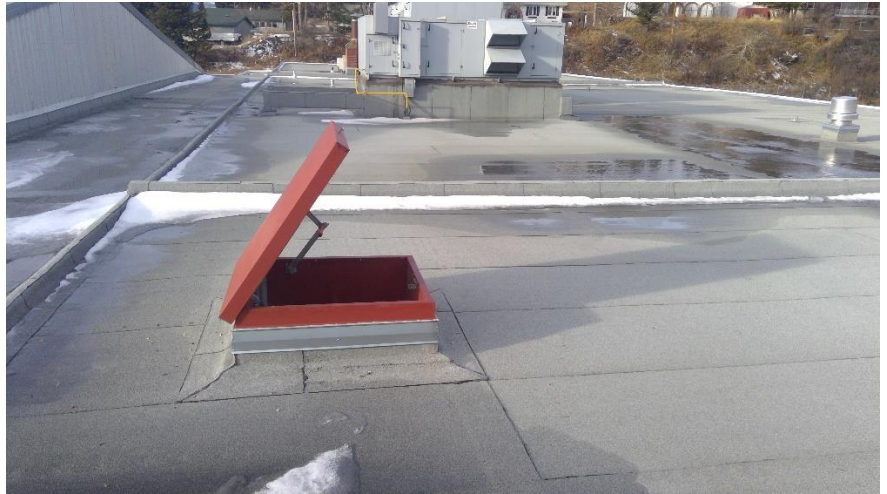
- 5) The low slope SBS roof area is in good shape and should last for many years. There is ponding in some areas.

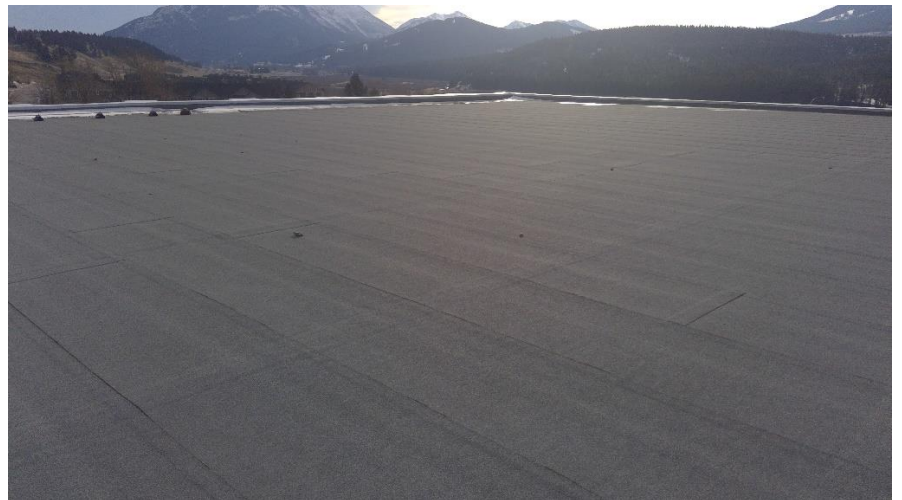
- 10) SBS gym roof is in good shape and should provide years of additional service life.

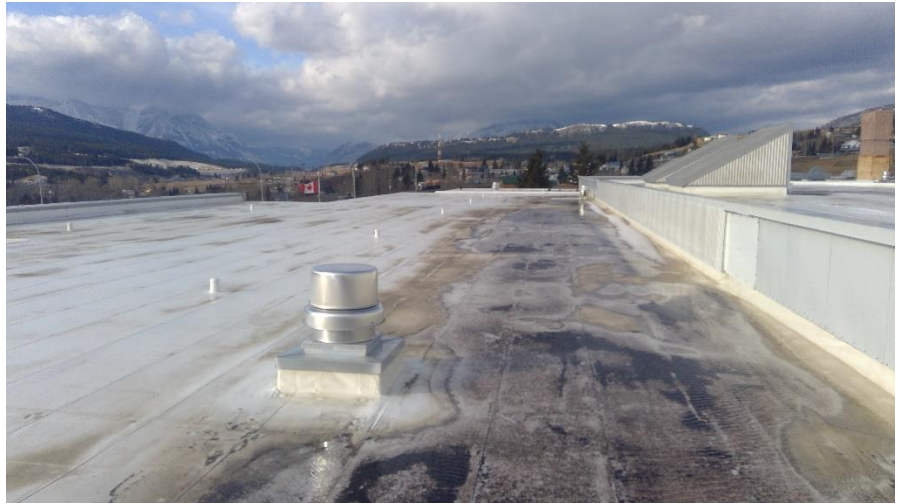
- 11) There are areas of severe ponding on the PVC roof areas.

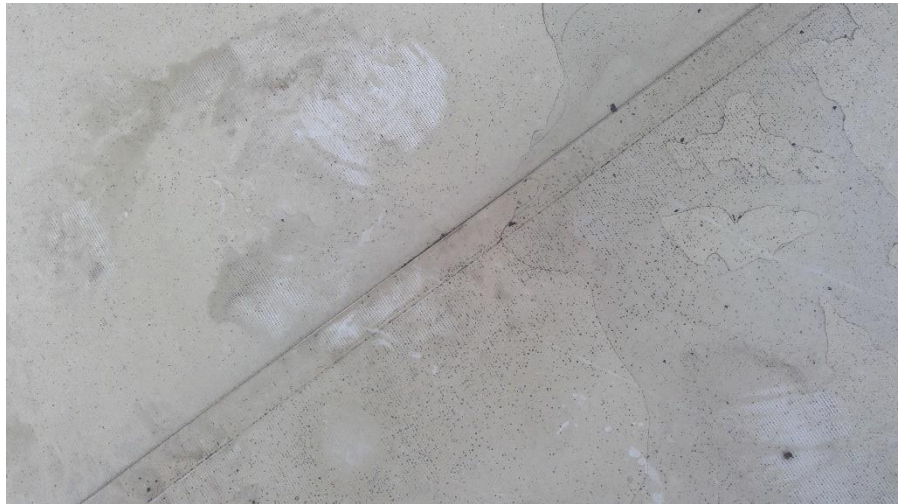
- 12) Exposure of the reinforcement in the PVC roofs due to UV exposure, This would indicate failure within the next few years.

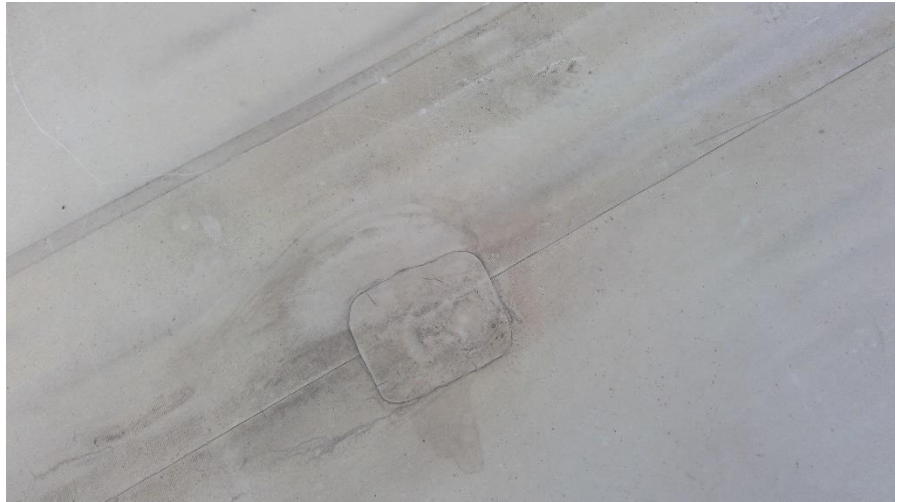
- 13) Repair to an area where the fastener protruded through the roof membrane.

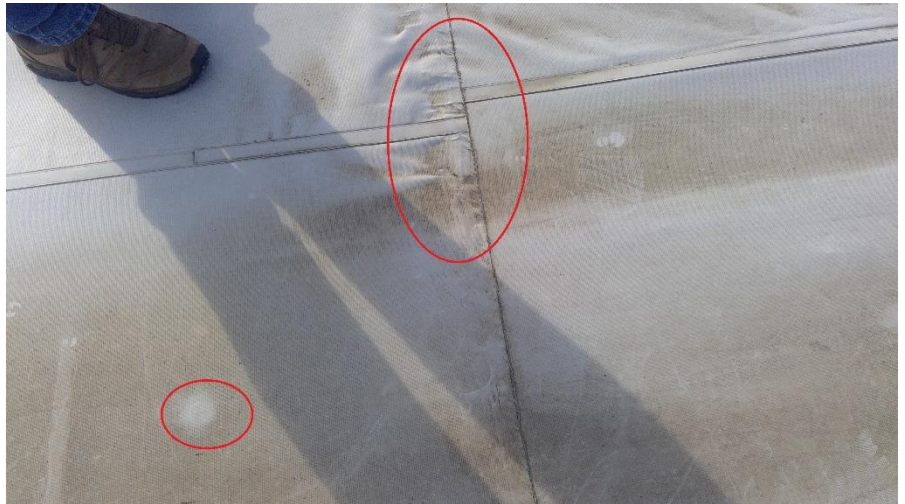
- 14) Protruding fastener (small circle)  
repaired seam (large circle)

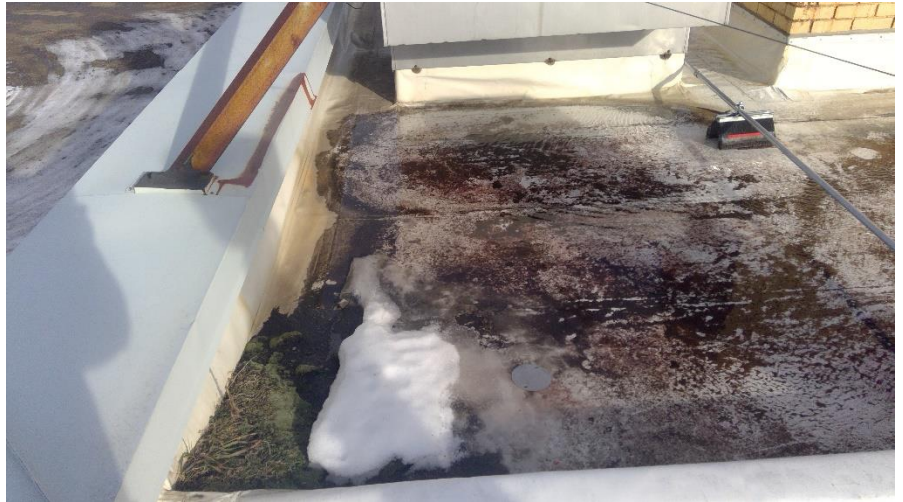
- 15) Sever ponding in some areas.

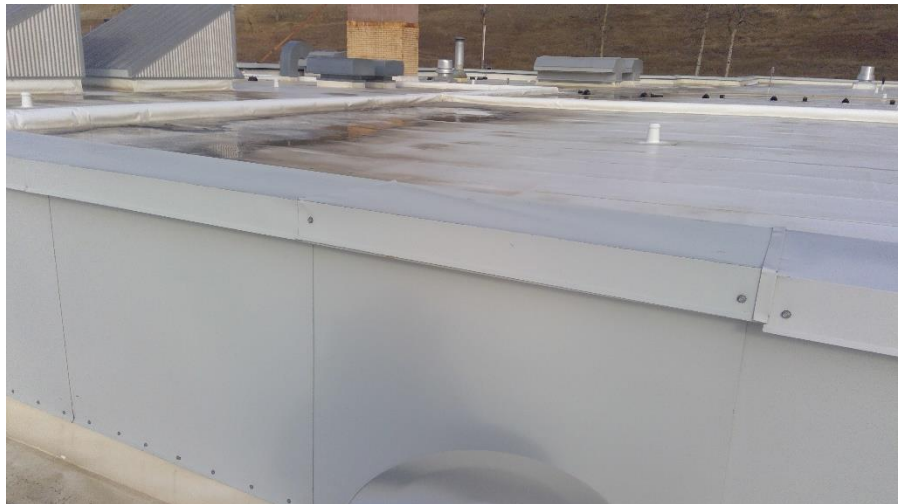
- 16) Metal flashing has been refastened after partial blow of in the wind.

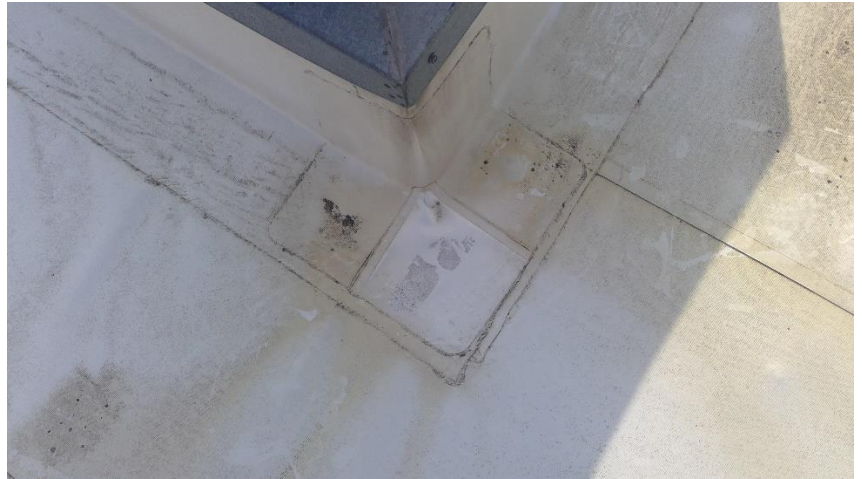
17) Patch repair on a unit curb corner.

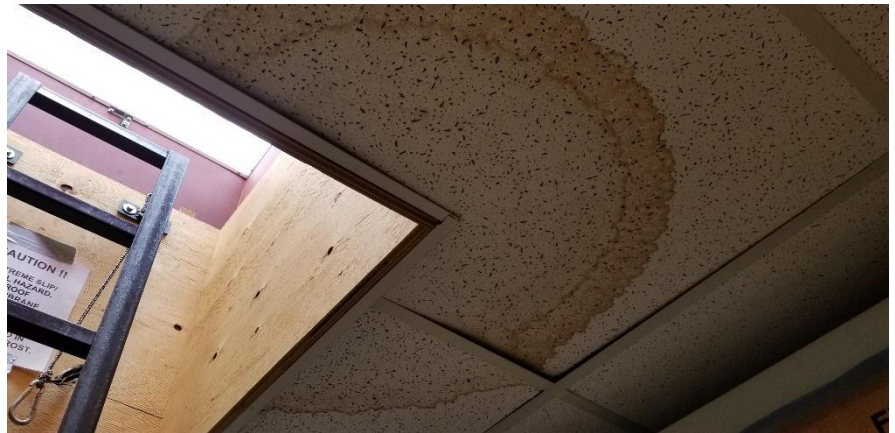
20) Evidence of roof leakage under the roof hatch on the PVC roof area.

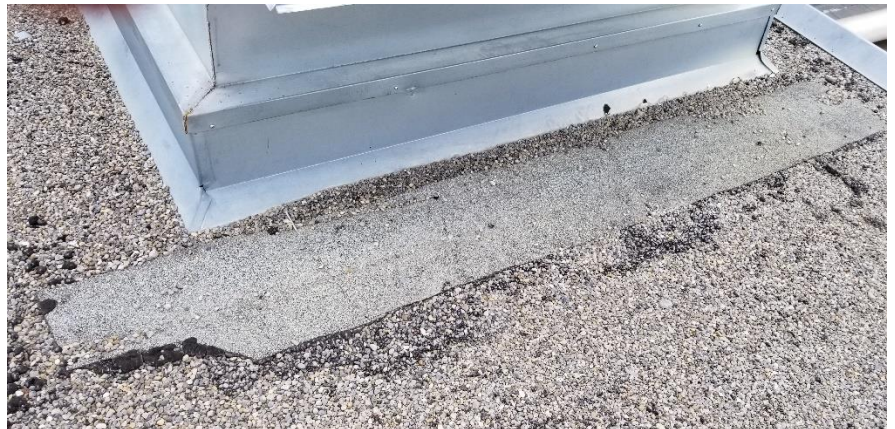
22) Repairs by the RTU on the BUR roof.

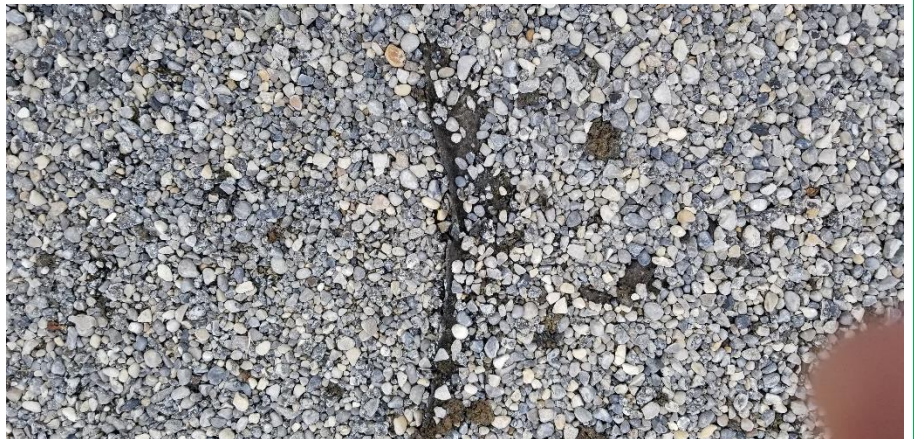
- 24) Felt exposure and evidence of blistering on the BUR roof.

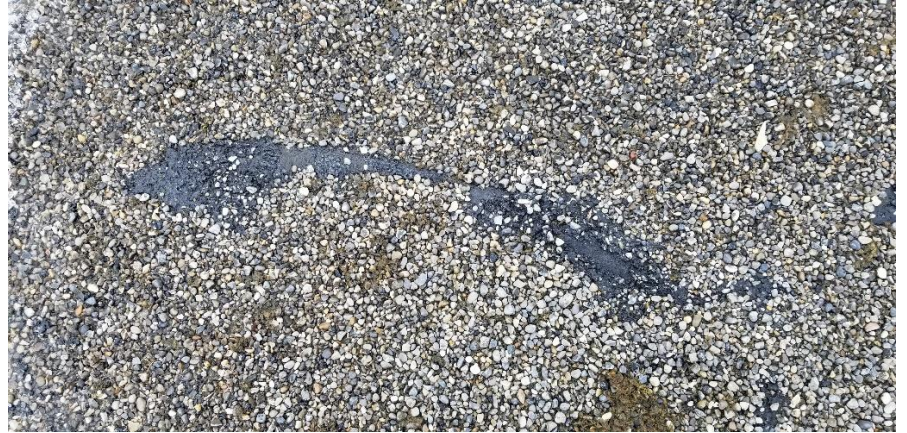
- 25) Felt exposure and evidence of blistering on the BUR roof.

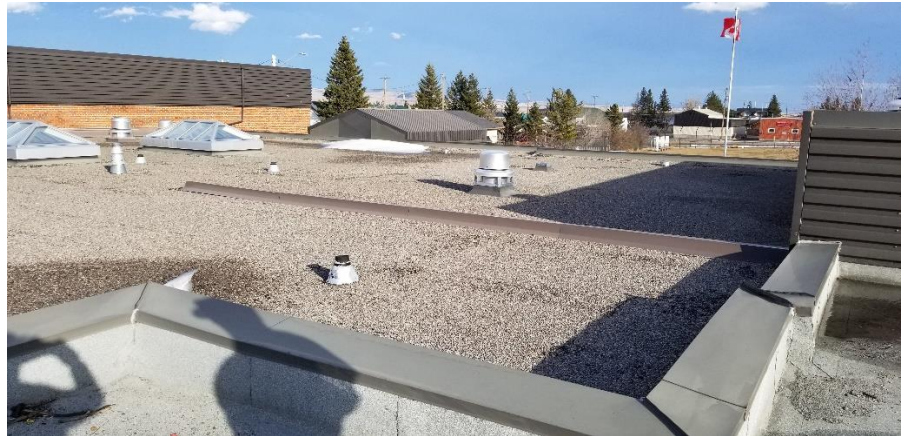
- 27) BUR Roof section evidence of blistering, felt exposure is prominent.

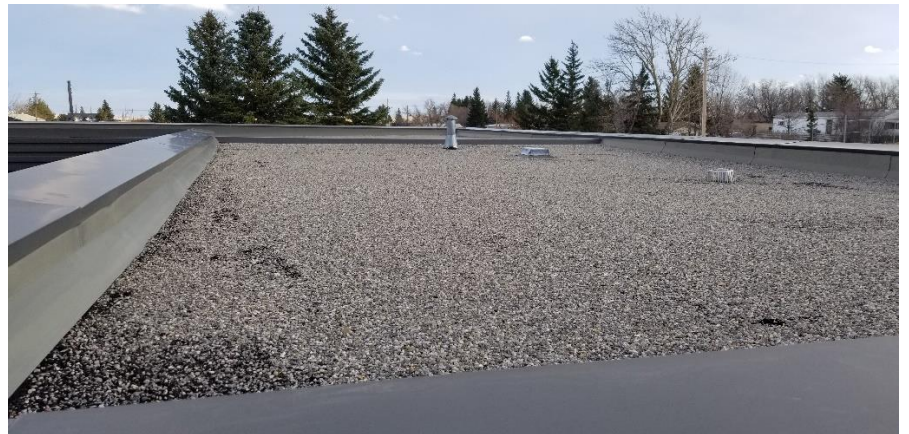
- 28) The BUR areas to the south are not quit as bad.

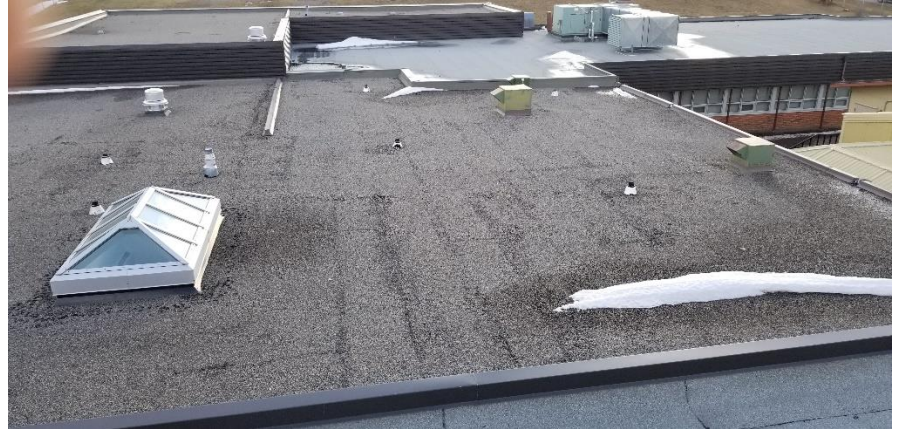
- 29) Exposure of the felt seams and asphalt exposure on the BUR roof.

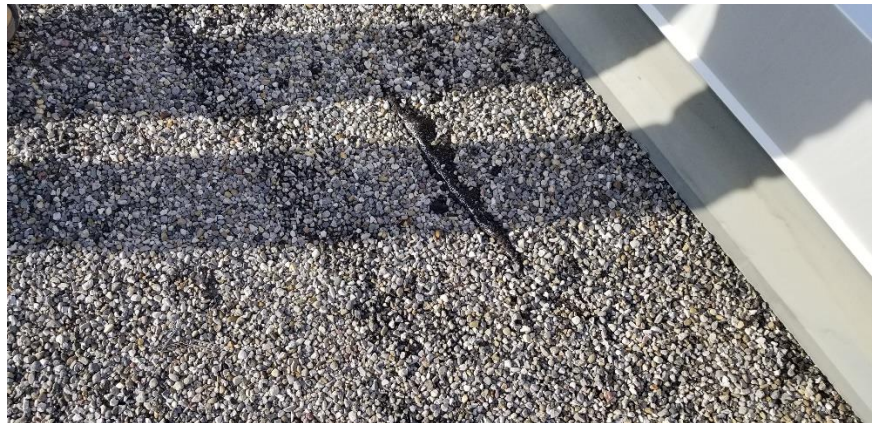
- 30) Felt exposure typical.

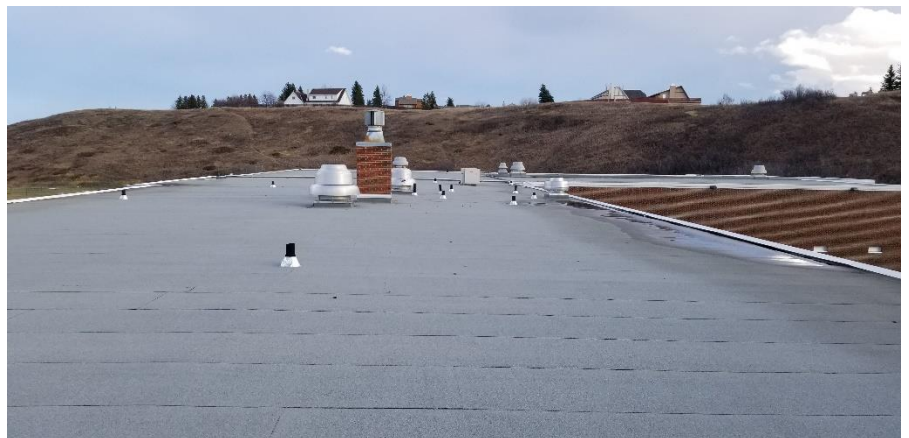
32) The roof is SBs and for the most part is in good shape; some minor repairs are required.

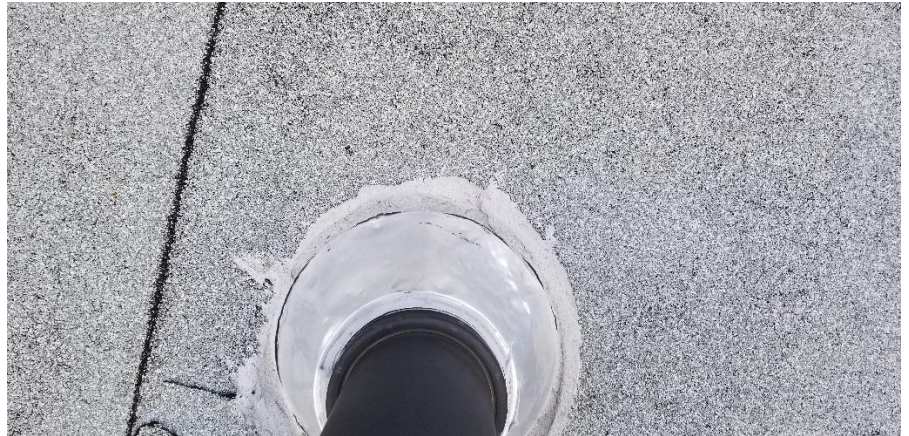
- 33) The seal around some plumbing vents has cracked and should be resealed.

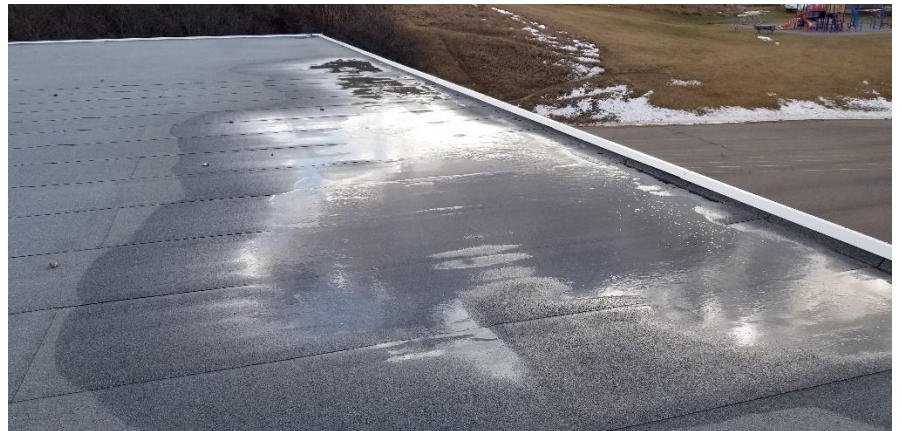
- 34) Some areas of ponding water.

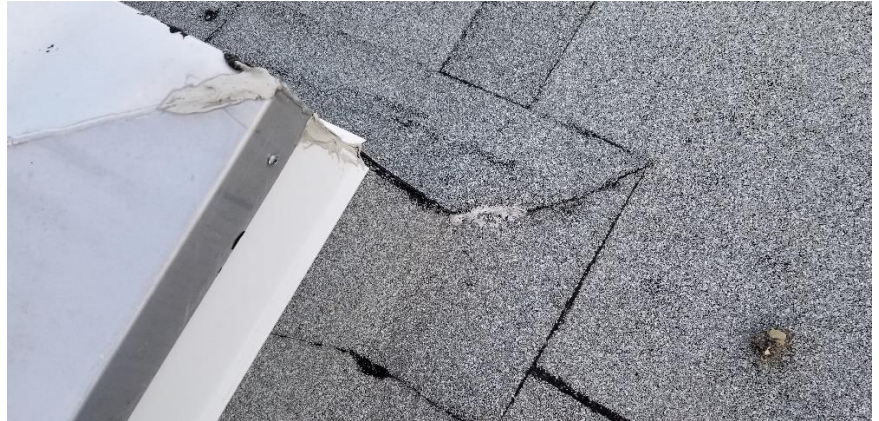
35) Evidence of repair.

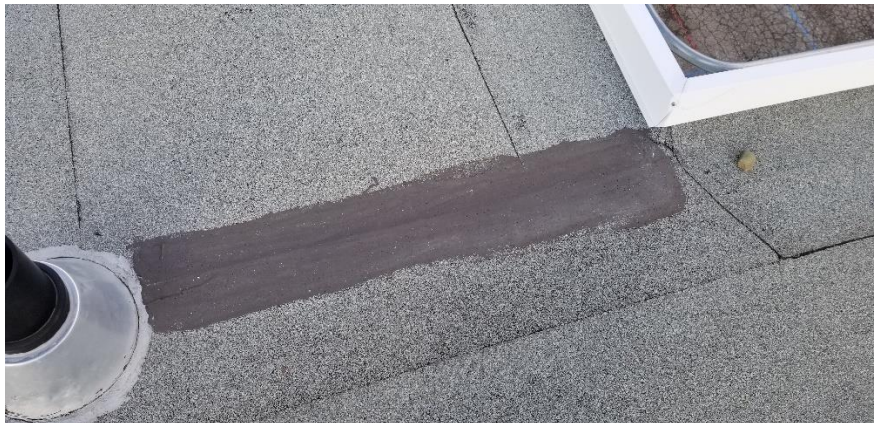
36) Repaired seam.

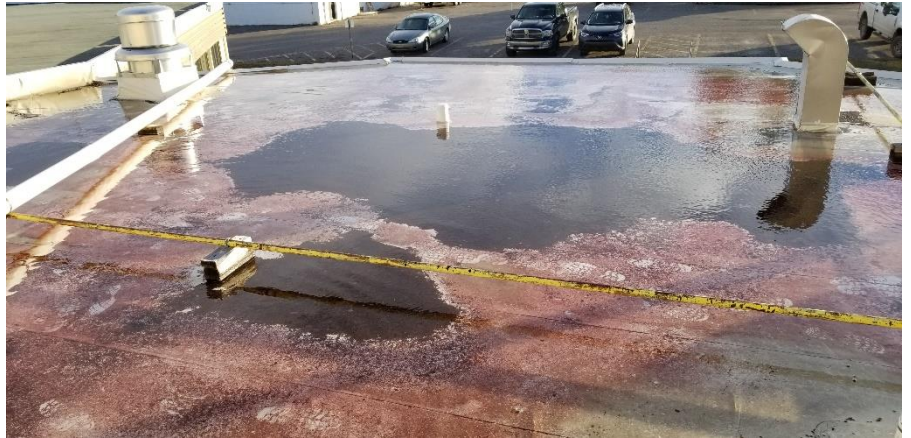
39) Substantial ponding in many areas.

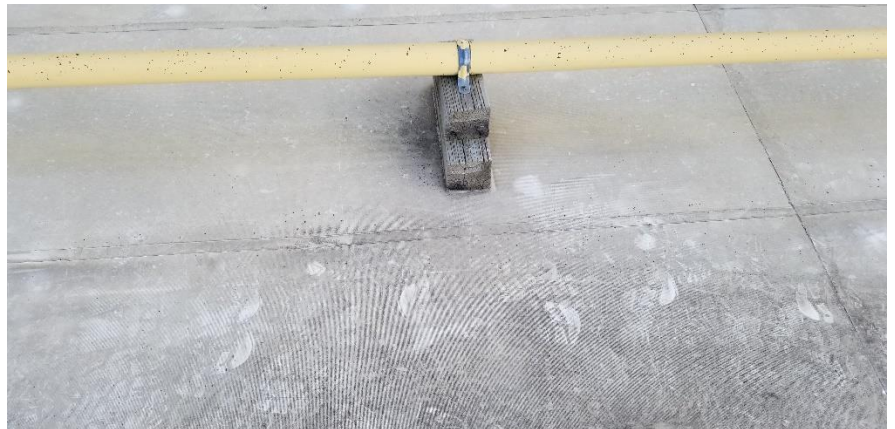
40) No membrane protection under pipe supports.

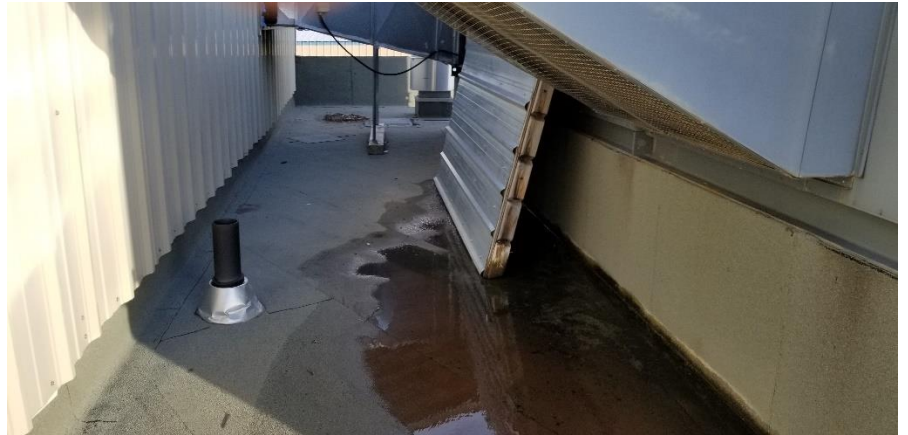
- 43) The roof should be protected under the panel in this picture.

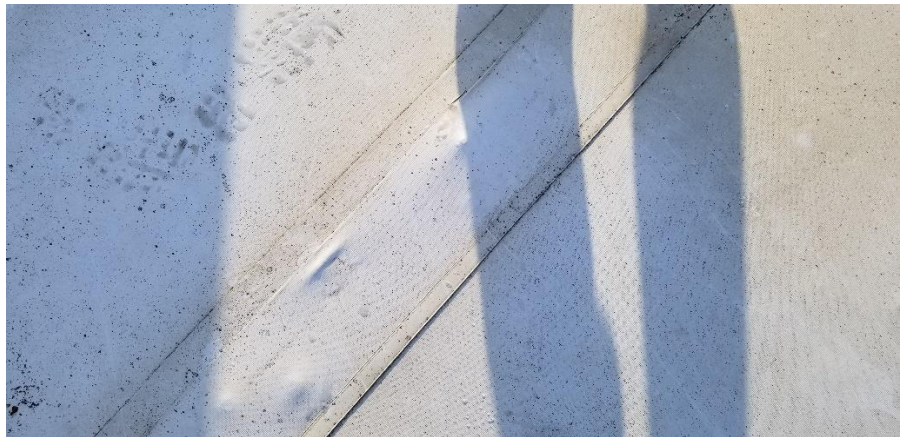
- 44) Fasteners protruding above the insulation could work their way through the roof membrane. Also, there is evidence of damage to the membrane from UV exposure, exposed reinforcement.

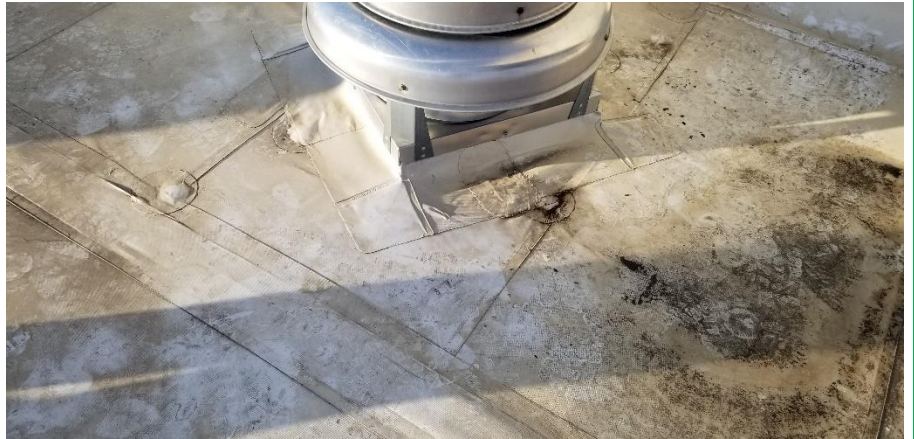
- 45) This curb is much lower than the industry standard of 8 inches.

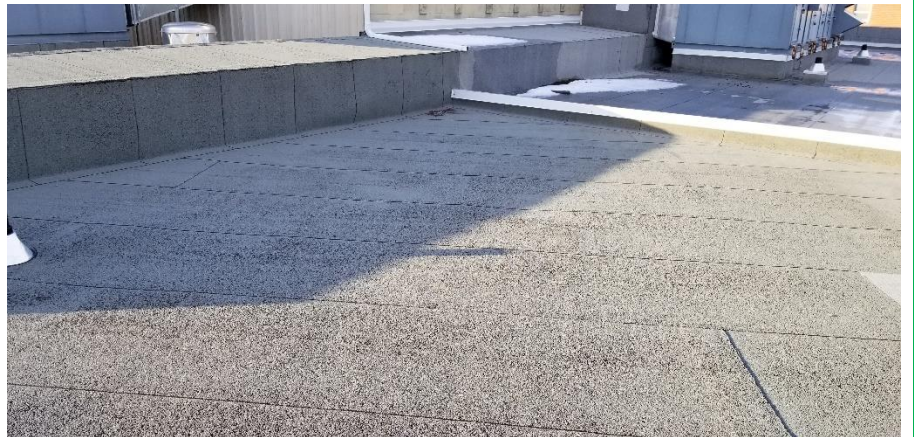
- 46) Siplast roof area with granule loss, failure is not imminent, but this is a rare opportunity to recap rather than reroof.

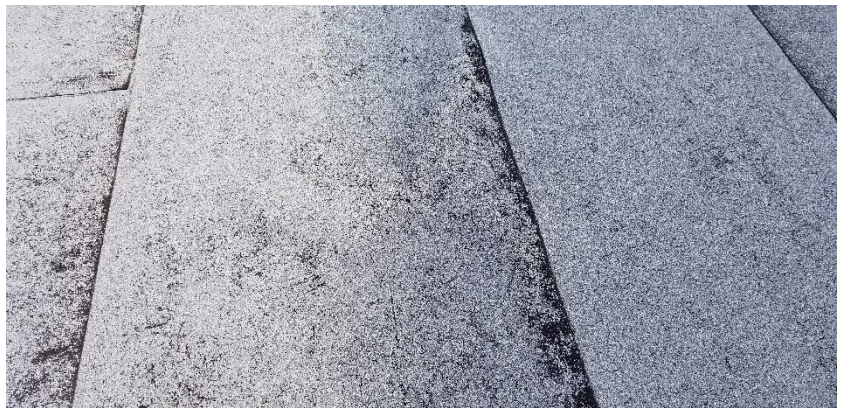
48) Granule loss in some areas

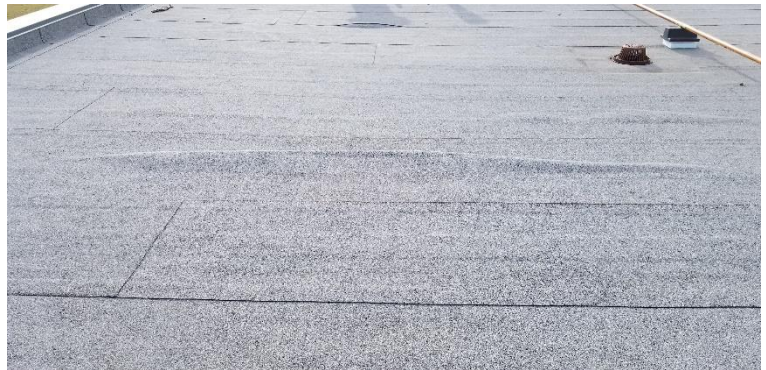
49) Interply blistering should be repaired.

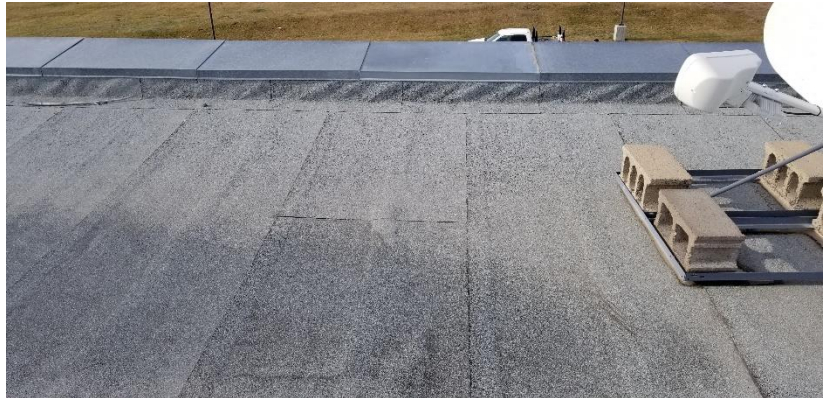
51) Tenting membrane on the parapet.

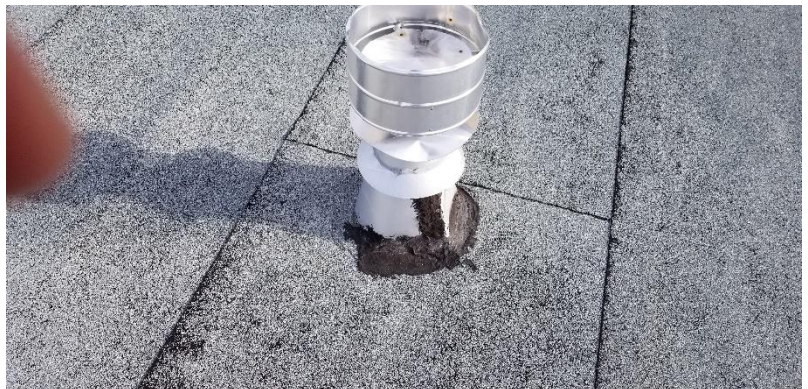
52) Damaged vent.

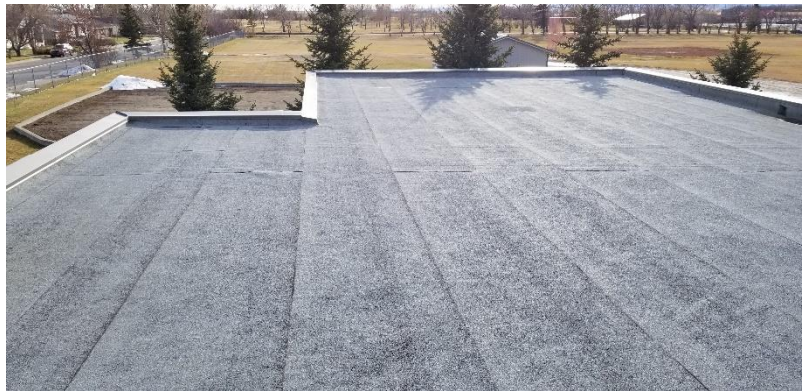
54) The cap membrane has granule loss in many areas.

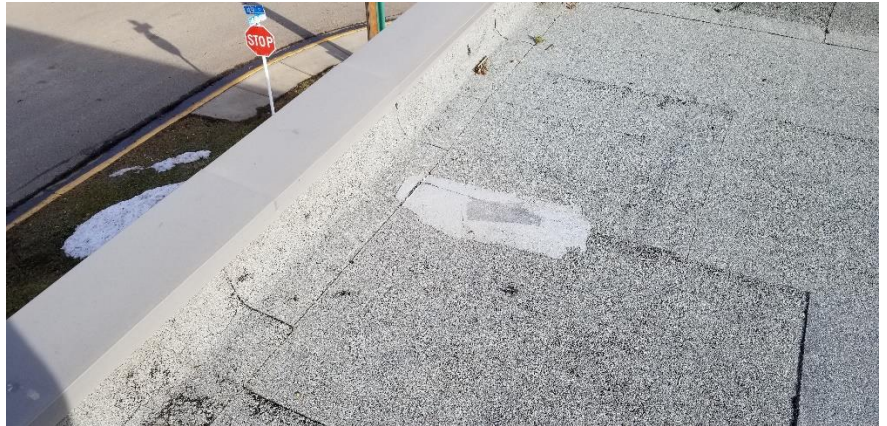
- 55) Evidence of numerous repairs on the roof.

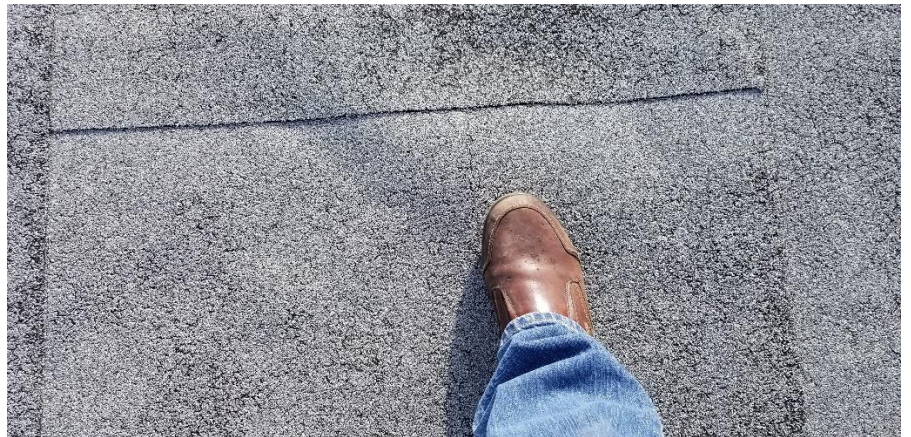
- 56) There is interply blistering in some areas, this should be monitored.

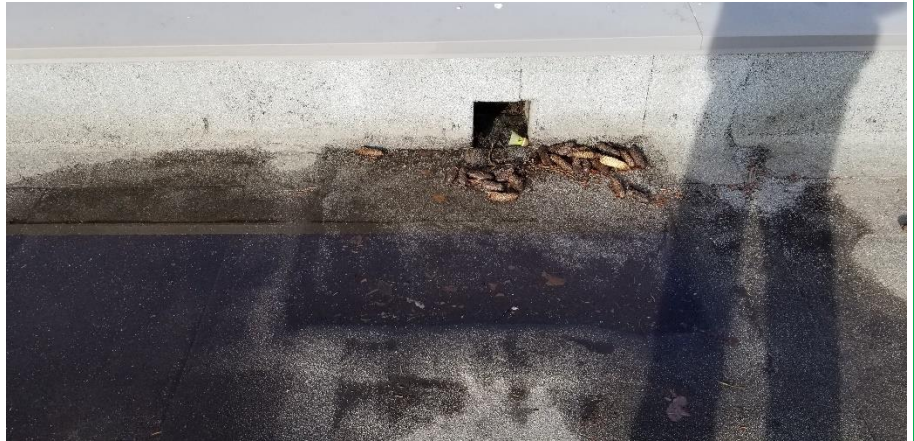
- 57) Debris should be removed on the upper north roof.

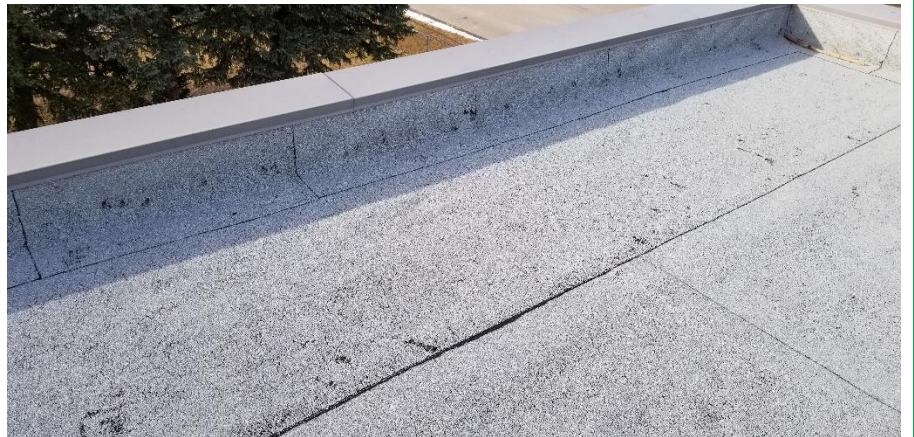
- 58) Some tenting on the parapets, this should be monitored.

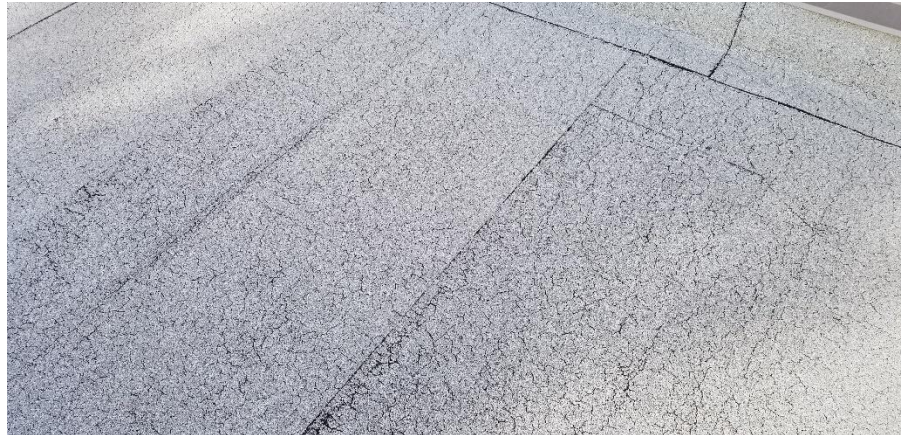
- 59) Blistering and crazing in the membrane in areas exposed to the most heat, this should be monitored.

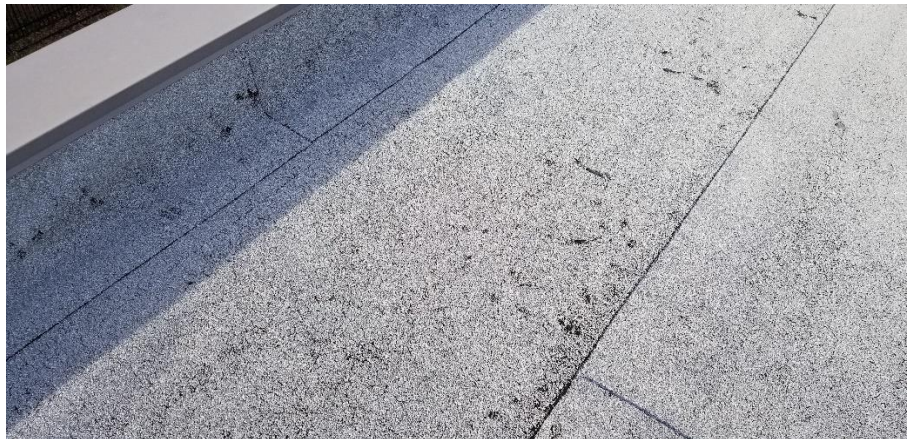
- 60) Evidence of hail damage in some areas.

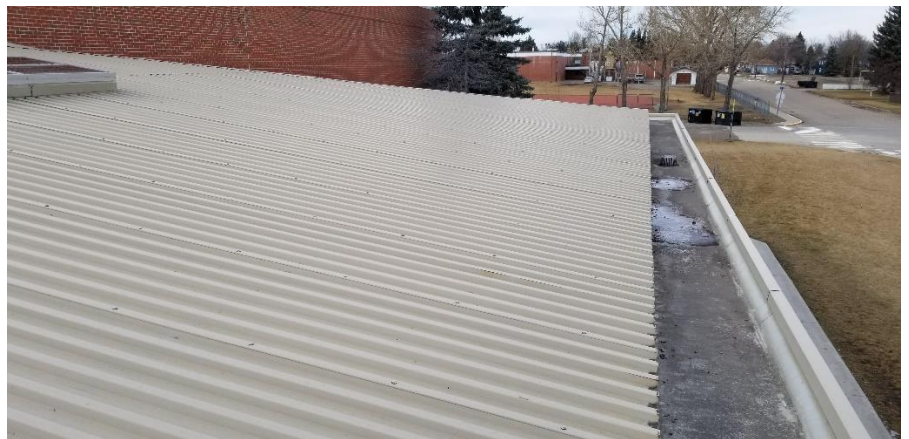
62) Gutters around the steep-slope roof should be cleaned.

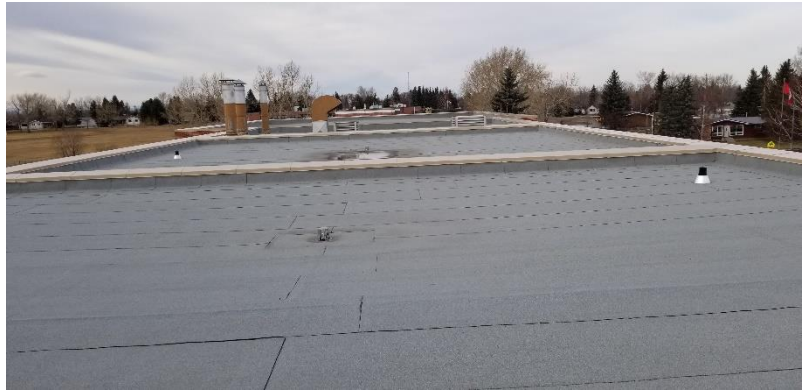
- 63) Upper SBS roof is relatively new and has no apparent issues.

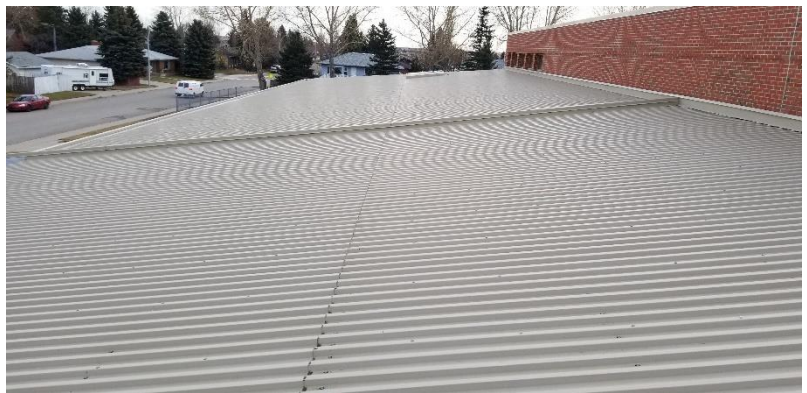
- 64) Sloped metal roof is fastened by screws with neoprene seals, these should be monitored as the neoprene becomes brittle over time due to UV and this can cause leaks into the fastening surface and possible rotting.

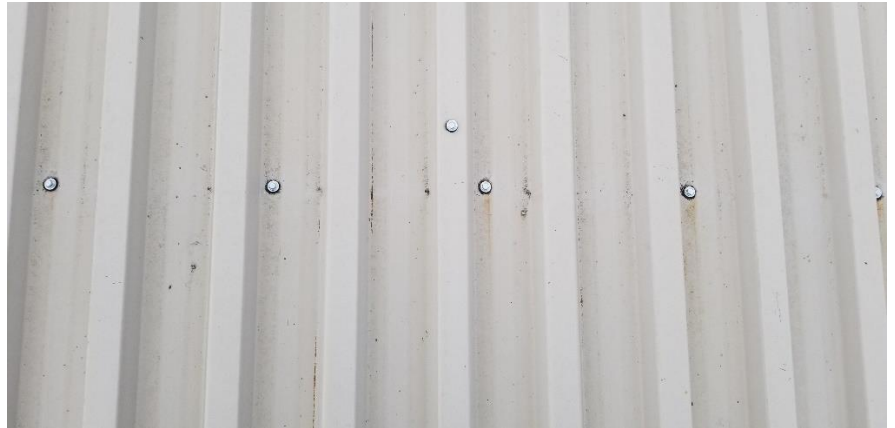
- 65) These fasteners look relatively new so some may have been replaced already.

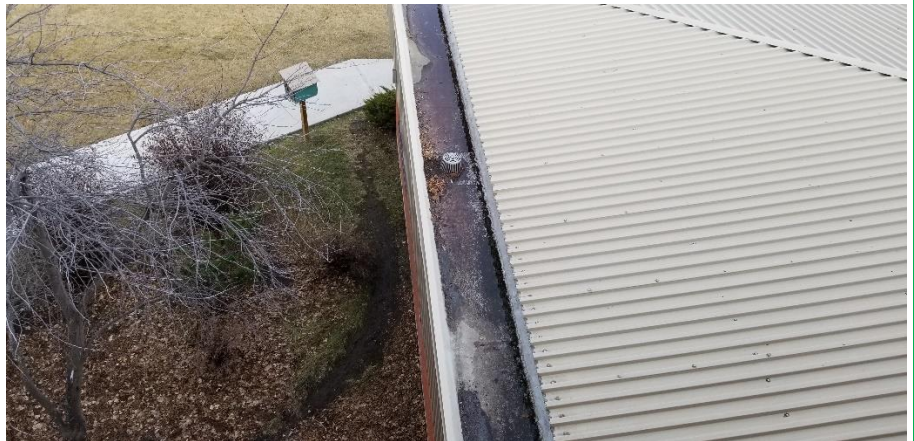
- 66) Gutter should be cleaned.
