Inspection Date:	June 01, 2021
Company:	O'Neil Consulting
Contact:

Inspection

This Infrared Thermography Inspection report provides complete documentation of the thermal patterns detected in your equipment, structures or systems. We use an objective evaluation to help you prioritize repairs to provide the maximum return for this Inspection and its Maintenance Program based on IR Thermography.

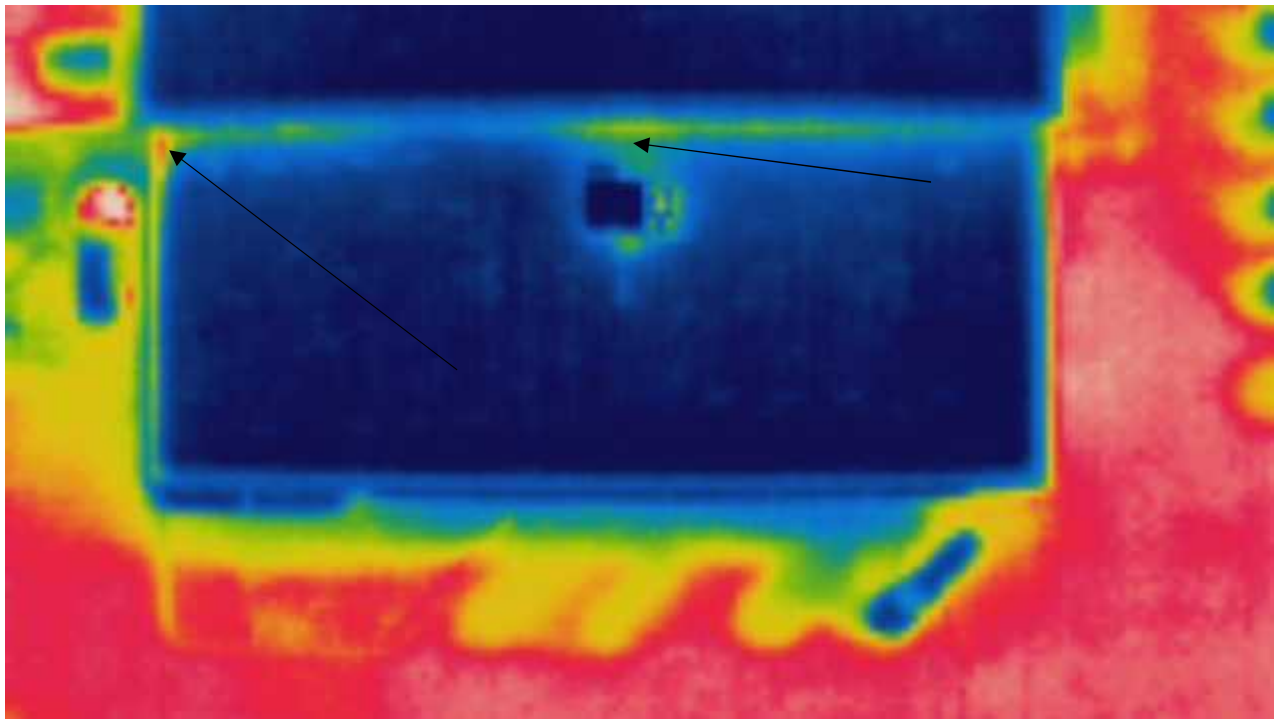
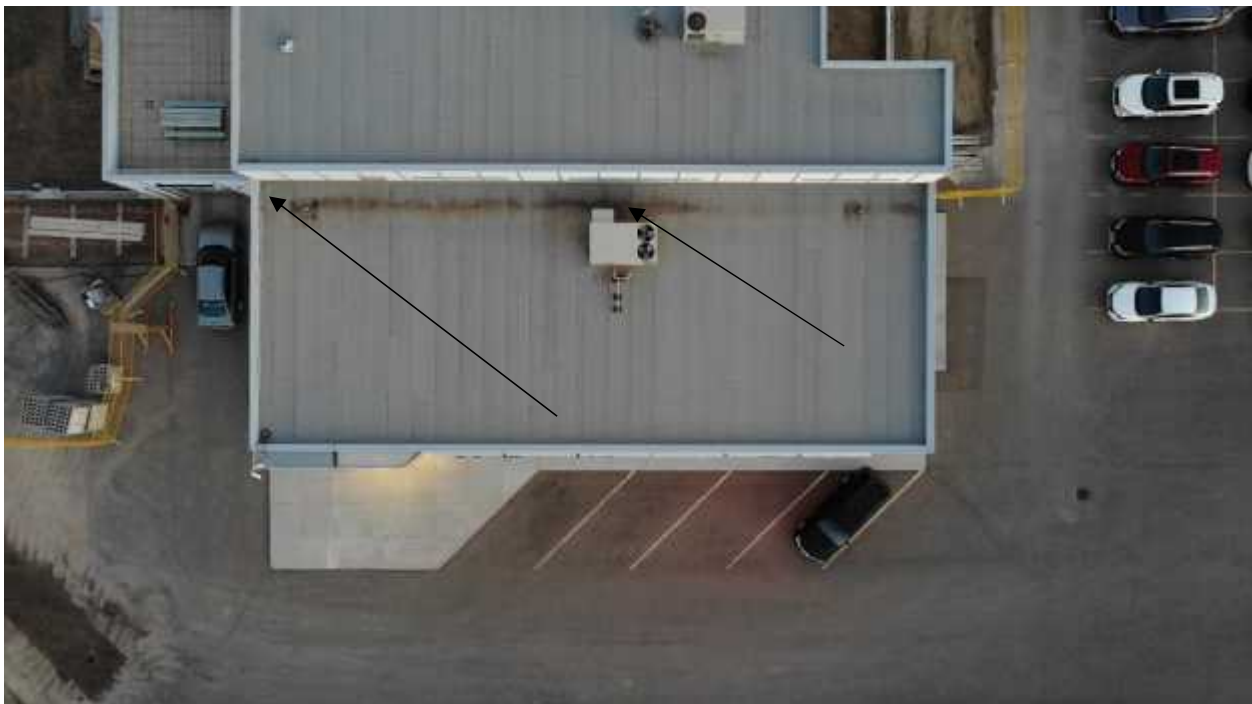
North roof section, anomaly found in the SE corner of this section could be due to a build up of granules in the corner holding the heat longer than the rest of the system. Also, possible wet area found south of the roof top unit, this could also be debris from ponding water, invasive test will be needed to confirm moisture in the system.

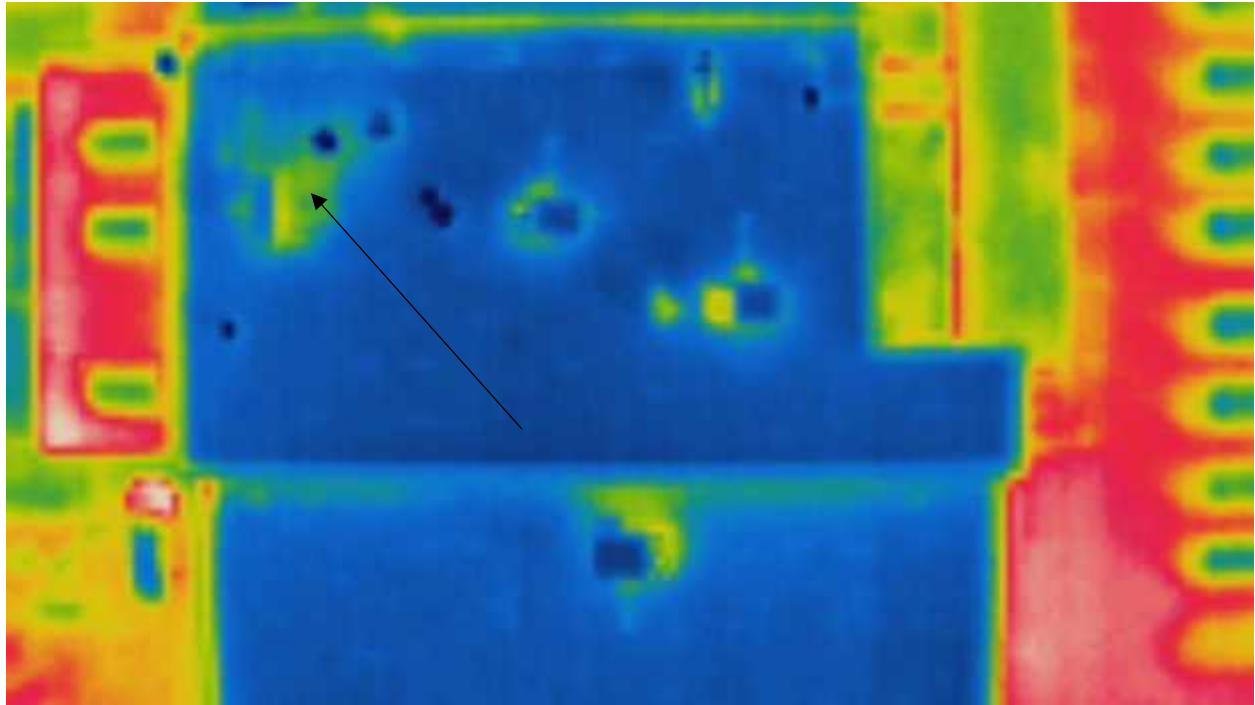
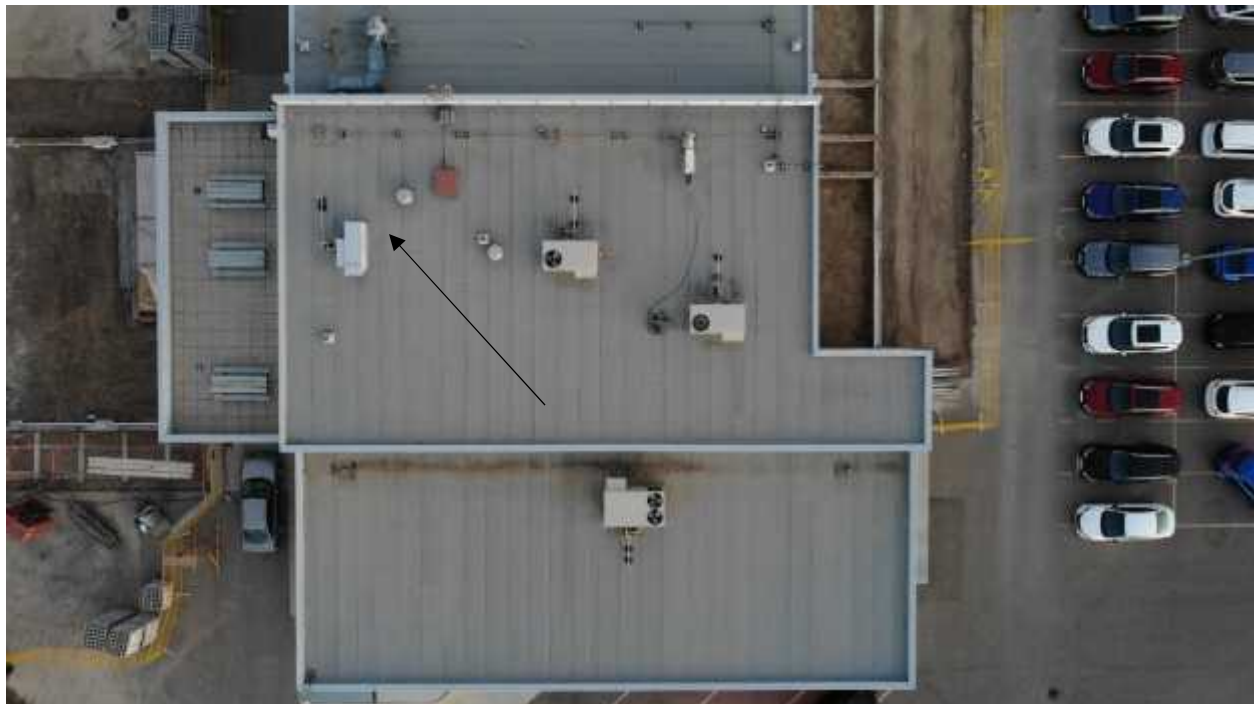
The center section has an anomaly on the east side of the roof, possibly water infiltrating from the roof top unit or the heat duct. Invasive test will be needed to confirm moisture in the system.

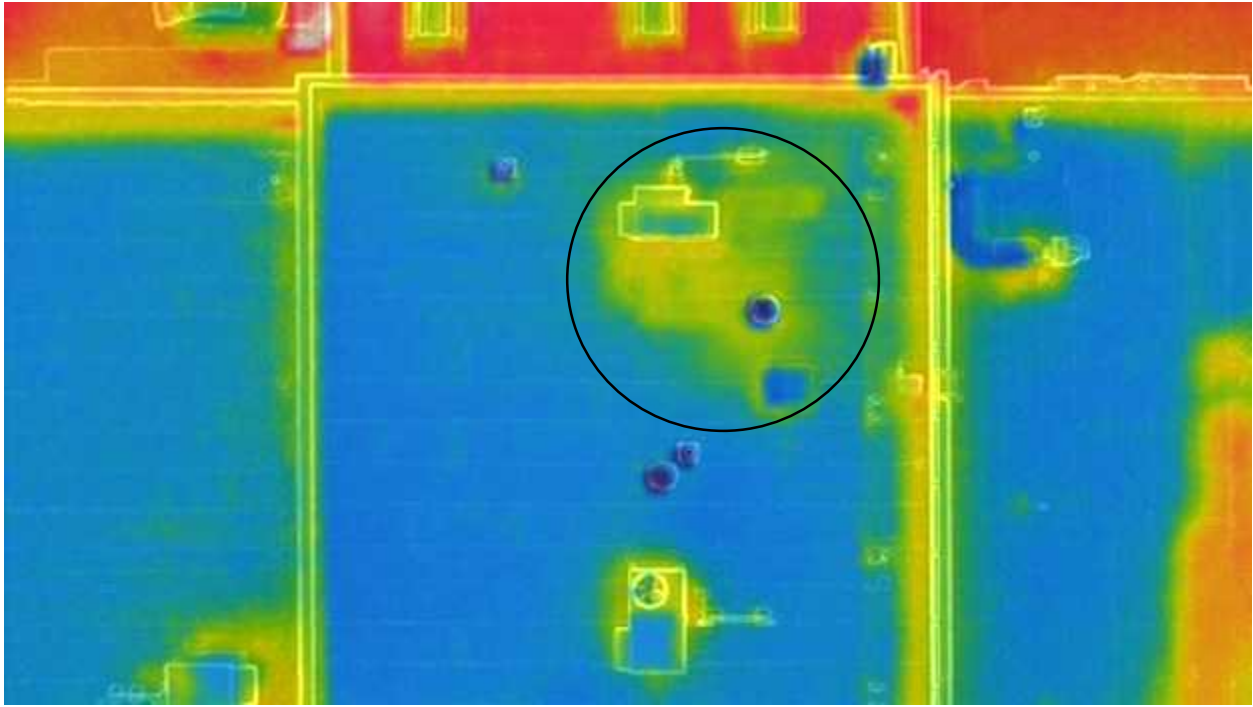
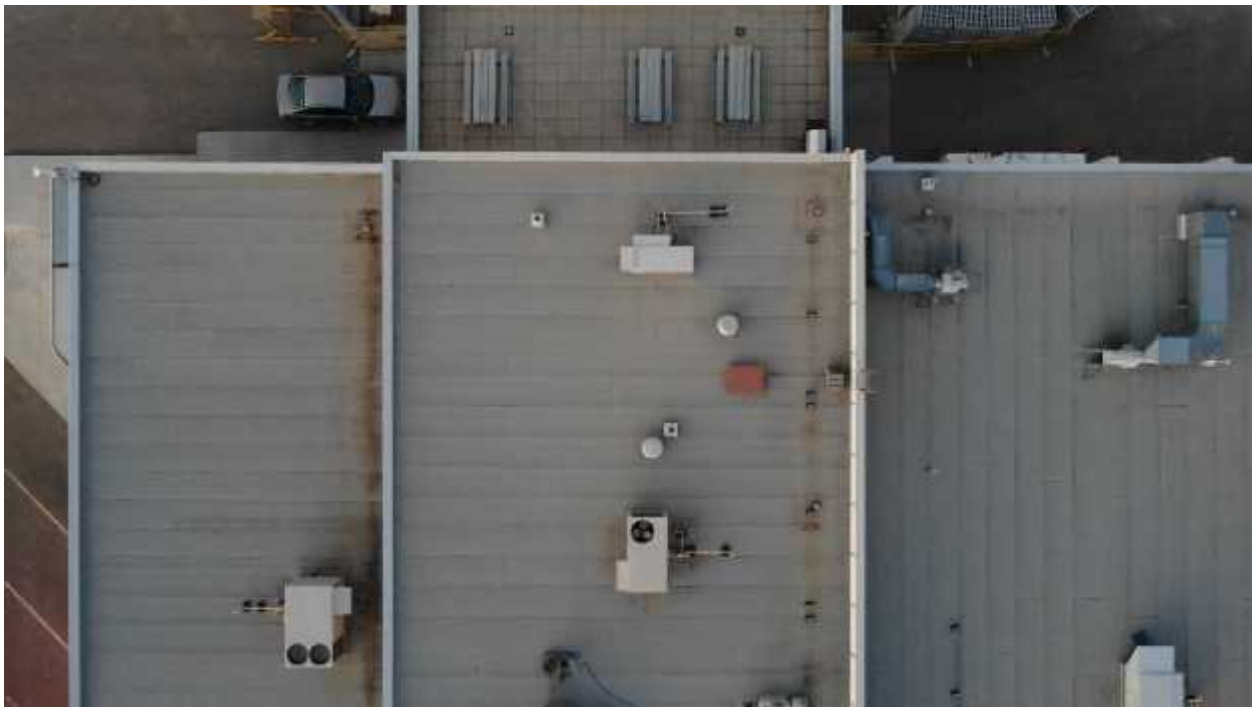
Close up of center section over anomaly

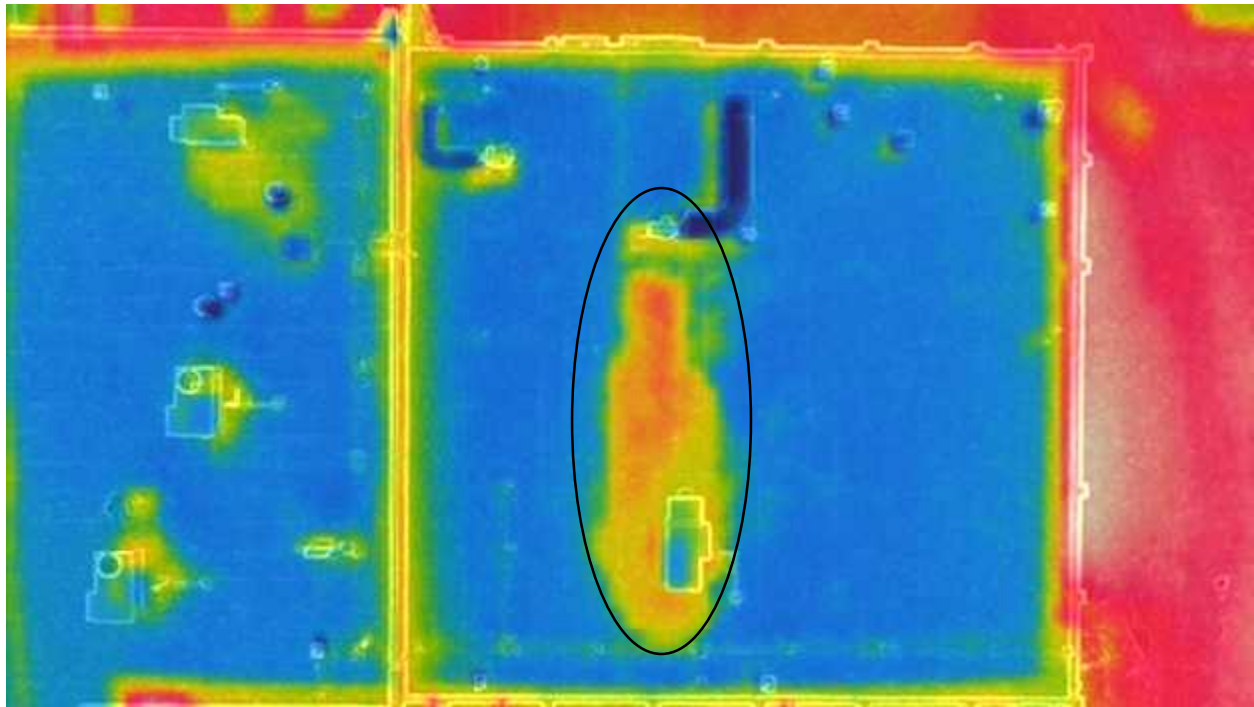
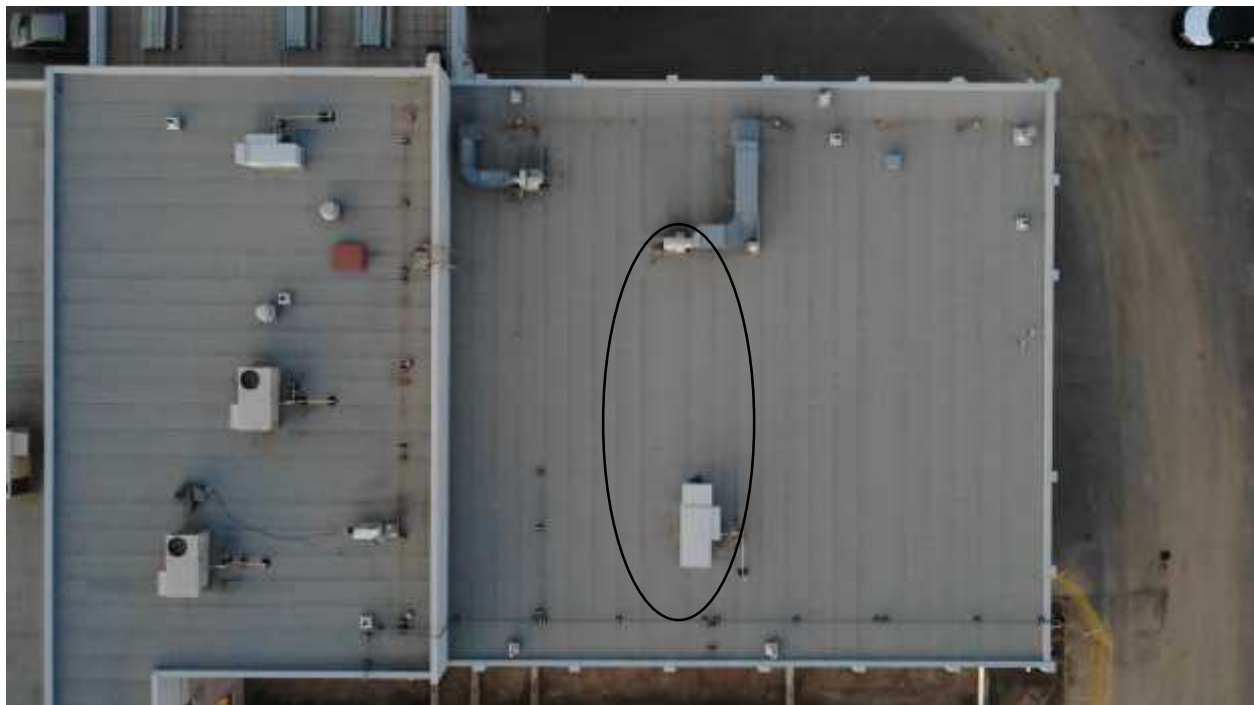
The south section of roof I have found the biggest anomaly, water seems to be infiltrating the system from the roof top unit on the west side of the building. Invasive test will be needed to confirm moisture in the system.
