Address:	[REDACTED]
Inspection Date:	September 14, 2021
Company:	O'Neil Consulting
Contact:	[REDACTED]
Certified Thermographer:	Matt O'Neil
Valid Certification Number:	CDN-2020314
Infrared Camera Used:	Mavic 2 Enterprise Dual/FlirOne Pro
Date of last calibration:	June 01 2021
Weather	10 Celsius, clear calm, wind at 15kph

Inspection

This Infrared Thermography Inspection report provides complete documentation of the thermal patterns detected in your equipment, structures or systems. We use an objective evaluation to help you prioritize repairs to provide the maximum return for this Inspection and its Maintenance Program based on IR Thermography.

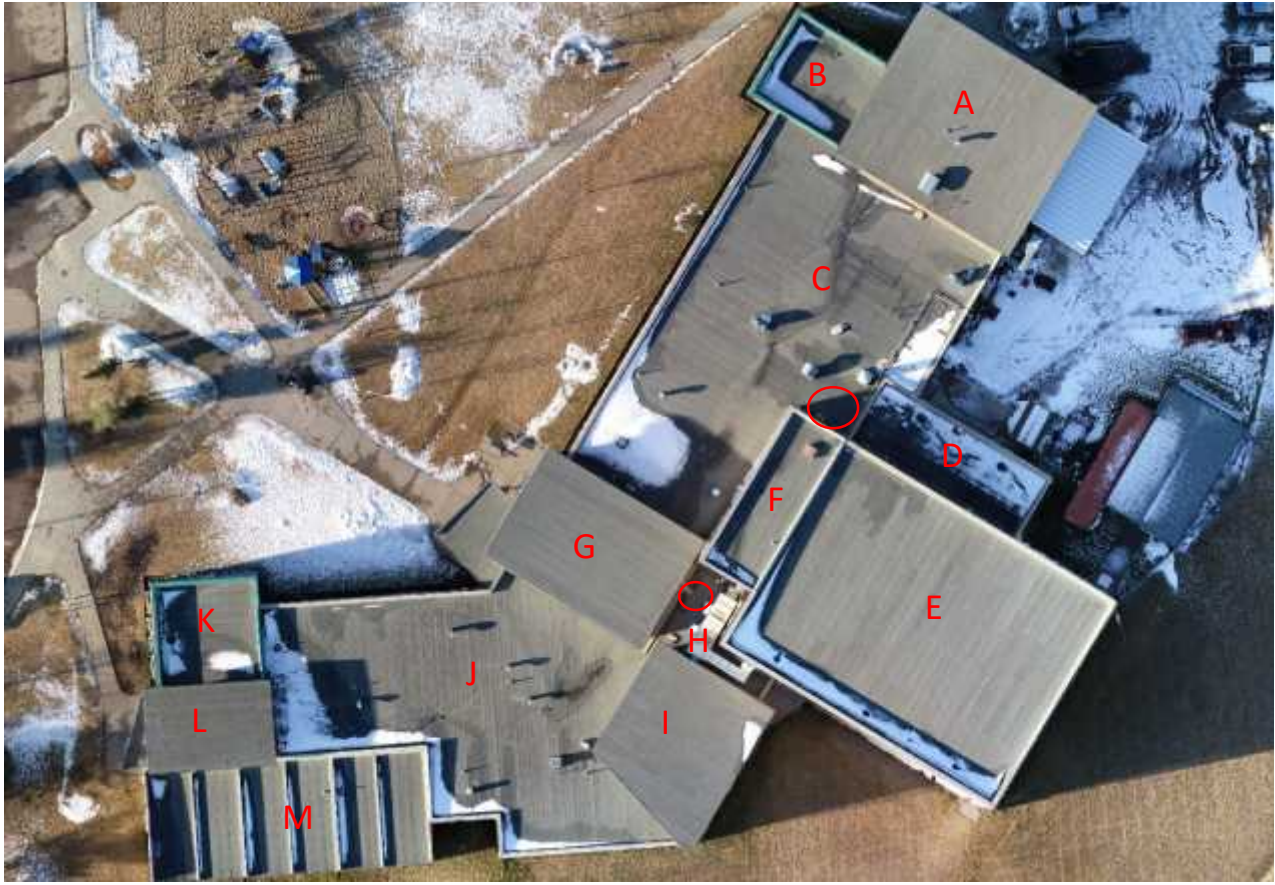
On the night of September 14, 2021, O'Neil Consulting conducted a thermal review of [REDACTED] school at the request of [REDACTED]. Above shows a complete overview of the roof outlining the sections scanned in the thermal review. Suspected wet areas have been circled in red on the above picture.

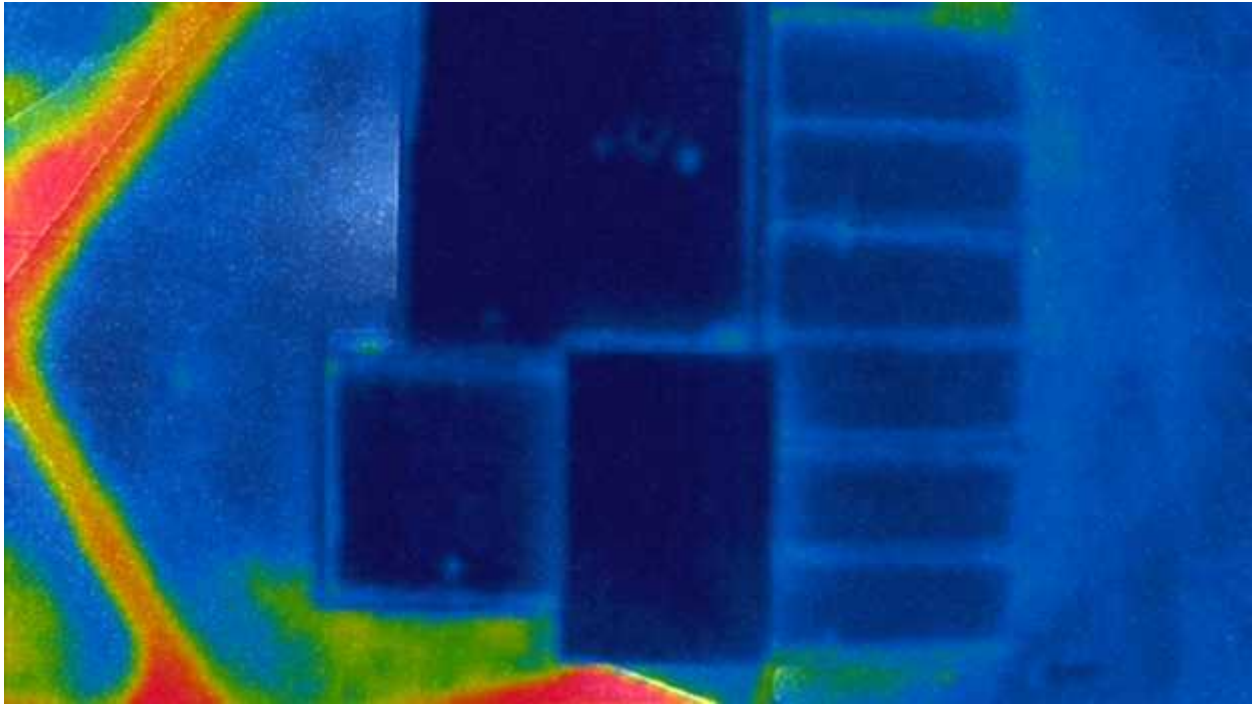
Starting on the south portion of the school, areas K, L and M show no signs of water infiltration into the system, and no ponding water.

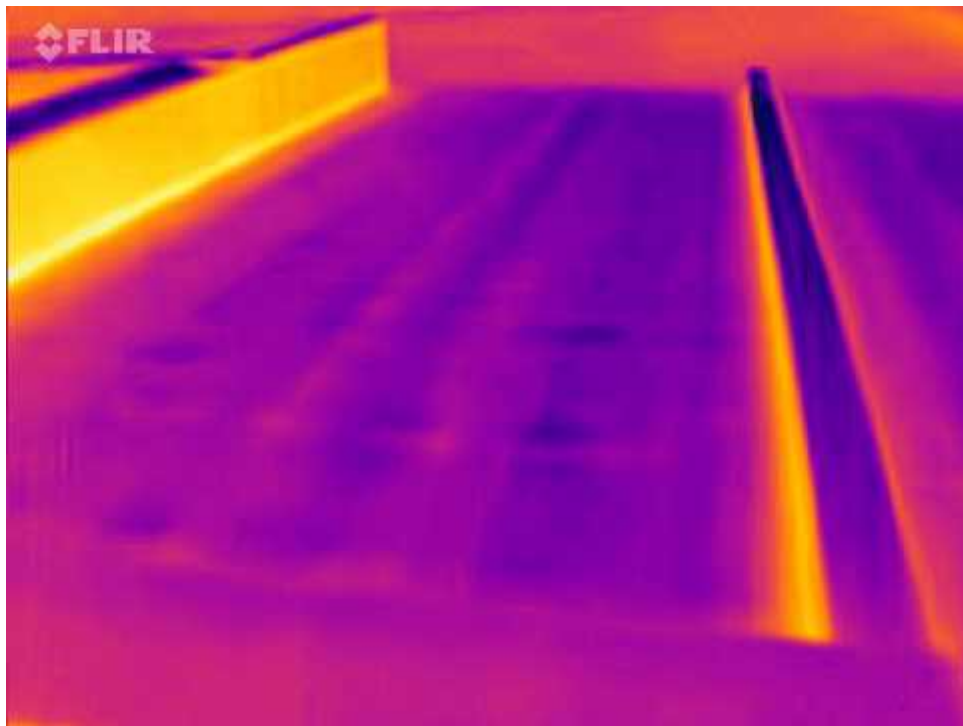
Flir One Photo taken in section M looking at the first portable to the north. No anomalies found.

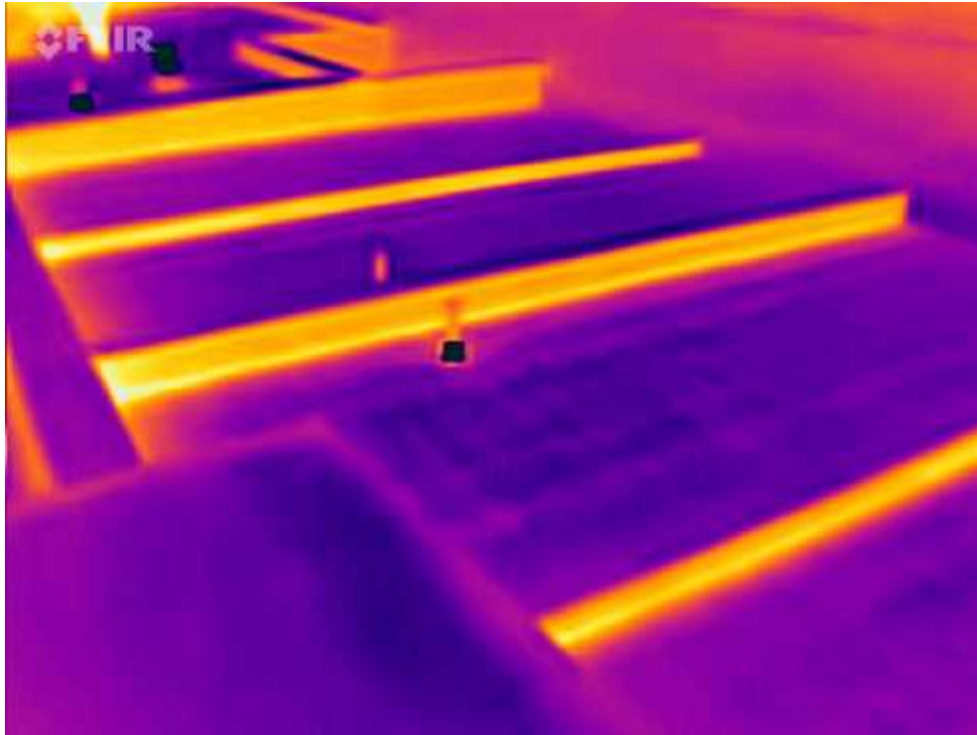
Flir One Photo taken in section M looking at the second portable to the north. No anomalies found.

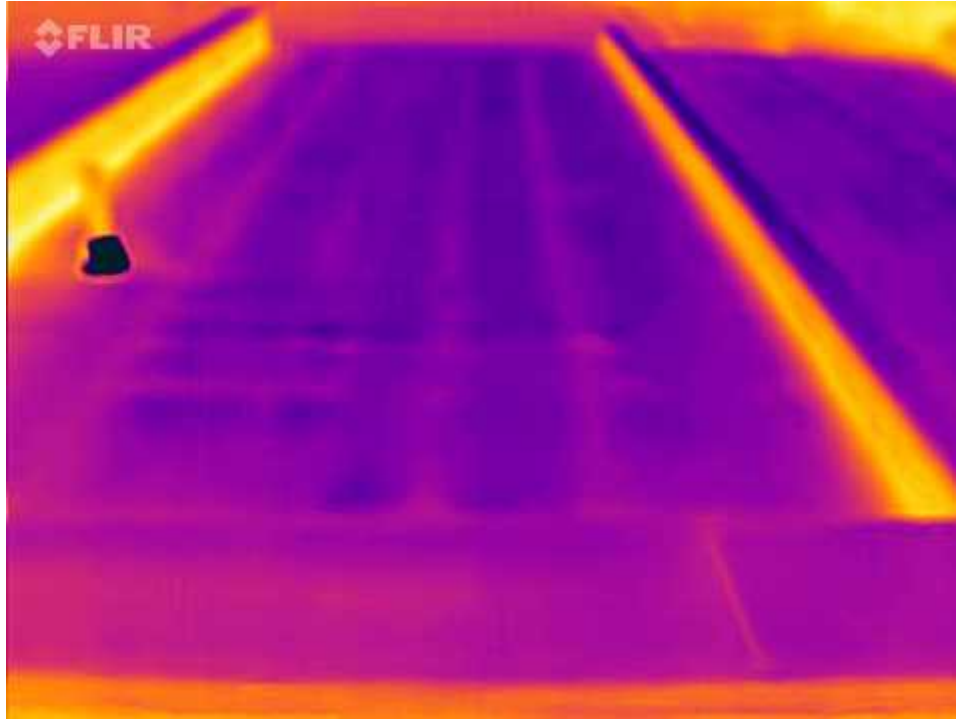
Flir One Photo taken in section M looking at the third portable to the north. No anomalies found.

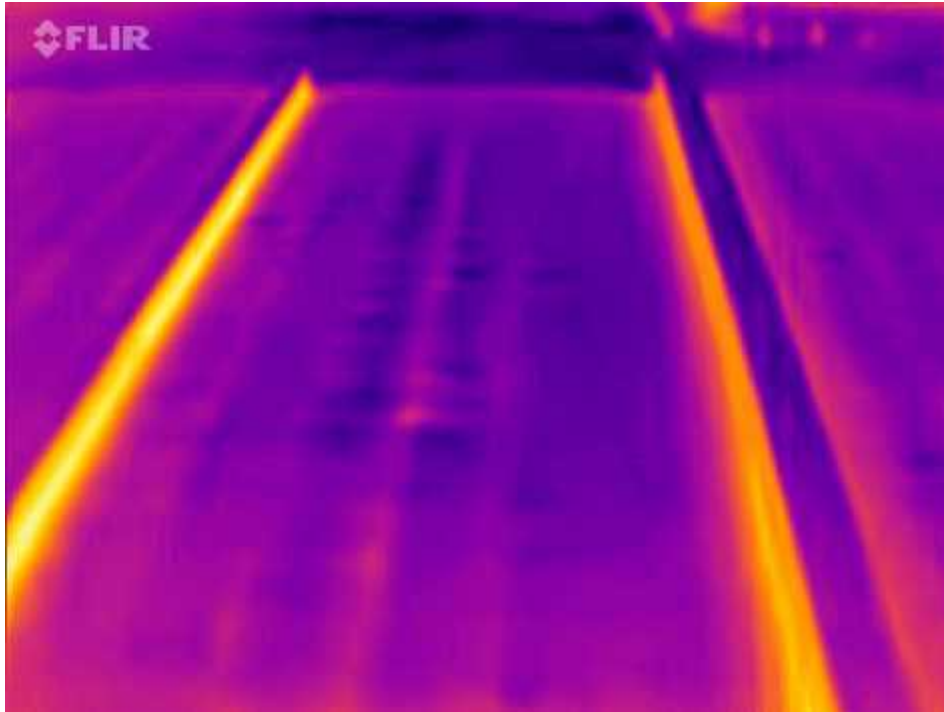
Flir One Photo taken in section M looking at the fourth portable to the north. No anomalies found.

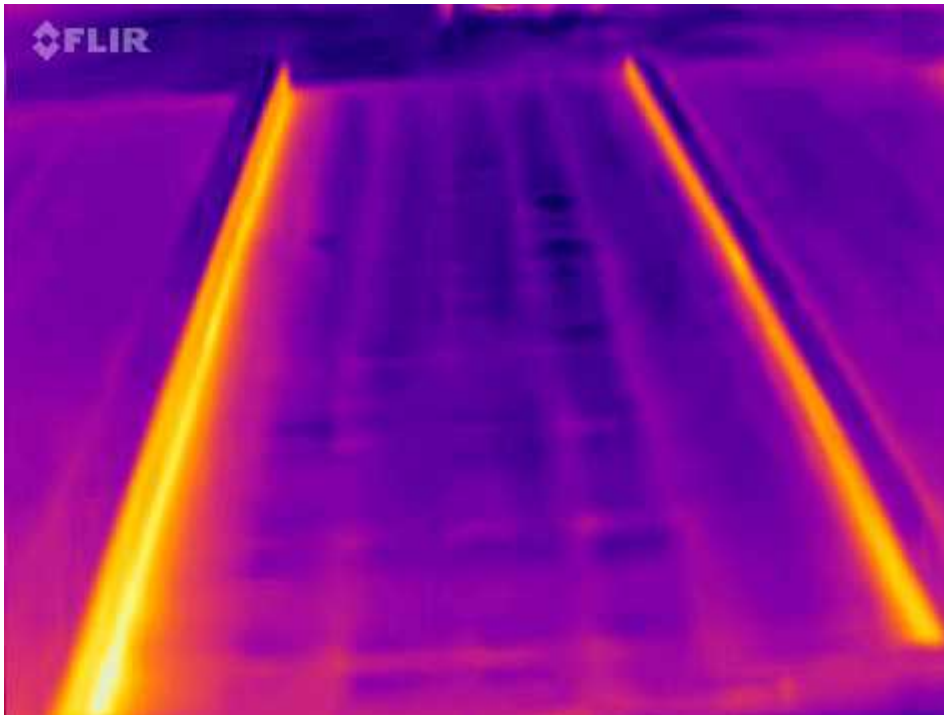
Flir One Photo taken in section M looking at the fifth portable to the north. No anomalies found.

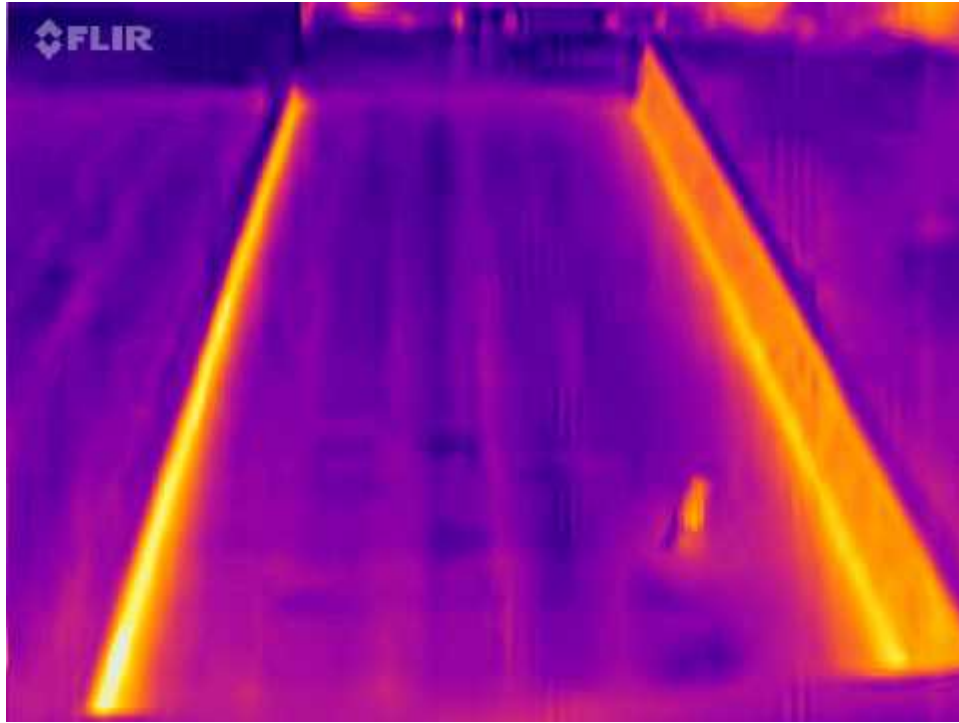
Flir One Photo taken in section M looking at the last portable. No anomalies found.

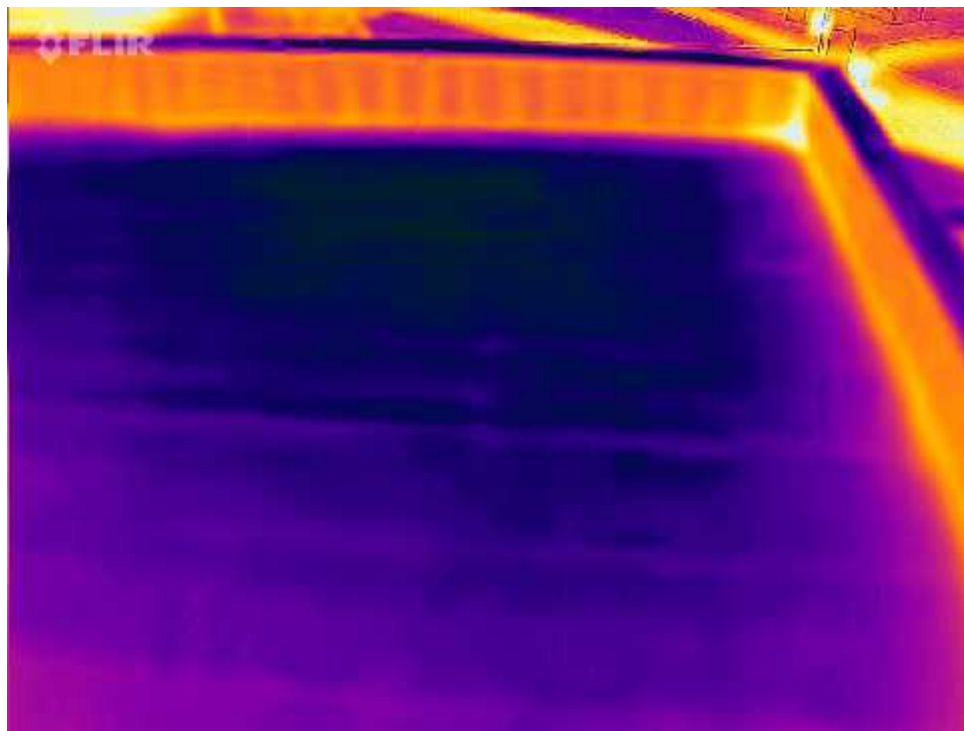
Flir One Photo looking over section K, no anomalies detected.

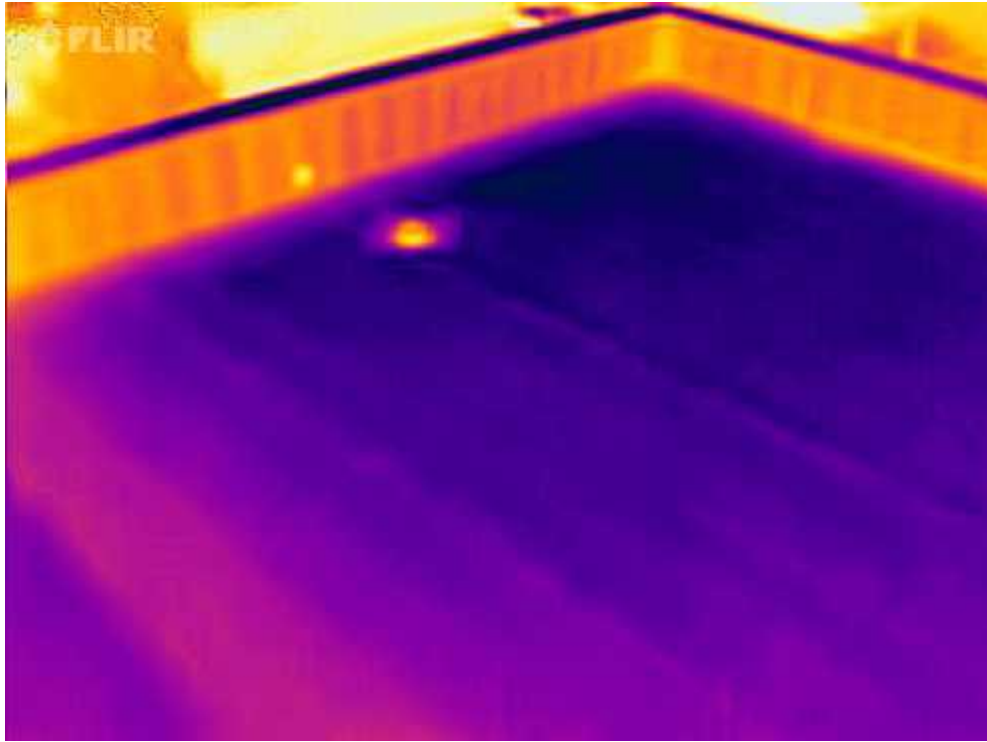
Flir One Photo looking over section K, no anomalies detected.

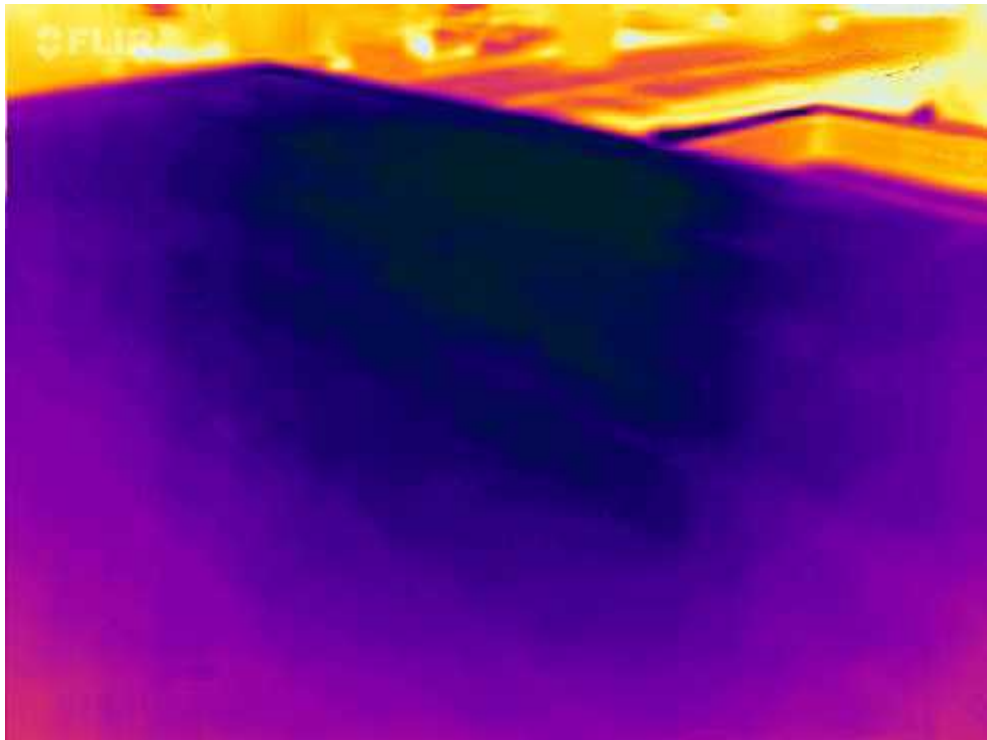
Flir One Photo looking over section L, no anomalies detected.

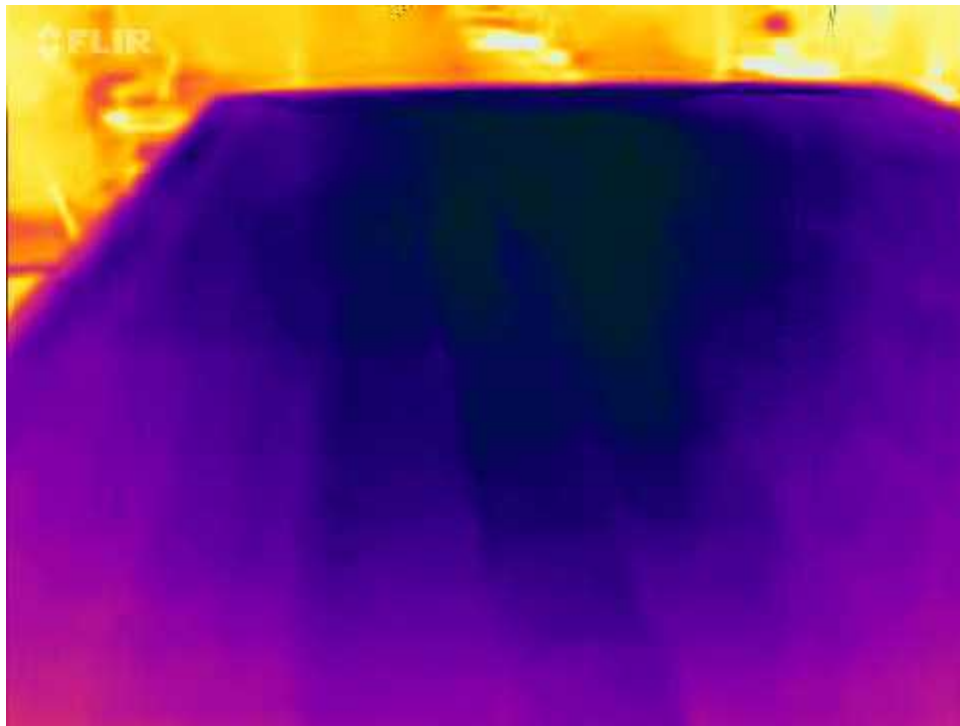
Flir One Photo looking over section L, no anomalies detected.

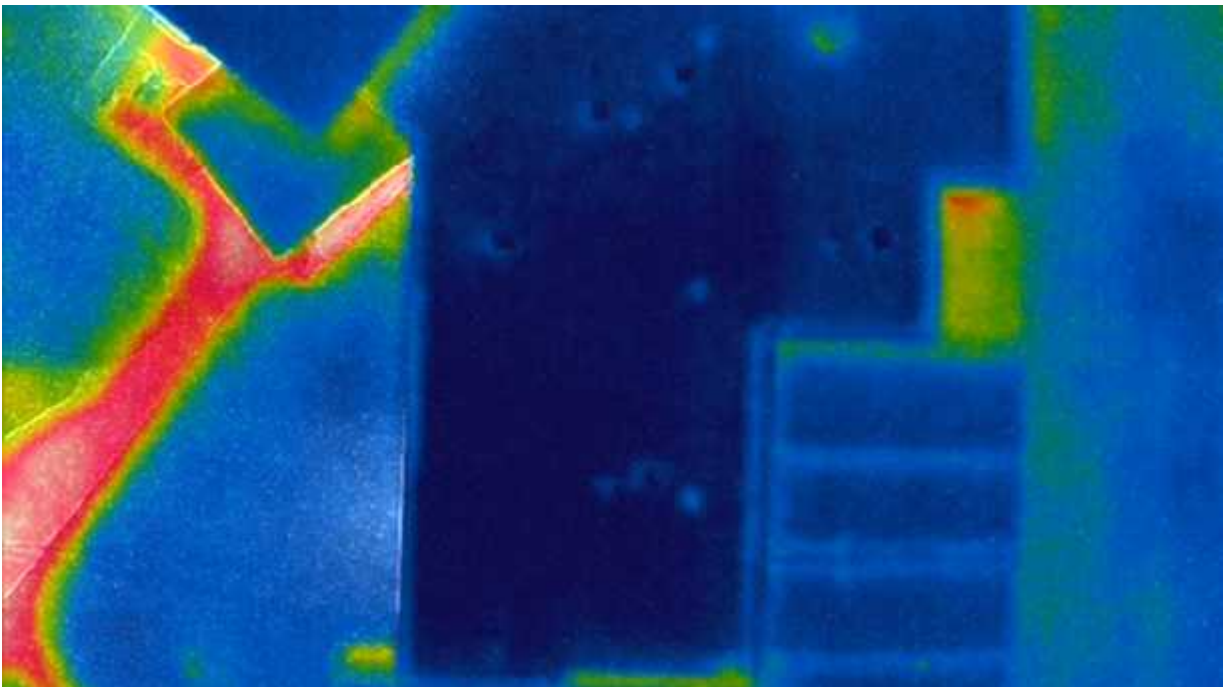
Moving to the north, section J depicted above has no anomalies to report, and no suspicion of water infiltrating the roofing system.

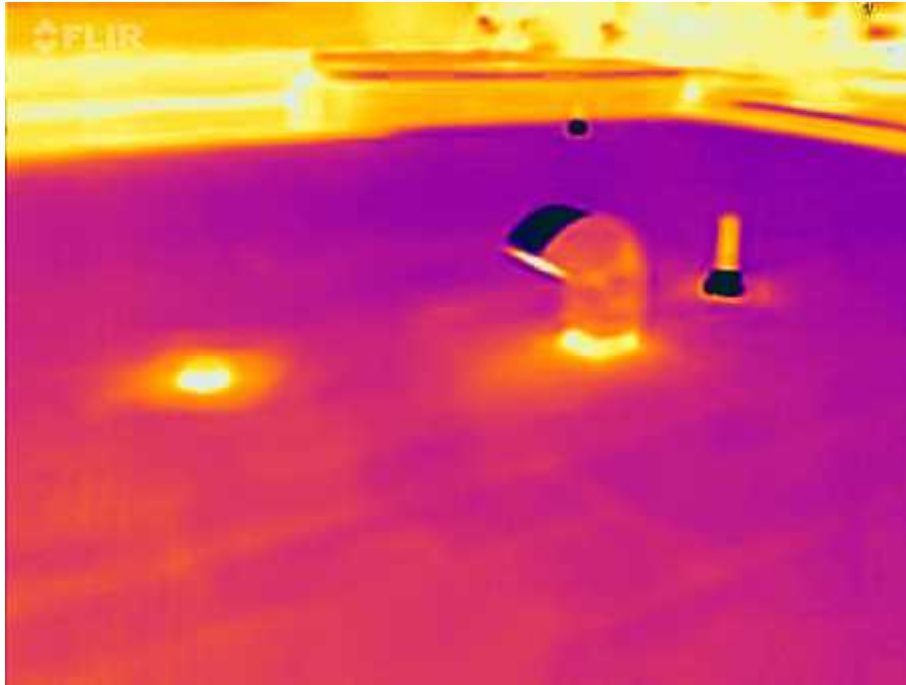
Flir One Photo looking over section J, picture taken looking south towards sections M and L, vent curb looks to have no insulation.

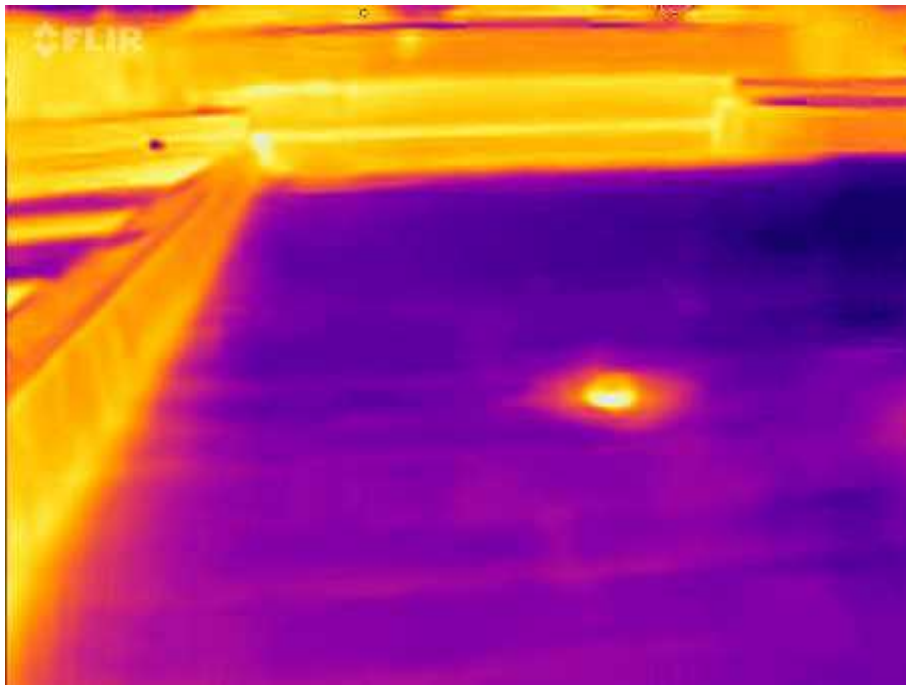
Flir One Photo looking south over section J, no anomalies detected.

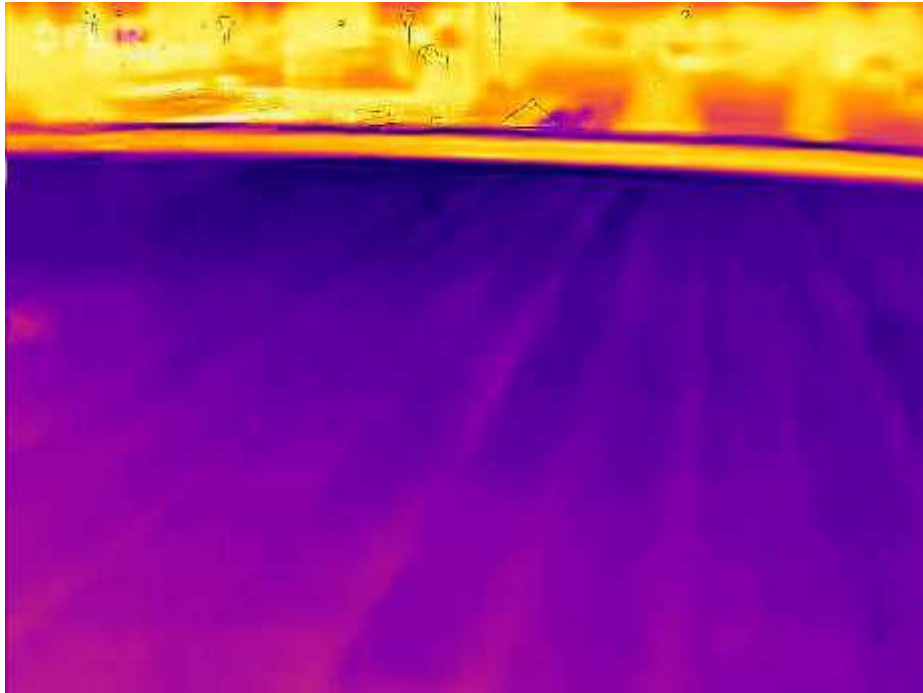
Flir One Photo looking west over section J, no anomalies detected.

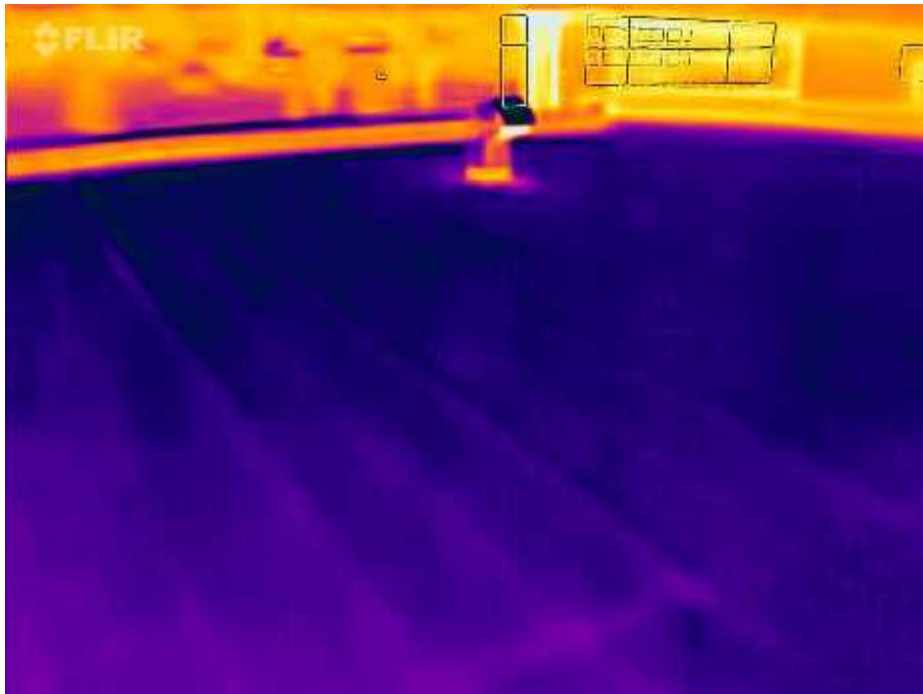
Flir One Photo looking northwest on section L, no anomalies detected.

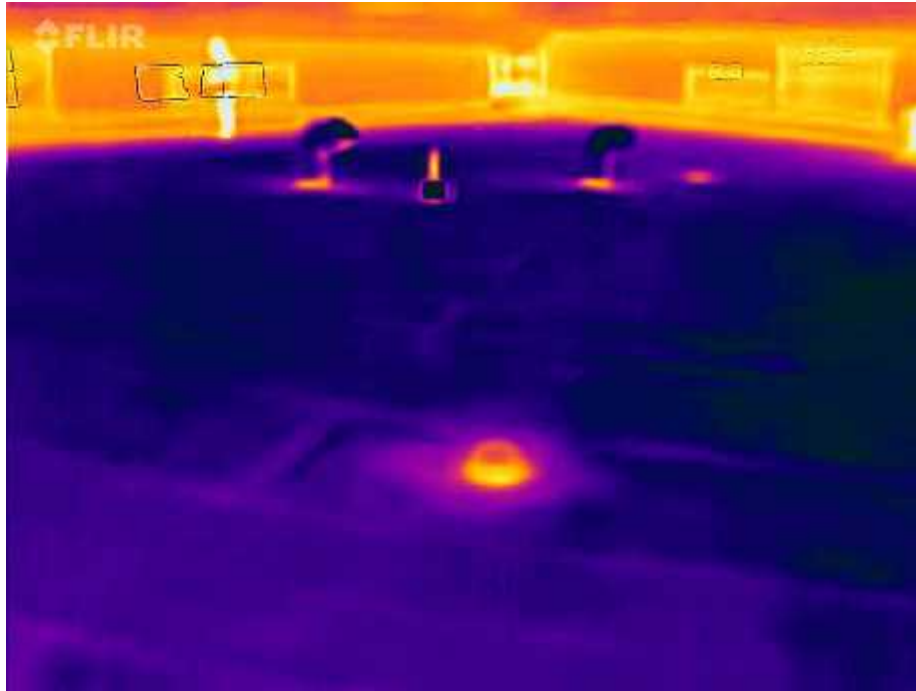
Flir One Photo looking north on section J, no anomalies detected.

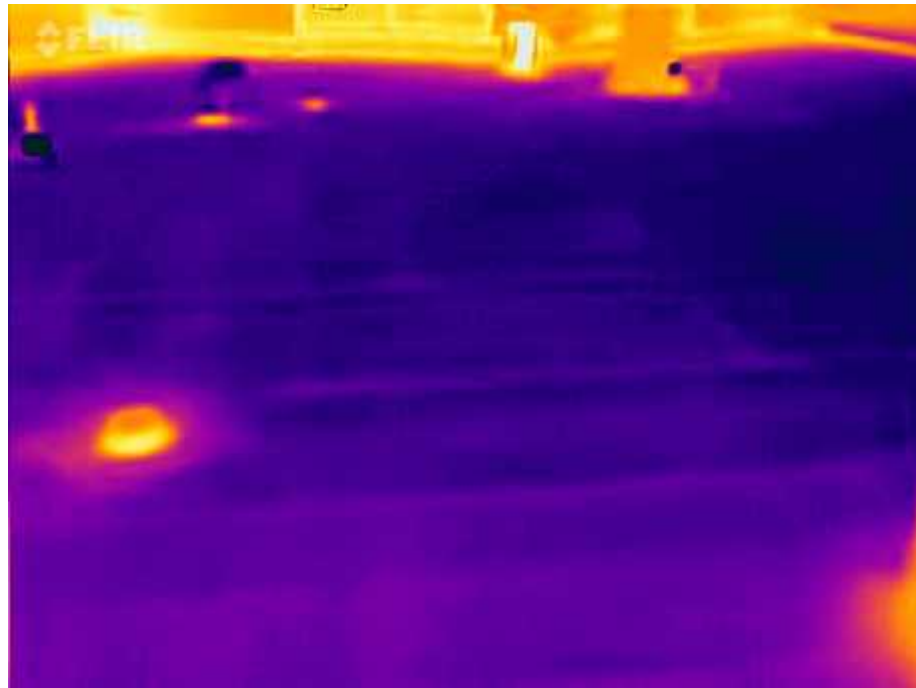
Flir One Photo looking north on section J, no anomalies detected.

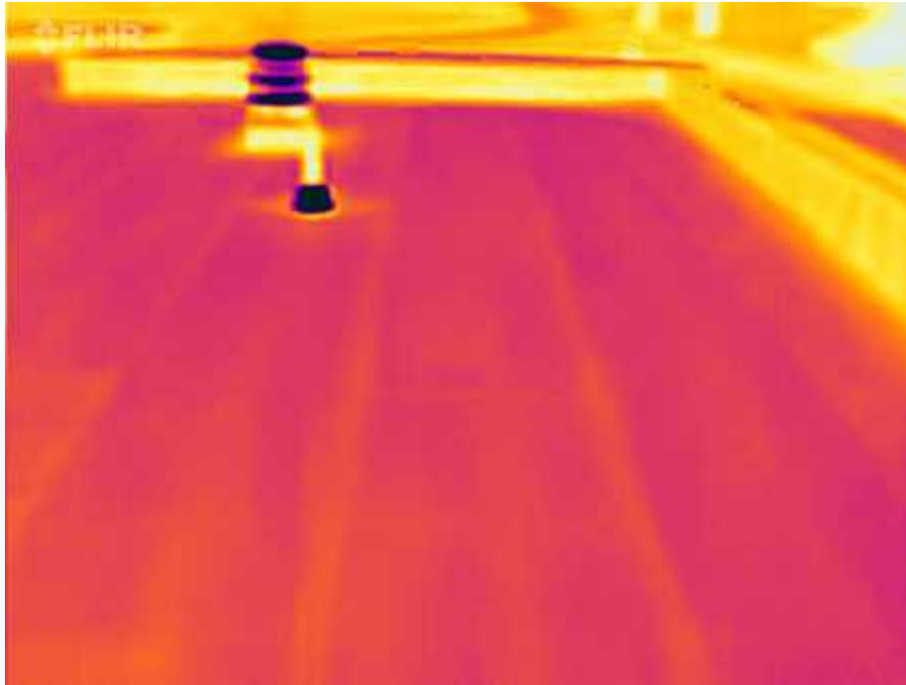
Flir One Photo looking east on section J, no anomalies detected.

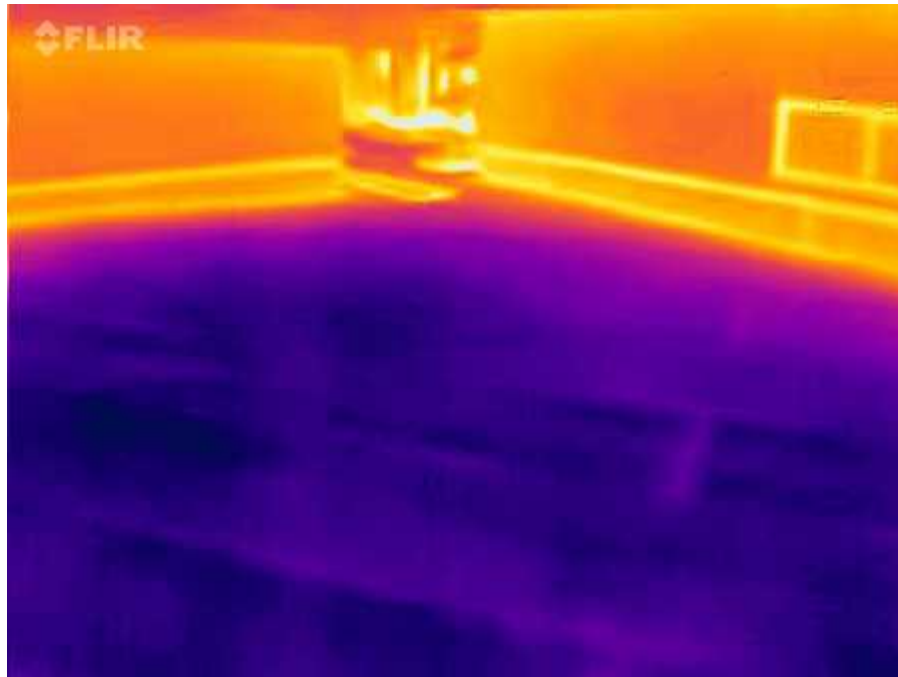
Flir One Photo looking north on section J into the corridor with the main roof top unit, no anomalies detected.

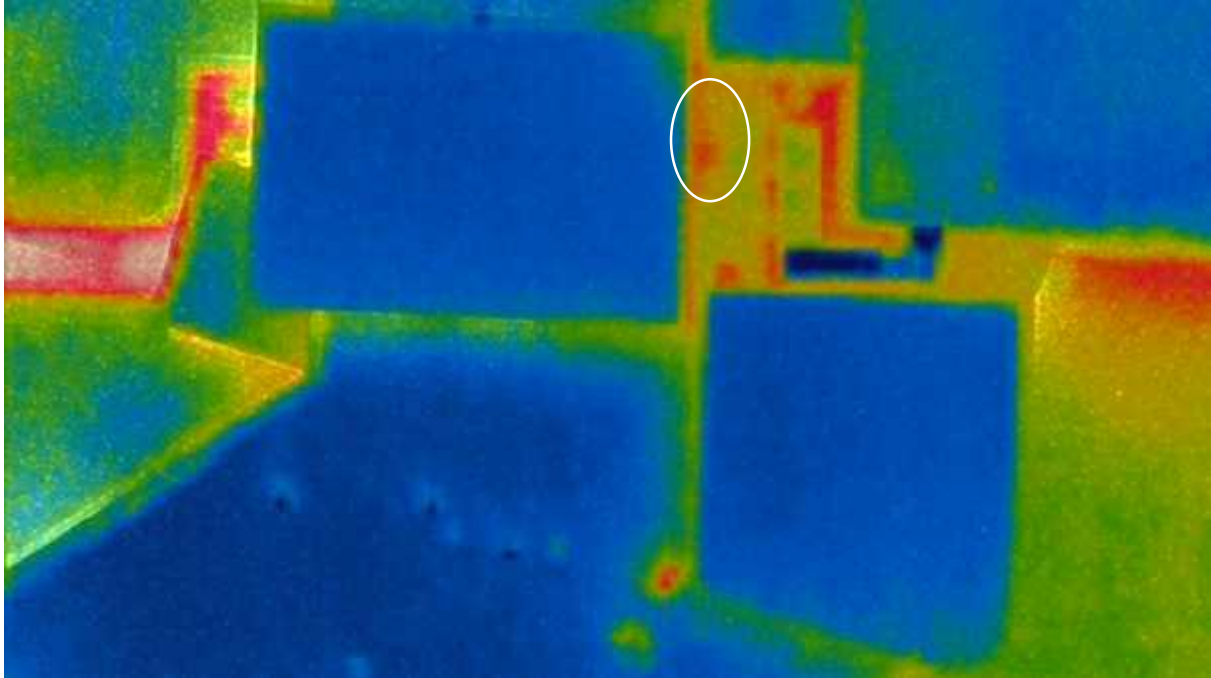
Moving north above shows areas G, H, I and the north section of J. Both sections I and G have no evidence that moisture has infiltrated the system, but in section H at the bottom of the ladder leading up to section G we have found evidence of water getting into the stripping surrounding the ladder and immersing itself into the system (area circled in white).

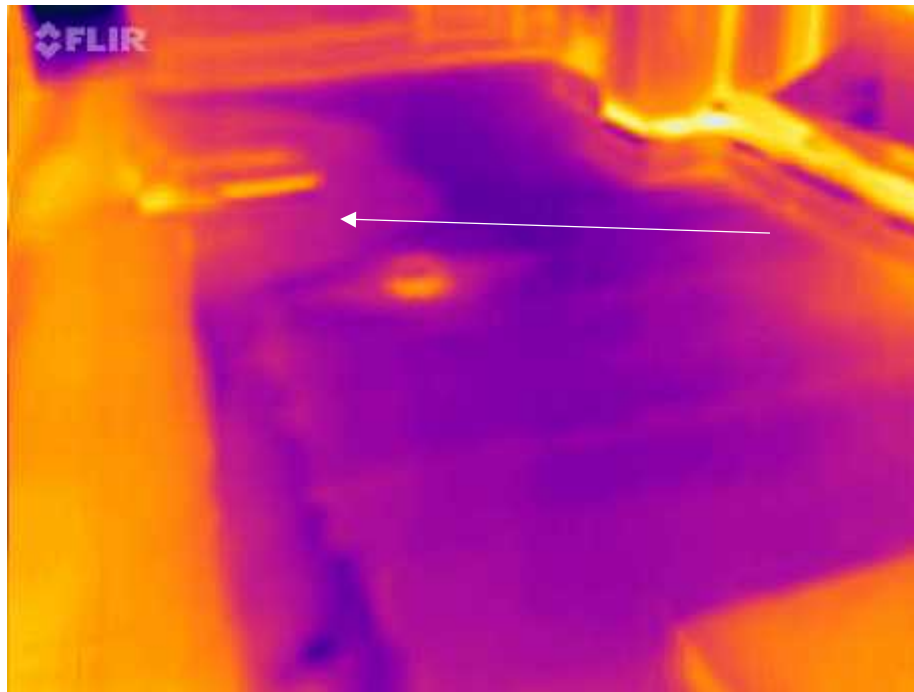
Flir One Photo looking north inside section H, due to the in closed space and the heat from the RTU thermal imaging was relatively difficult but one area was found to be suspected wet.

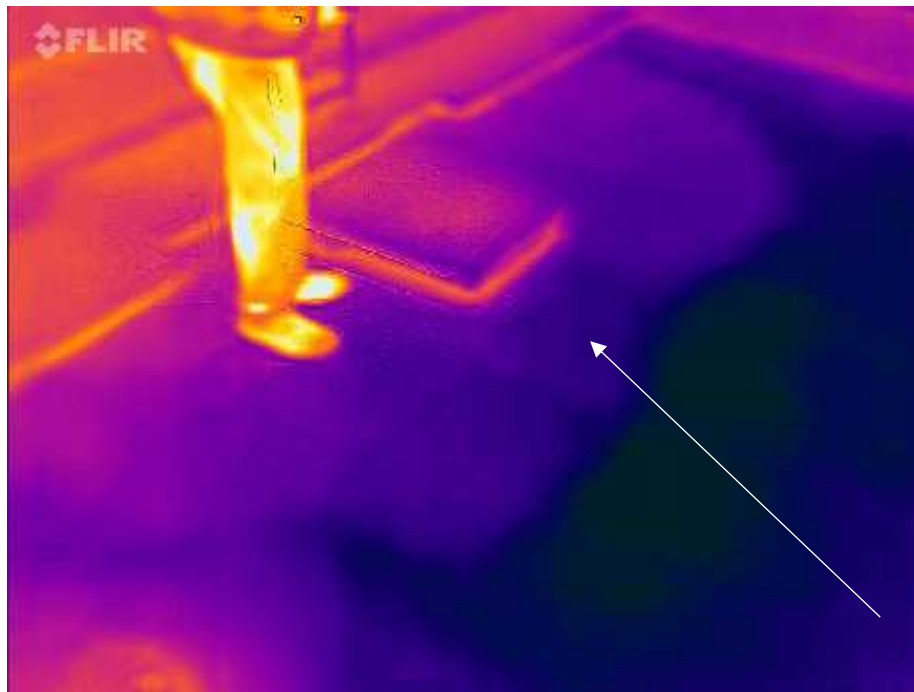
Flir One Photo suspected wet area at the bottom of the ladder leading to section G. water is suspected to be getting in where stripping is run up tying to seal the ladder. If the ladder is not secured properly any movement could jeopardize the seal.

In conclusion O'Neil Consulting found two areas possibly containing infiltrated water, section H underneath the ladder leading up to section G. Section C, just west of section D. Both of those sections will need to be invasively tested to confirm or debunk the findings of the thermal scan.

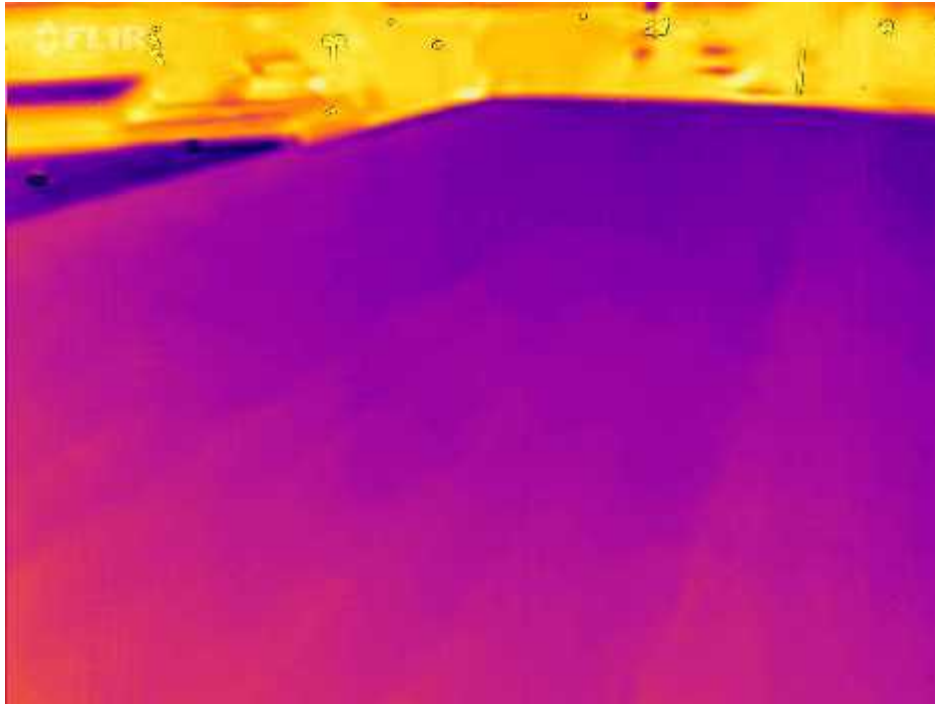
Flir One Photo looking southeast on section G, no anomalies detected.

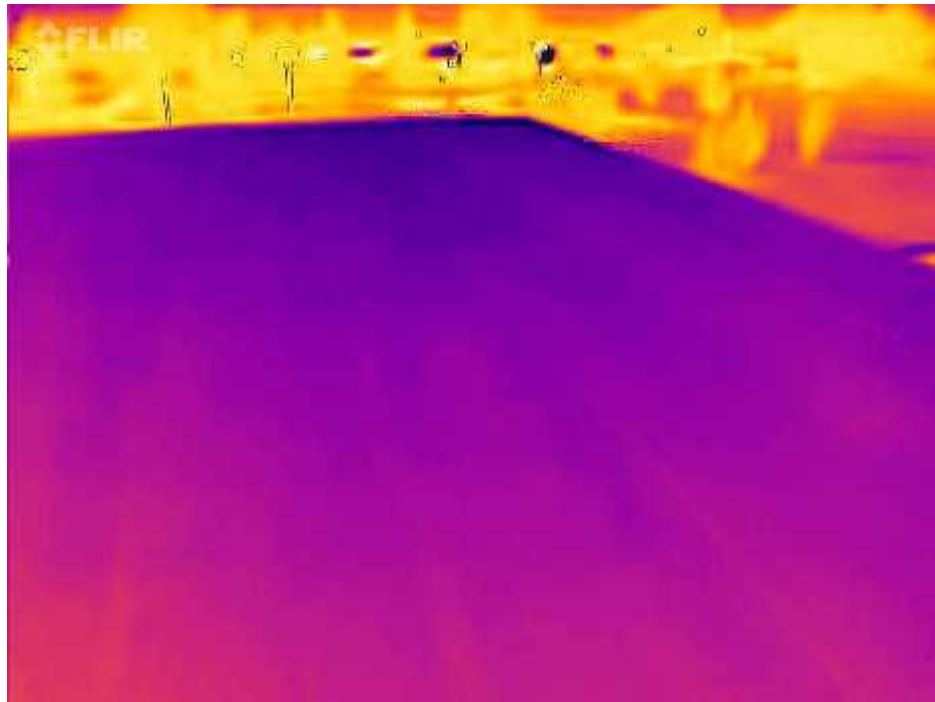
Flir One Photo looking northeast on section G, no anomalies detected.

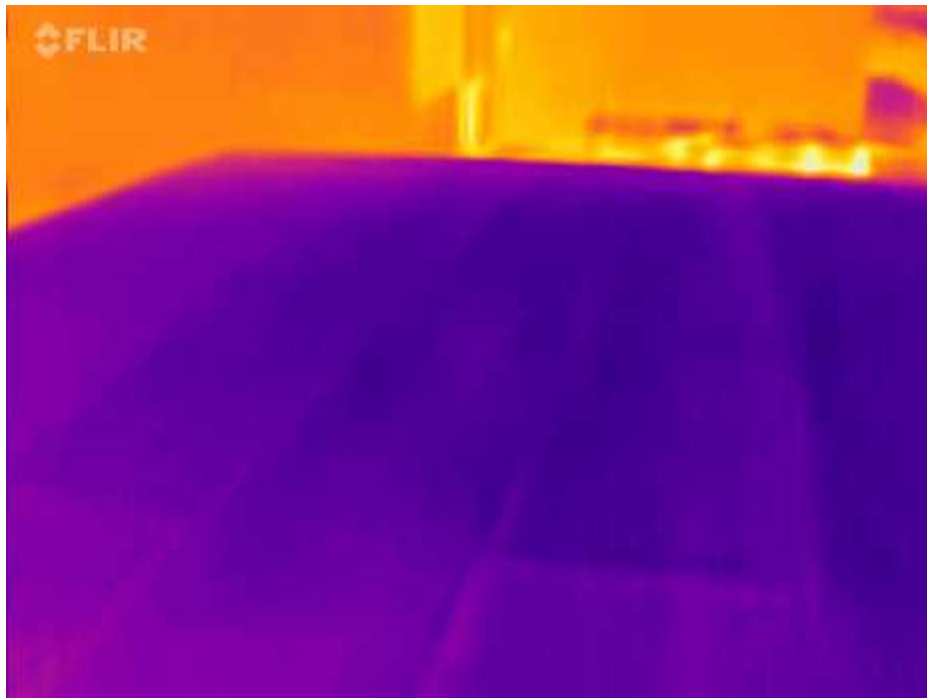
Flir One Photo looking southeast on section I, no anomalies detected.

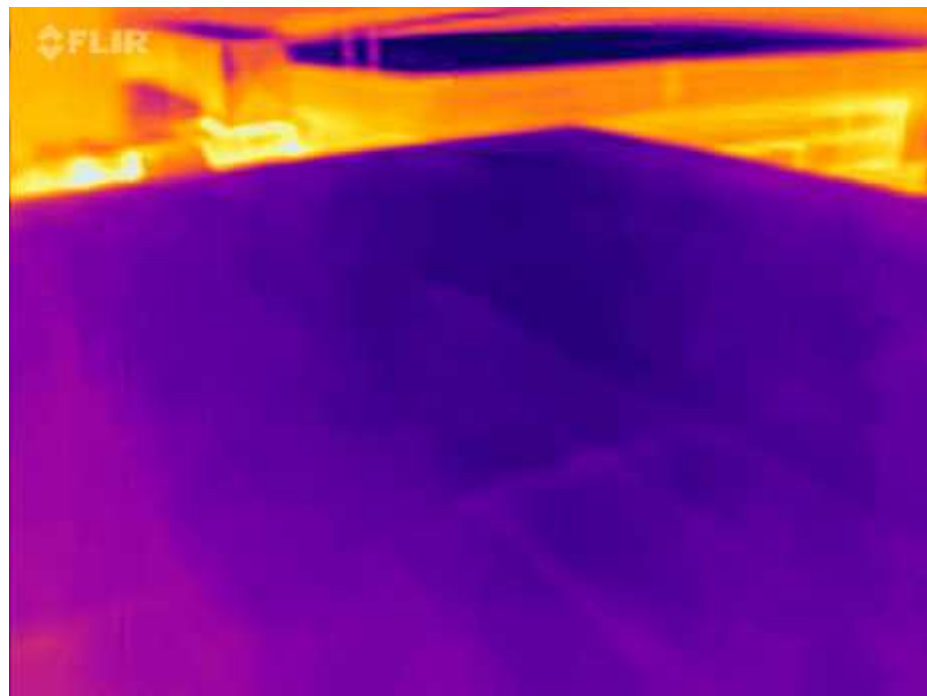
Flir One Photo looking northeast on section I, no anomalies detected.

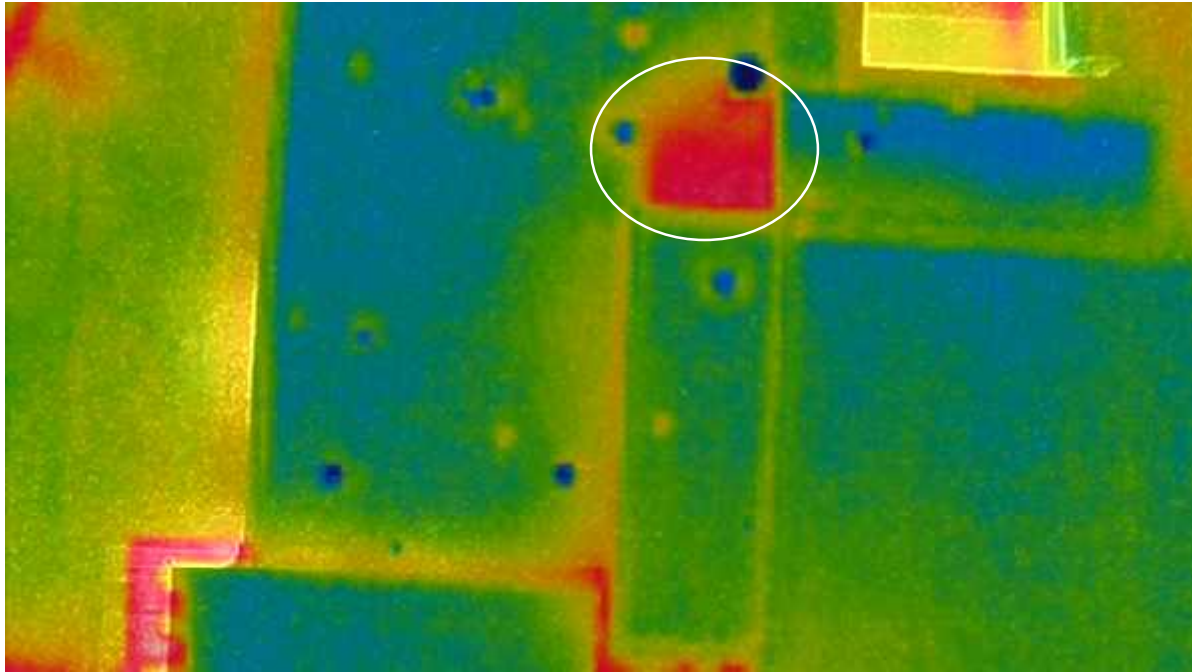
Moving north onto section C a large anomaly can be seen just to the north of section F, suspected wet area although several vents in the area could make this a false positive but an invasive test will need to be conducted to kind out with certainty that the area does have moisture in the system (area circled in white). Section F has no anomalies detected.

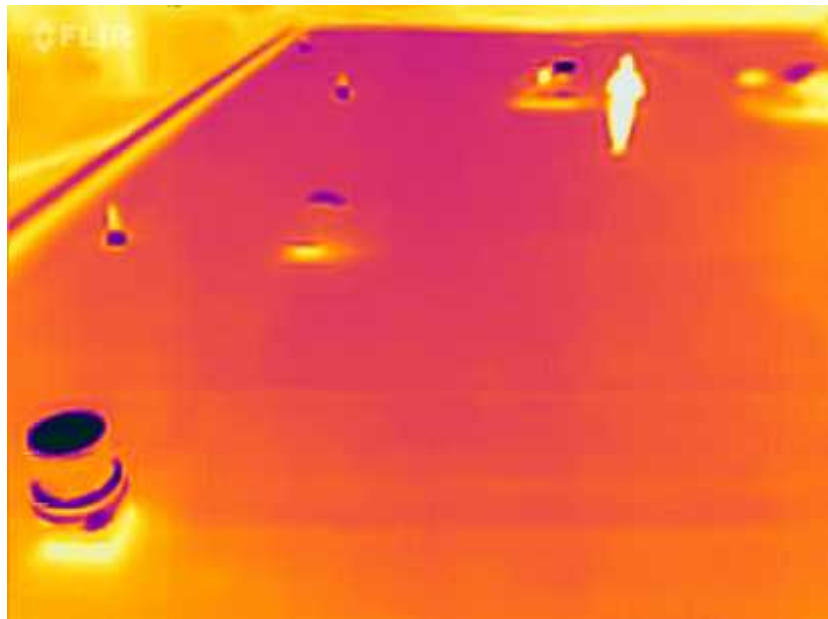
Flir One Photo standing on section G looking north to section C, no anomalies found.

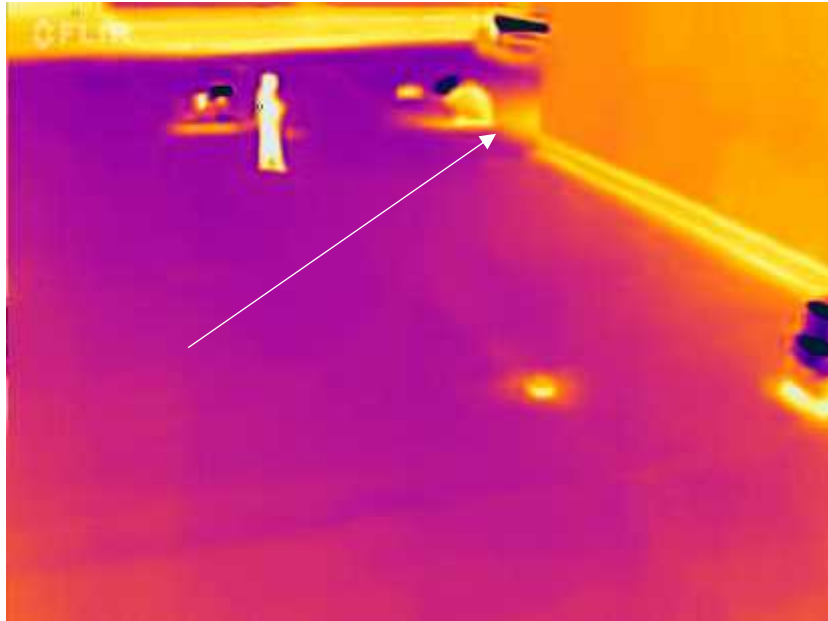
Flir One Photo standing on section G looking north to section C, anomaly found just west of section D, Invasive test will need to be conducted to confirm moisture in the system.

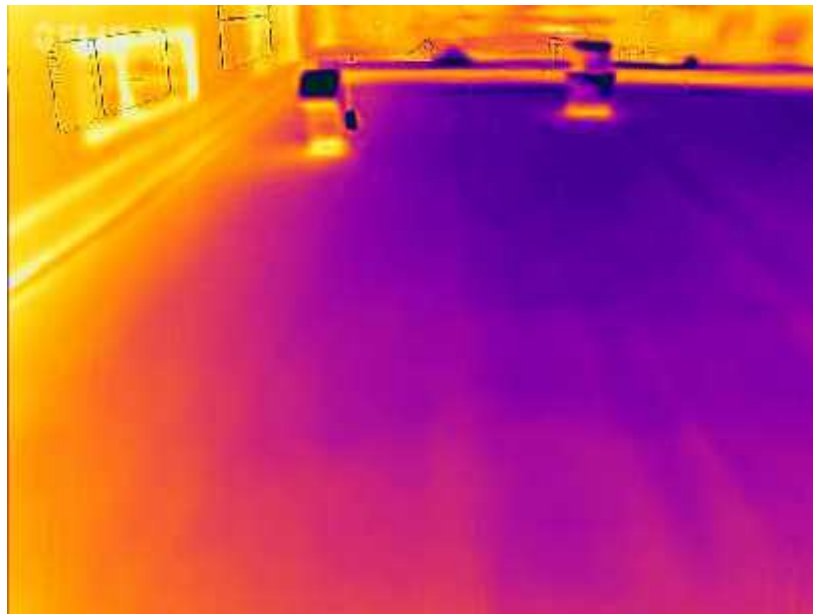
Flir One Photo standing below section F looking to the east, no anomalies detected.
