Address:	[REDACTED]
Inspection Date:	September 14, 2021
Company:	O'Neil Consulting
Contact:	[REDACTED]
Certified Thermographer:	Matt O'Neil
Valid Certification Number:	CDN-2020314
Infrared Camera Used:	Mavic 2 Enterprise Dual/FlirOne Pro
Date of last calibration:	June 01 2021
Weather	10 Celsius, clear calm, wind at 15kph

Inspection

This Infrared Thermography Inspection report provides complete documentation of the thermal patterns detected in your equipment, structures or systems. We use an objective evaluation to help you prioritize repairs to provide the maximum return for this Inspection and its Maintenance Program based on IR Thermography.

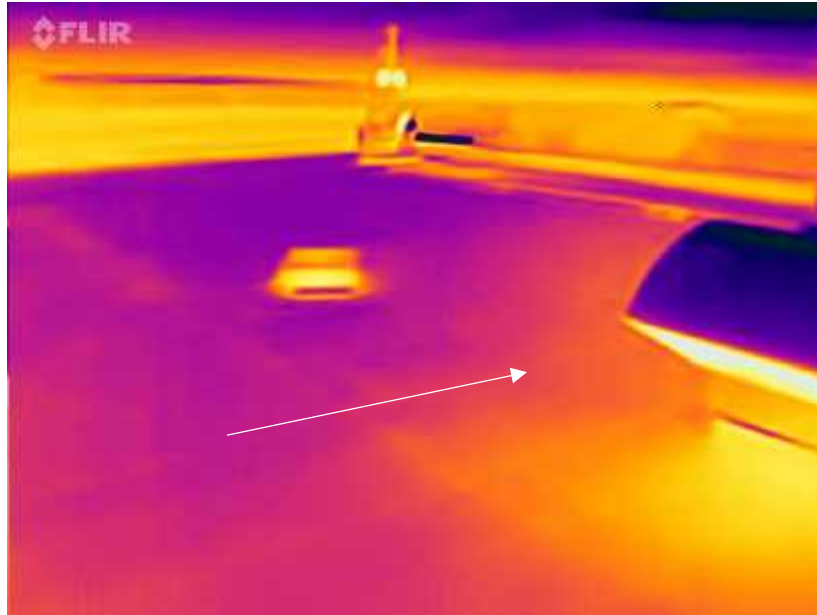
Flir One Photo standing on section C looking northeast, anomaly detected but could be because of multiple heat vents invasive testing will be required

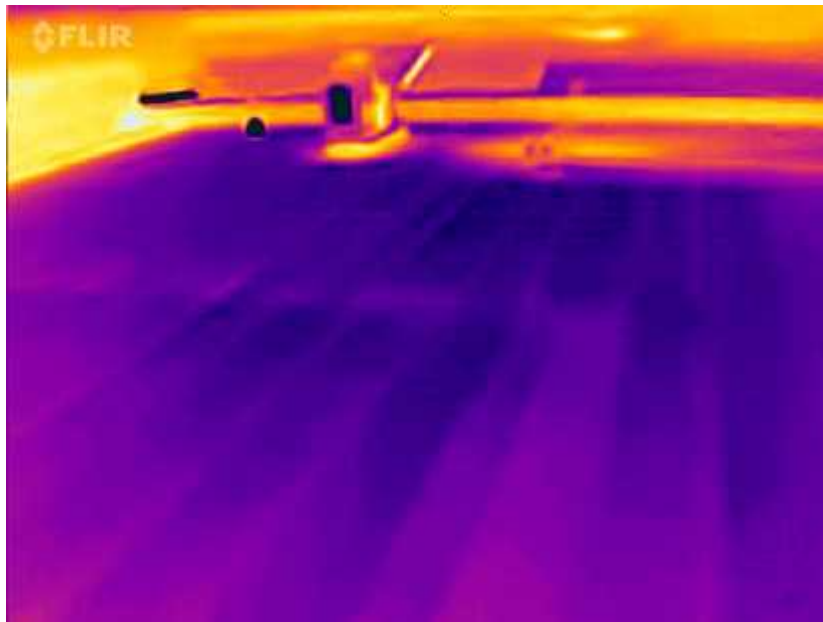
Flir One Photo standing on the north side of section C looking east, an exhaust vent is heating up the system creating a false positive. No suspected wet areas.

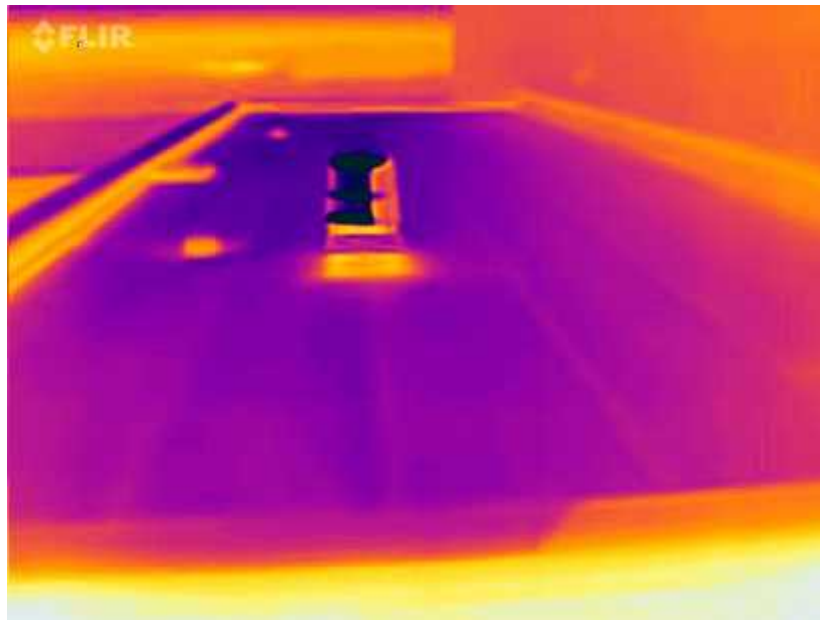
Flir One Photo standing on section C looking at section D to the east, no anomalies found in this section

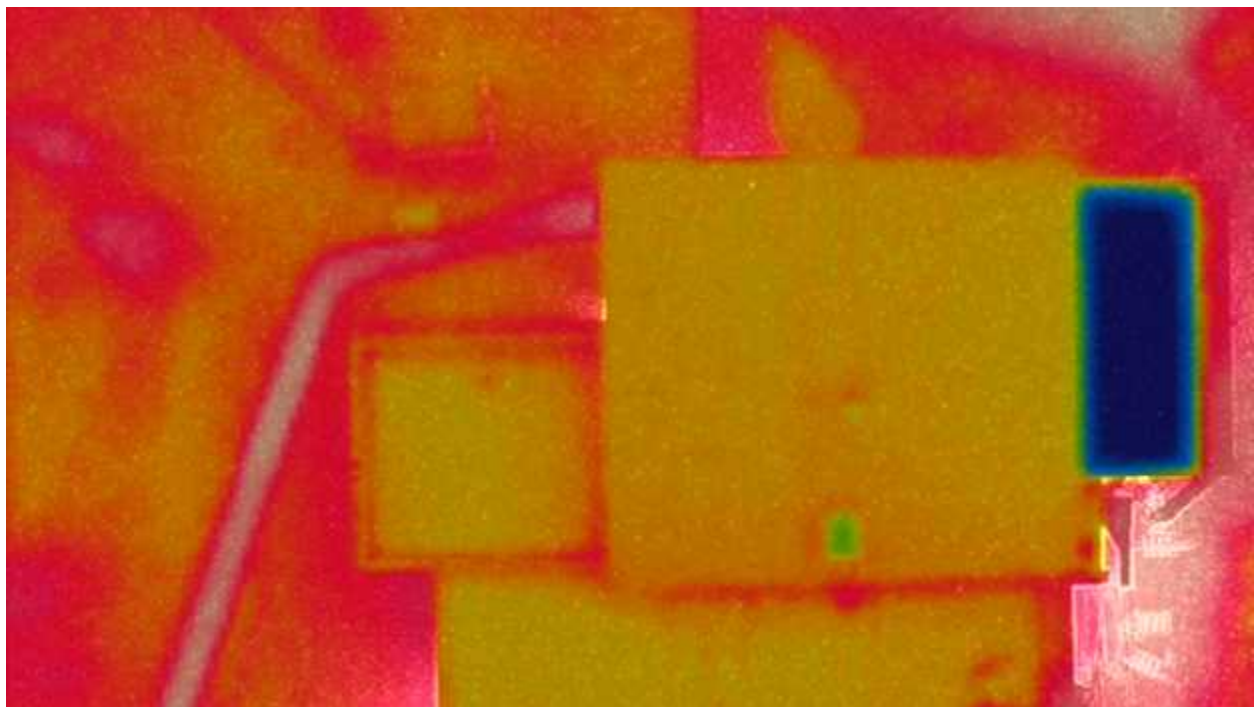
Moving north to sections A and B the color palette on this picture has changed dramatically because of the cold metal roof to the east. Section A and B have no indication of moisture infiltrating the system.

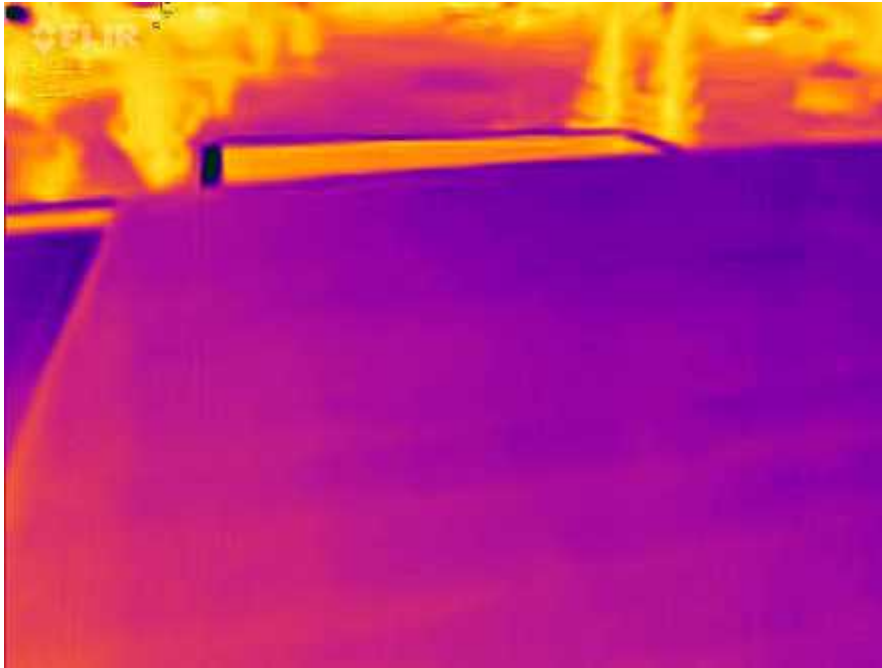
Flir One Photo standing on section A looking to the east, no anomalies detected.

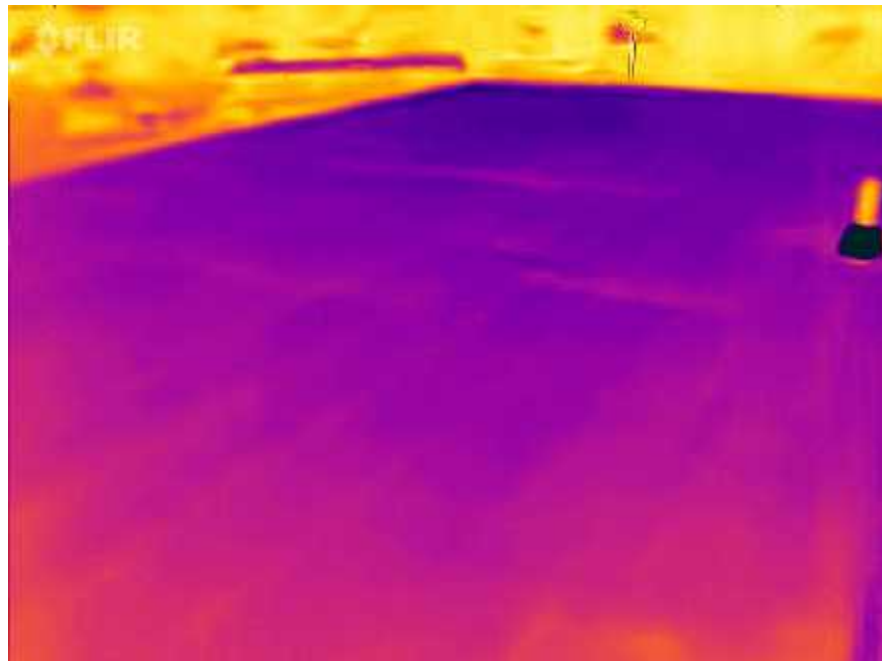
Flir One Photo standing on section A looking northwest, no anomalies detected.

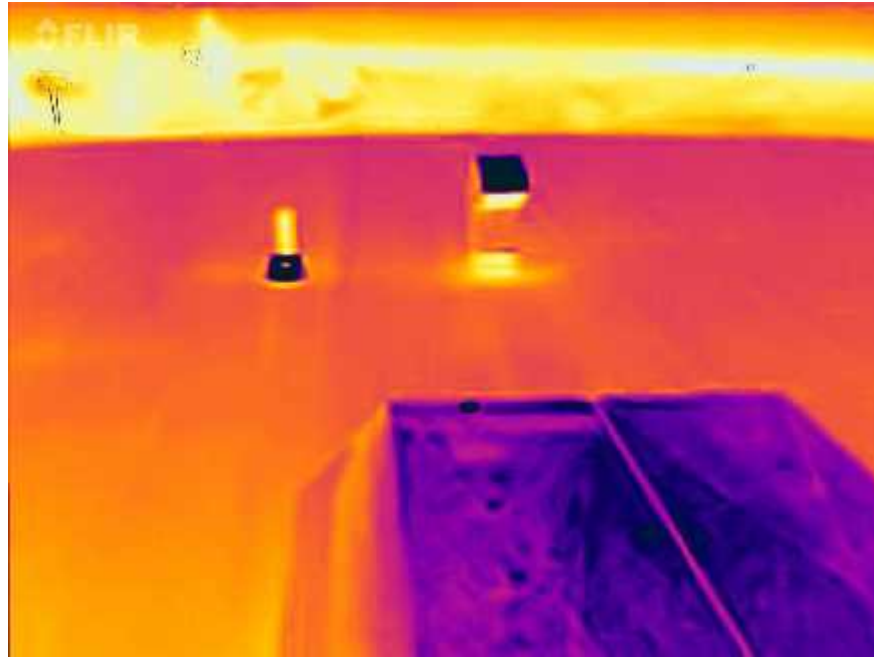
Flir One Photo standing on section A looking north, no anomalies found.

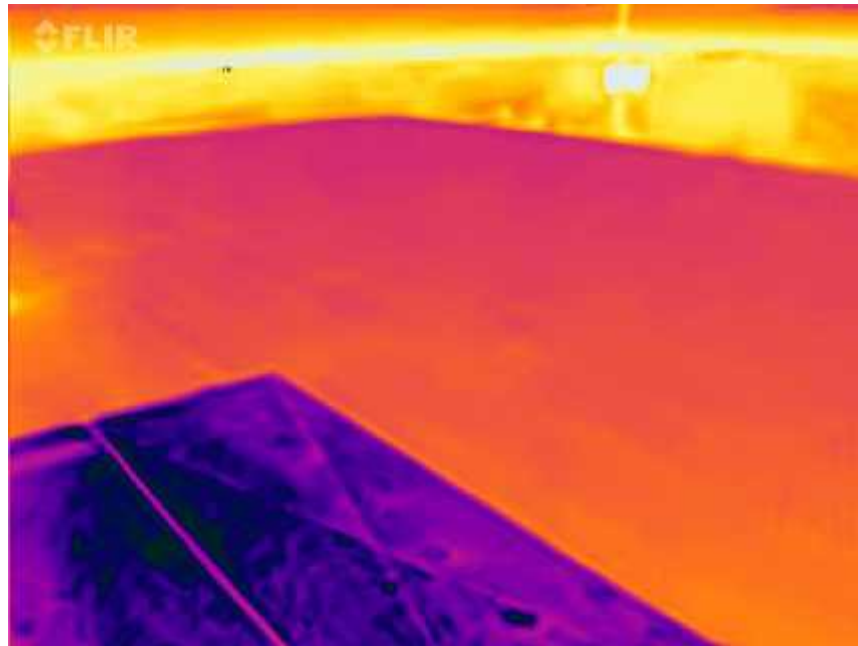
Flir One Photo standing on section A looking northwest, no anomalies found.

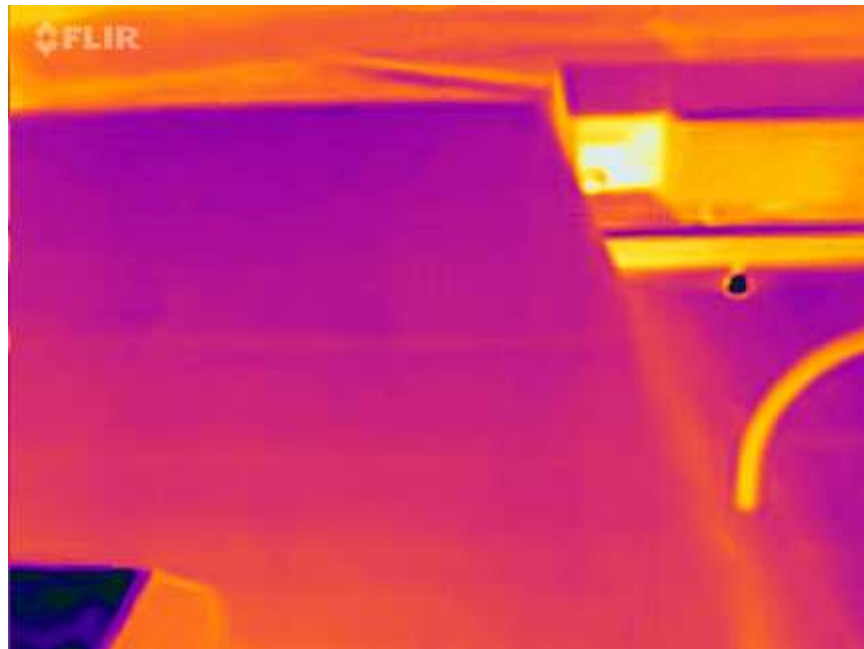
Flir One Photo standing on section A looking west, no anomalies found.

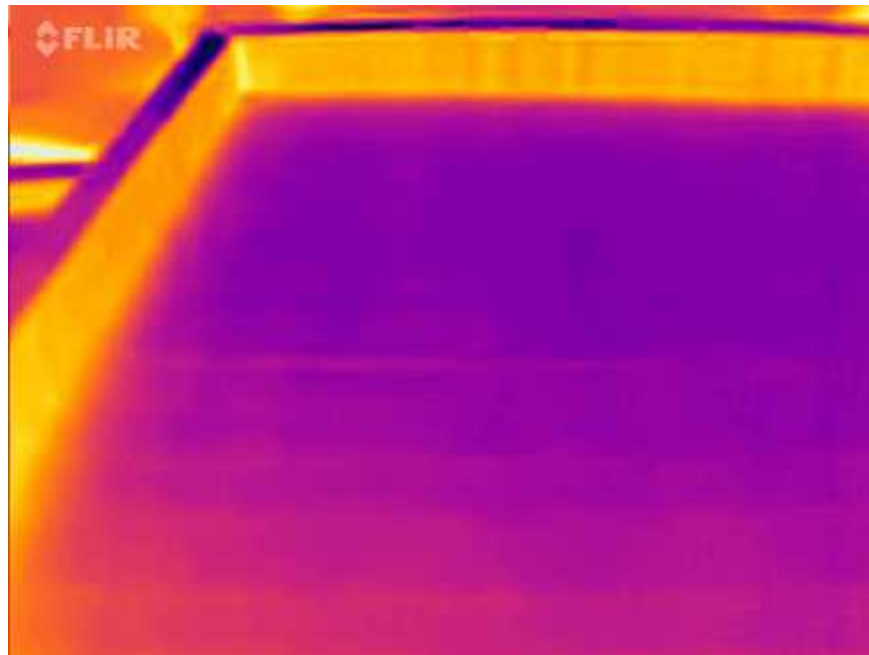
Flir One Photo standing on section A west to section B, no anomalies detected.

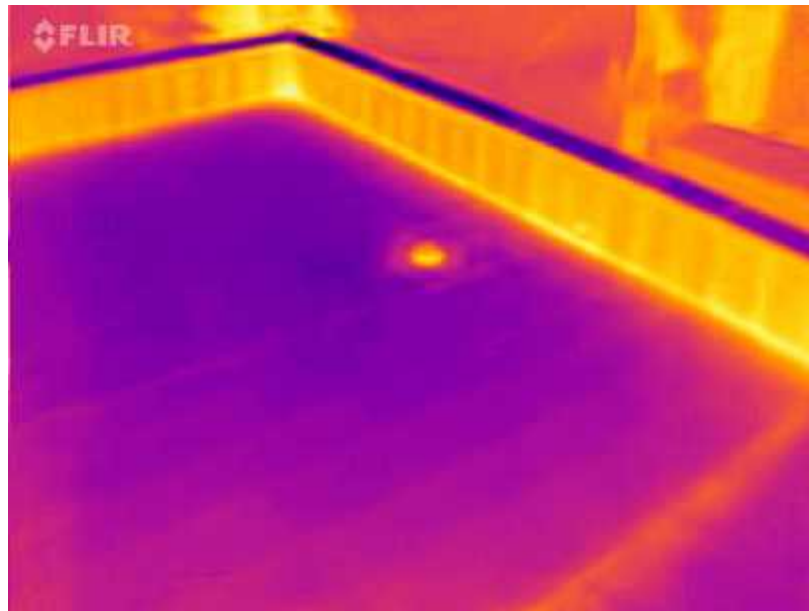
Flir One Photo standing on section A northwest to section B, no anomalies

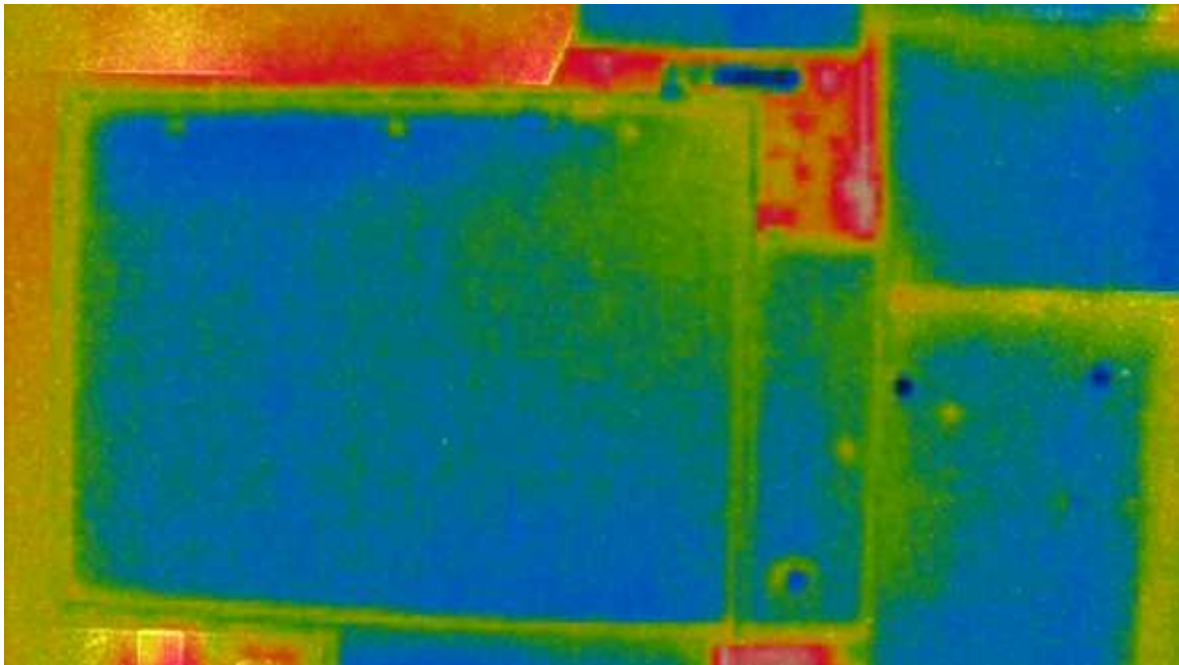
Moving to the east, the gym roof (section E and F) have no indication of water infiltrating the system.

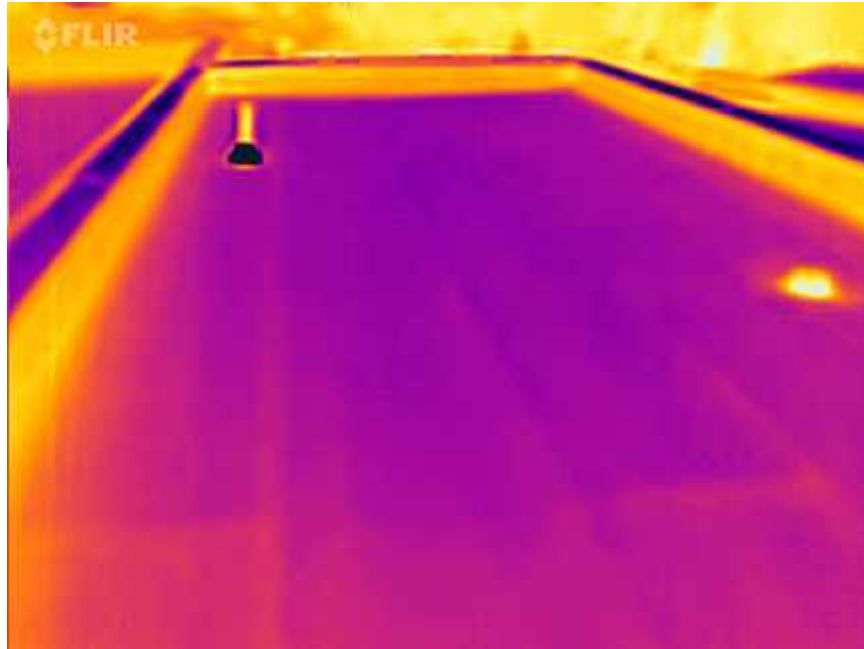
Flir One Photo standing on section F looking south at the hatch, no anomalies detected.

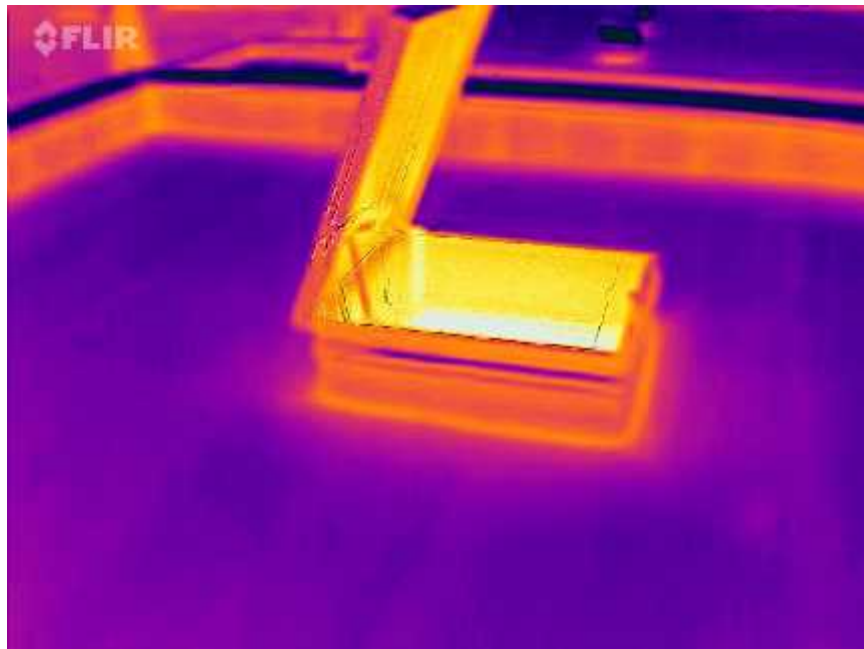
Flir One Photo standing on section F looking north at the hatch, no anomalies detected.

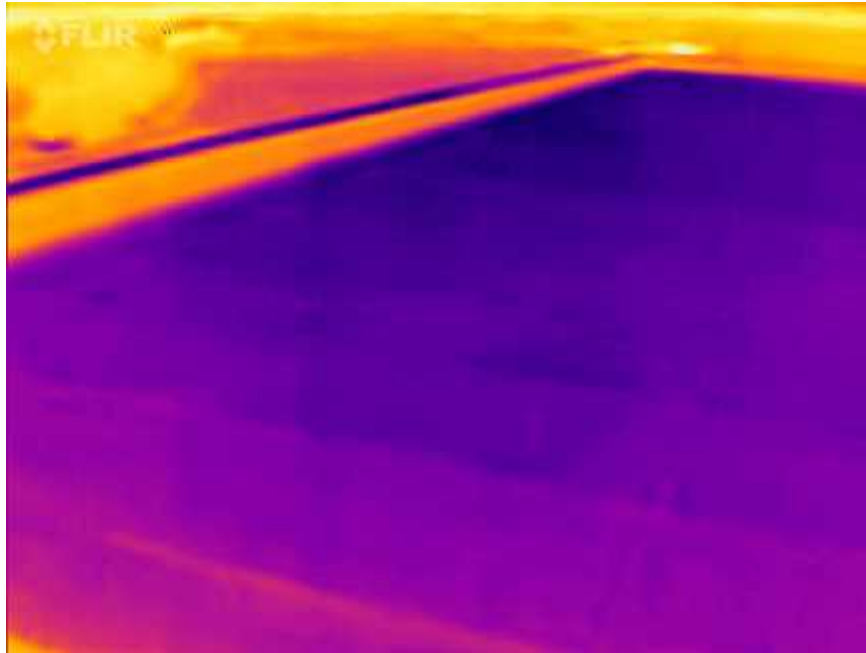
Flir One Photo standing on section f looking southeast to section E, no anomalies detected.

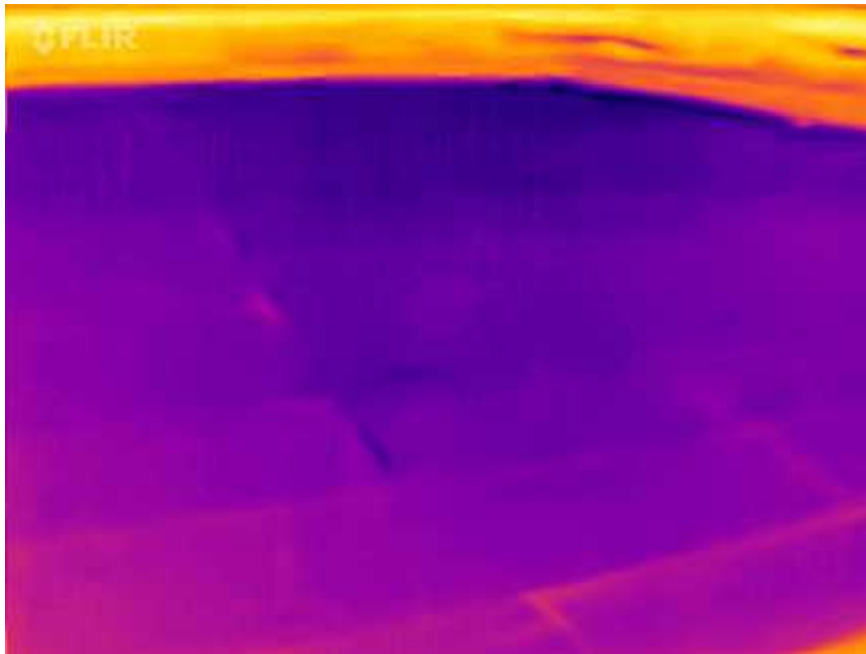
Flir One Photo standing on section A looking south to section E, no anomalies detected.
