## 2019 Schools Roofing Review

**O'Neil Consulting**

December 31, 2019

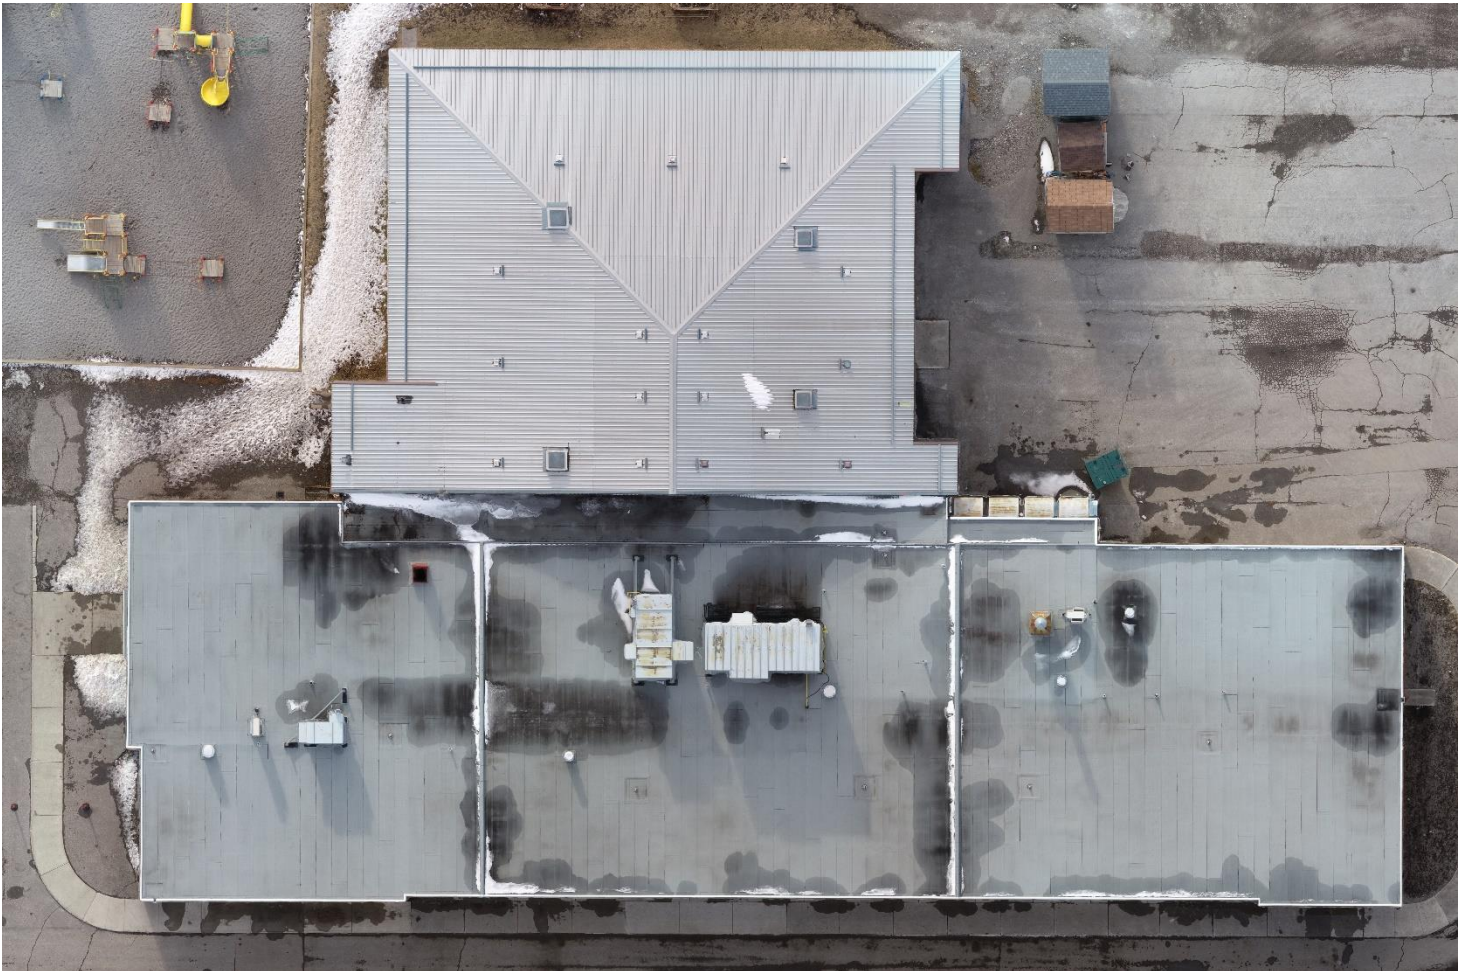
The building is a one and two storey building with a low slope roofing system. The roof consists of several distinct roof sections identified on the figure above. Low slope roof areas are 2 ply SBS, steep slope roof areas are surface fastened metal, fastened with bolts sealed with neoprene seals. The transition area between the sloped metal roof and the 2 ply SBS system has been problematic and should be taken apart and redone.

The sloped metal roof should be monitored for deterioration of the neoprene seals in the fasteners and they should be replaced prior to leakage as that can cause the fastening surface to rot and fasteners could pull out.

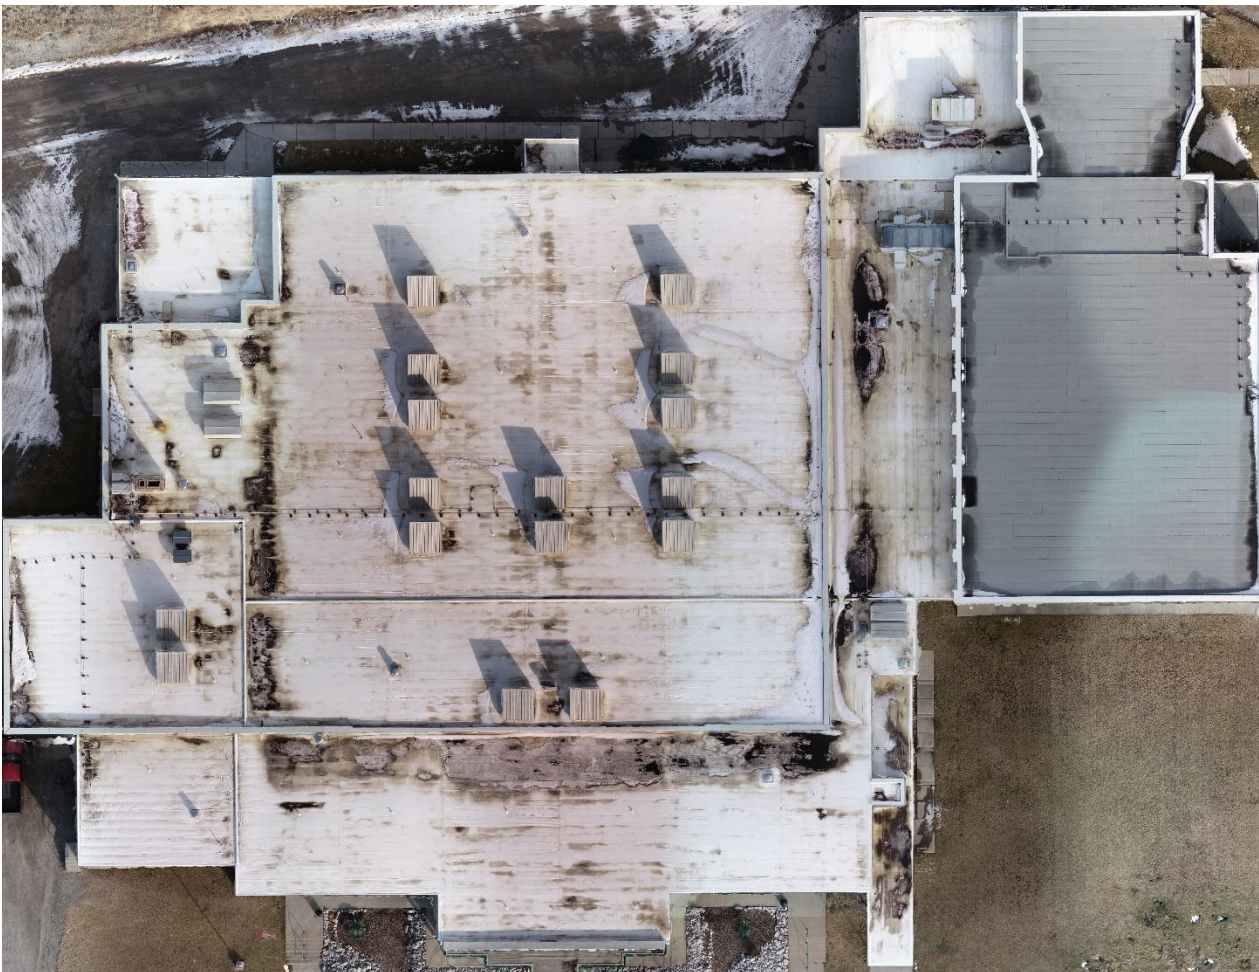
The building is a one and two storey building with a low slope roofing system. The roof consists of several distinct roof sections identified on the figure above. Low slope roof areas are 2 ply SBS and PVC roof systems manufactured by Duro-last, (areas in white).

PVC roofs are a single ply system and, in this case, mechanically fastened to the roof deck, they tend to be more prone to damage due to rooftop activity and are easily damaged by vandals. Continuous movement due to strong winds can also cause problems. In many areas the fasteners are protruding above the collapsing roof systems below and this is a potential membrane rupture problem.

The SBS roof sections are relatively new and should provide a good service life expectancy

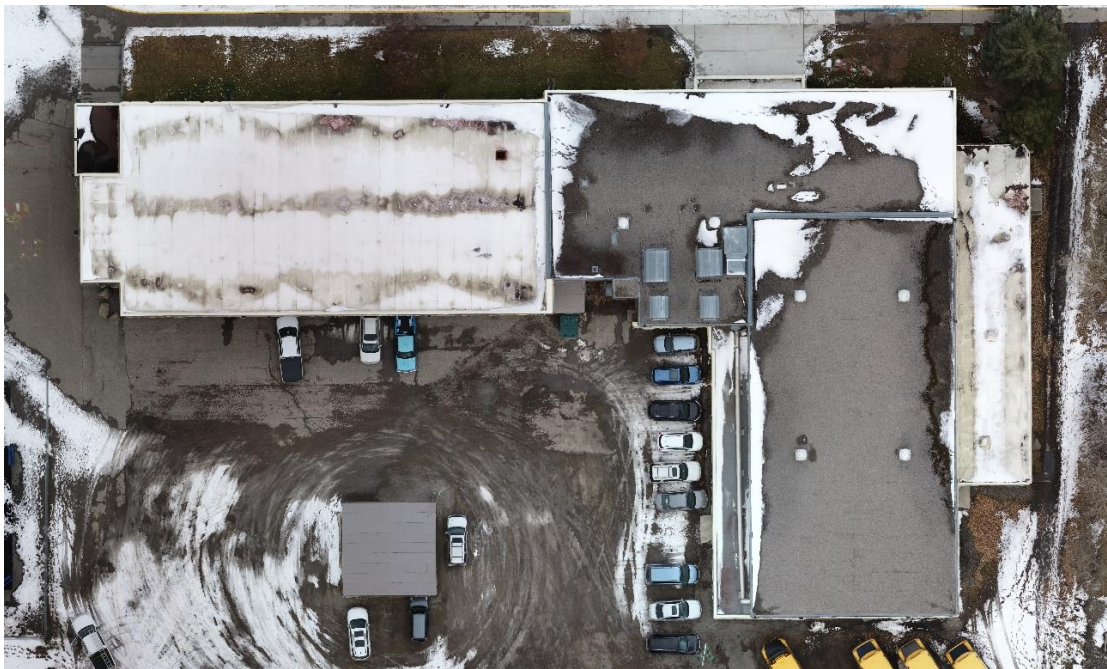
The building is a one and two storey building with a low slope roofing system. The roof consists of several distinct roof sections identified on the figure above. Low slope roof areas are Built up roof (BUR) and PVC roof systems manufactured by Duro-last, (areas in white).

PVC roofs are a single ply system and, in this case, mechanically fastened to the roof deck, they tend to be more prone to damage due to rooftop activity and are easily damaged by vandals. Continuous movement due to strong winds can also cause problems. In many areas the fasteners are protruding above the collapsing roof system below and this is a potential membrane rupture problem.

The BUR roof sections are showing their age and have limited service life expectancy, there is evidence of blistering and exposed felts which generally limits the future life of the roof system.

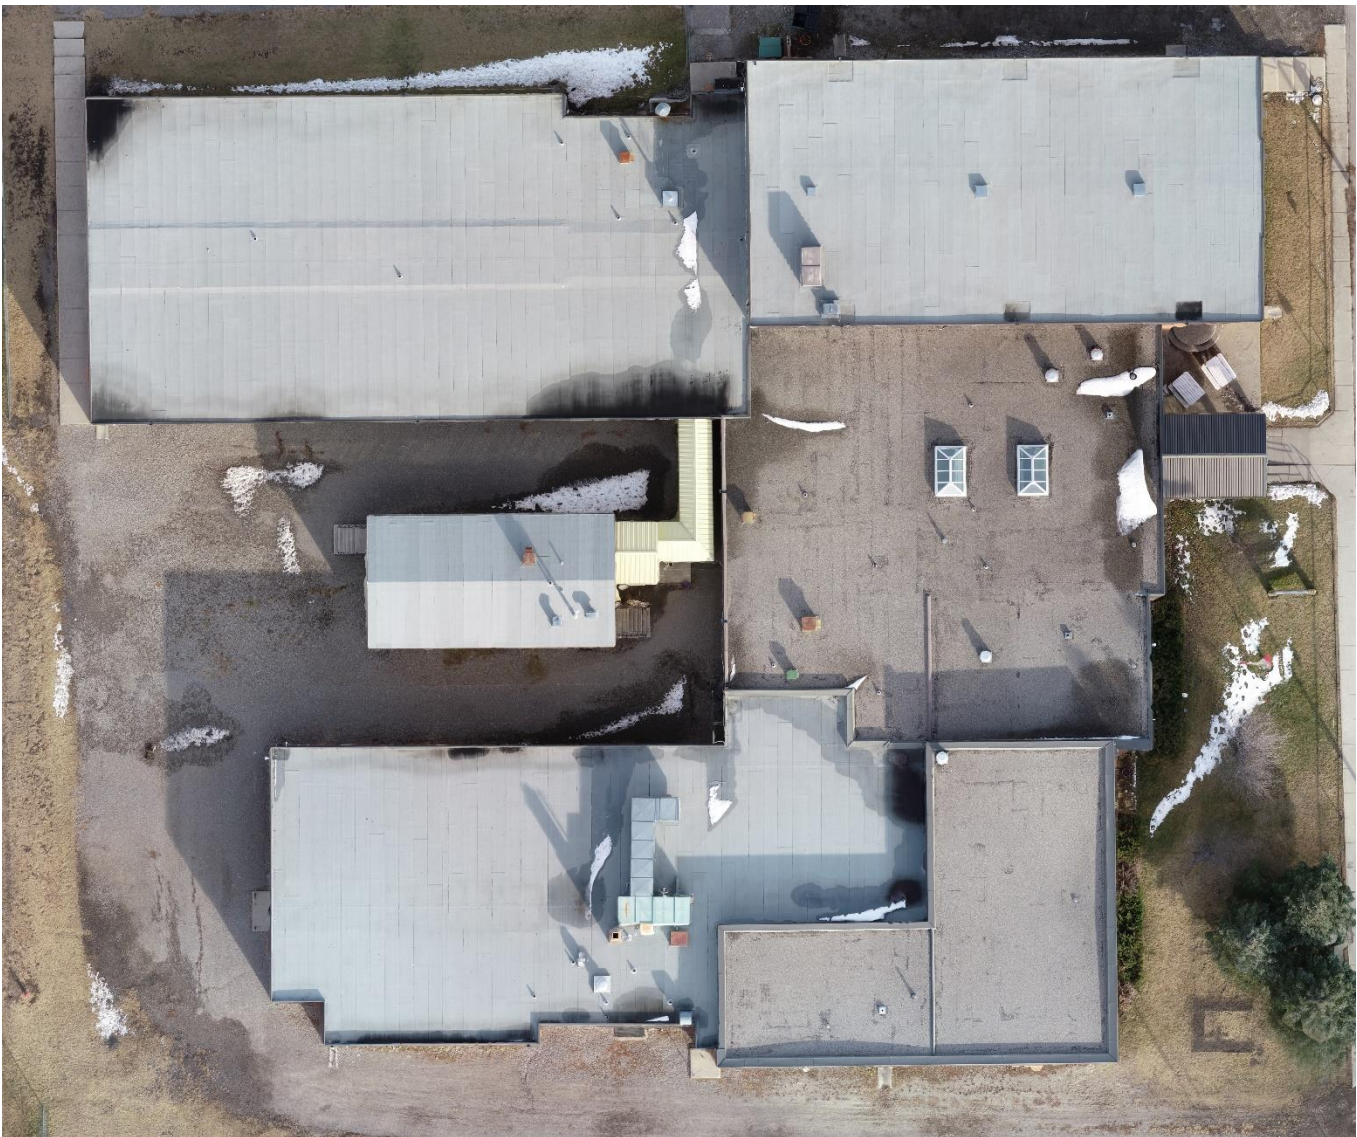
The building is a one and two storey building with a low slope roofing system. The roof consists of several distinct roof sections identified on the figure above. Low slope roof areas are Built up roof (BUR) and SBS roof systems.

The BUR roof sections are showing their age and have limited service life expectancy, there is evidence of blistering and exposed felts which generally limits the future life of the roof system.

The SBS roof sections are relatively new and should provide a good service life expectancy

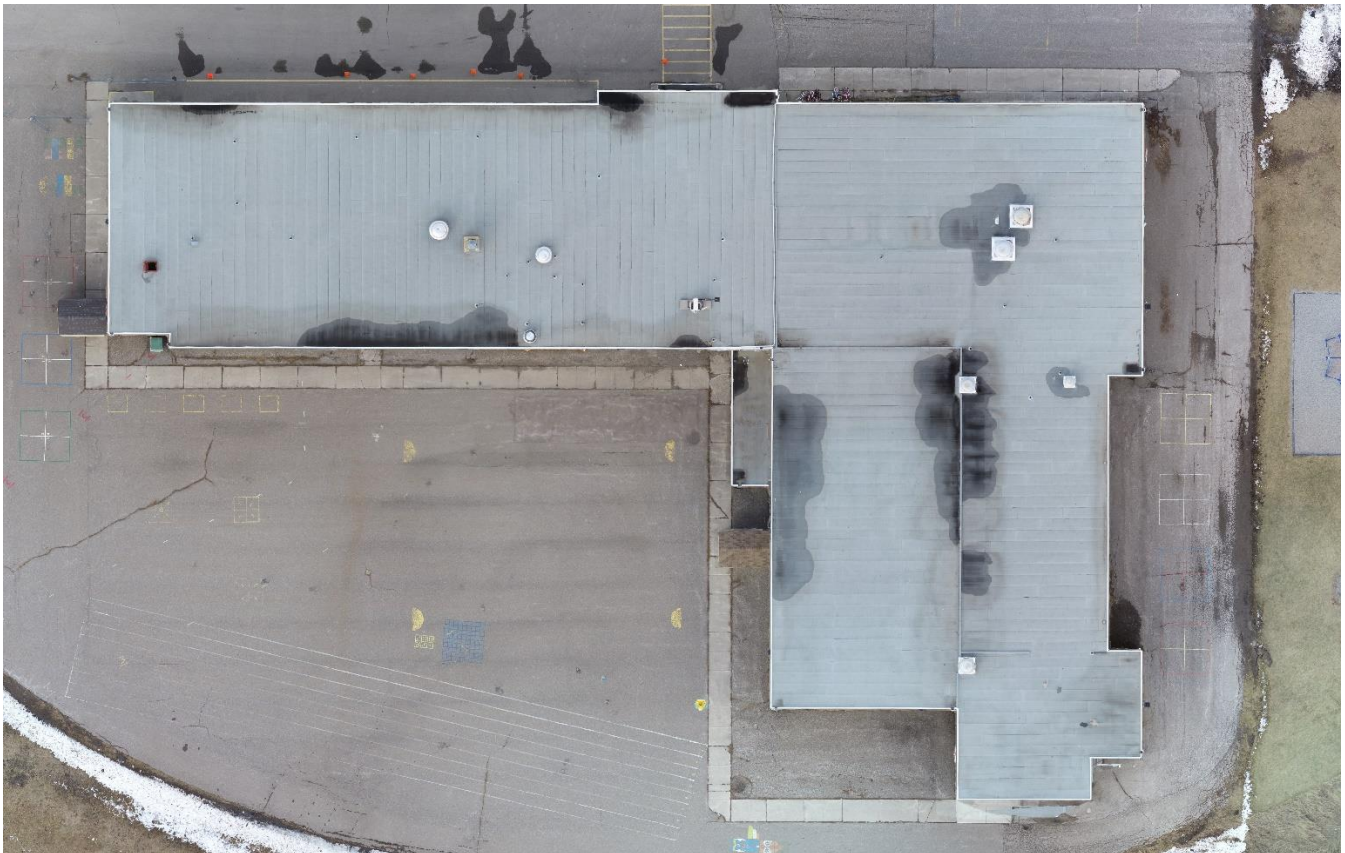
The building is a two-storey building with a low slope roofing system. The roof consists of several distinct roof sections identified on the figure above. Low slope roof areas are SBS roof systems.

The SBS roof sections are relatively new and should provide a good service life expectancy

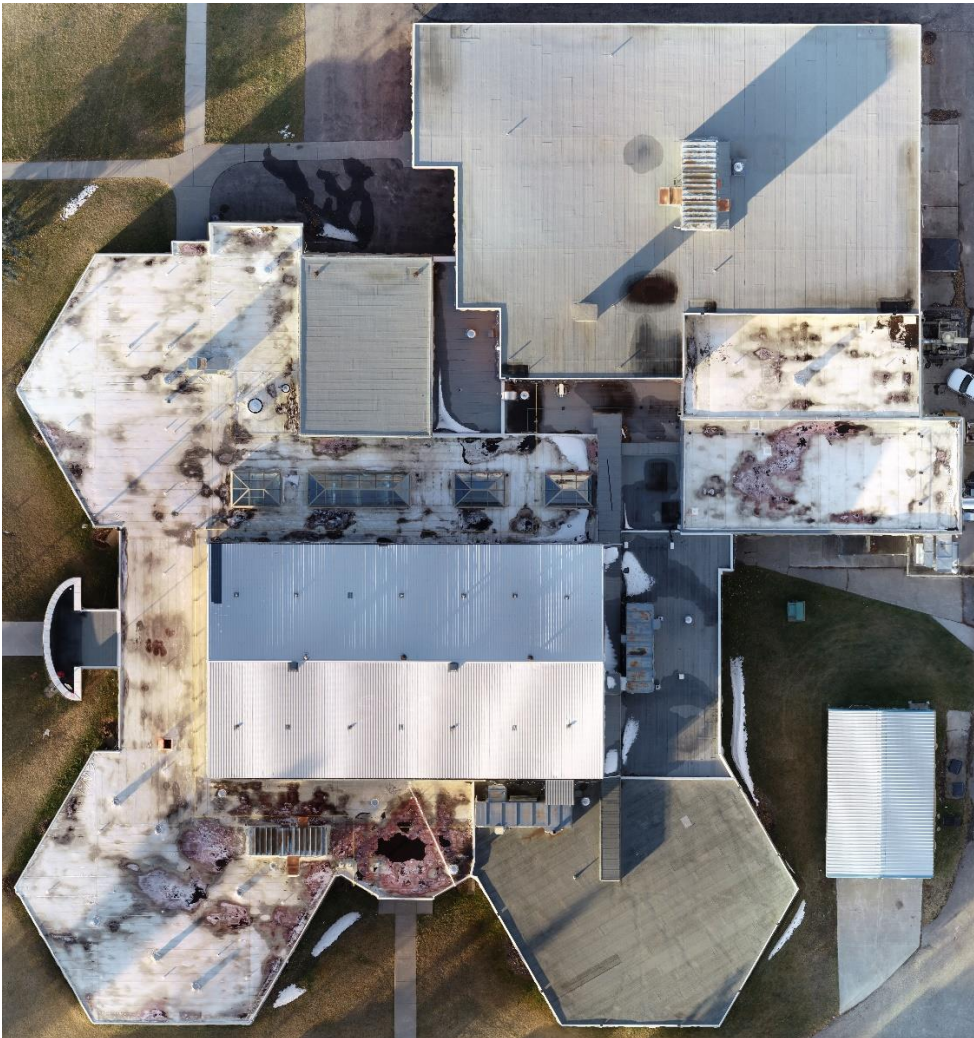
The building is a one and two storey building with a low slope roofing system. The roof consists of several distinct roof sections identified on the figure above. Low slope roof areas are 2 ply SBS and PVC roof systems manufactured by Duro-last, (areas in white).

PVC roofs are a single ply system and, in this case, mechanically fastened to the roof deck, they tend to be more prone to damage due to rooftop activity and are easily damaged by vandals. Continuous movement due to strong winds can also cause problems. In many areas the fasteners are protruding above the collapsing roof systems below and this is a potential membrane rupture problem.

The SBS roof sections other than the Siplast area are relatively new and should provide a good service life expectancy. The Siplast roof area should be recapped in the next few years due to granule loss.

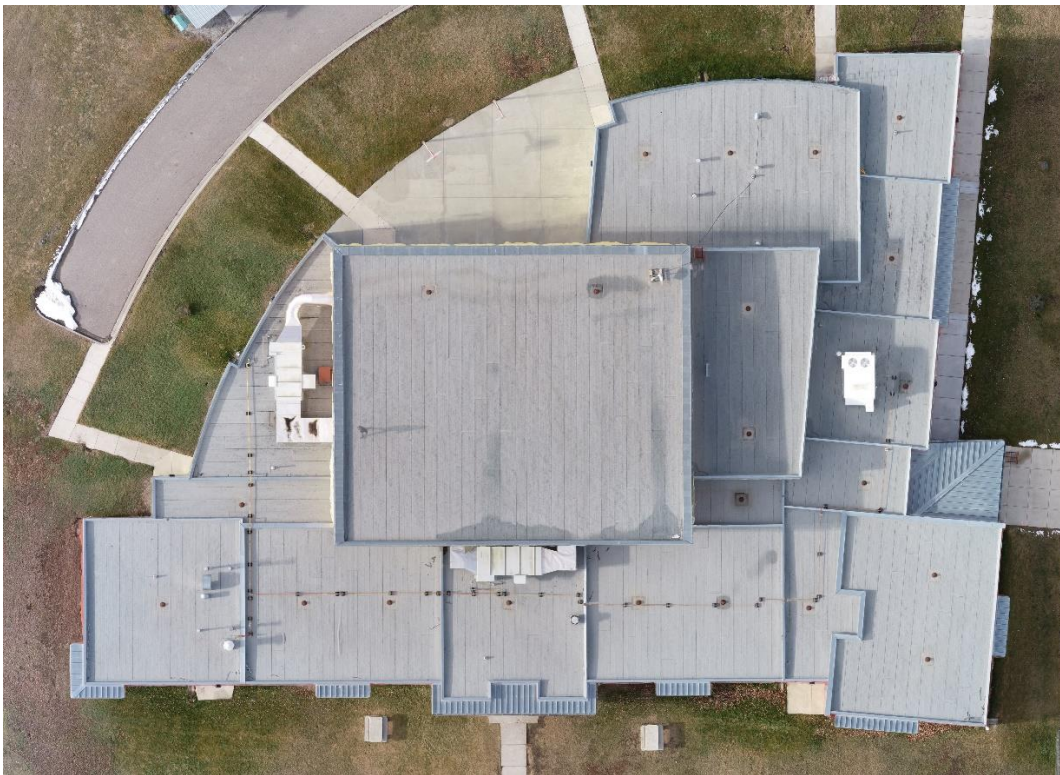
The building is a one and two-storey building with a low slope roofing system. The roof consists of several distinct roof

sections identified on the figure above. Low slope roof areas are SBS roof systems.

The SBS roof sections are relatively new and should provide a good service life expectancy.

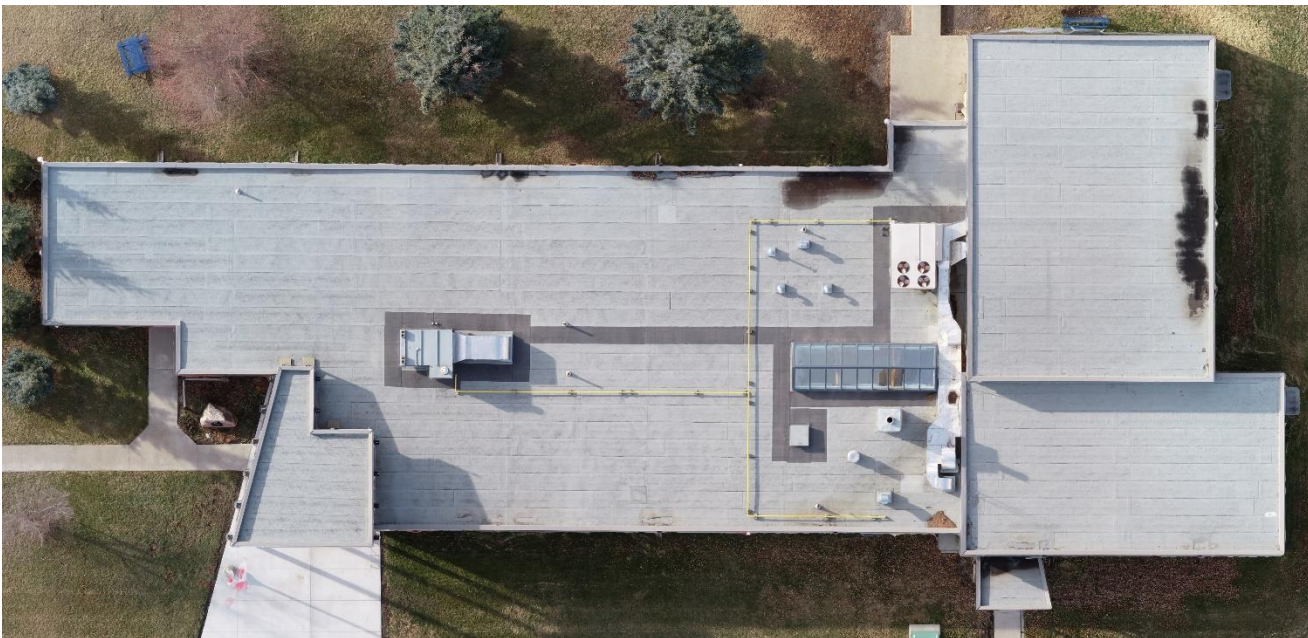
The building is a one storey building with a low slope roofing system. The roof consists of several distinct roof sections identified on the figure above. Low slope roof areas are SBS roof systems.

The SBS roof sections are relatively new and should provide a good service life expectancy

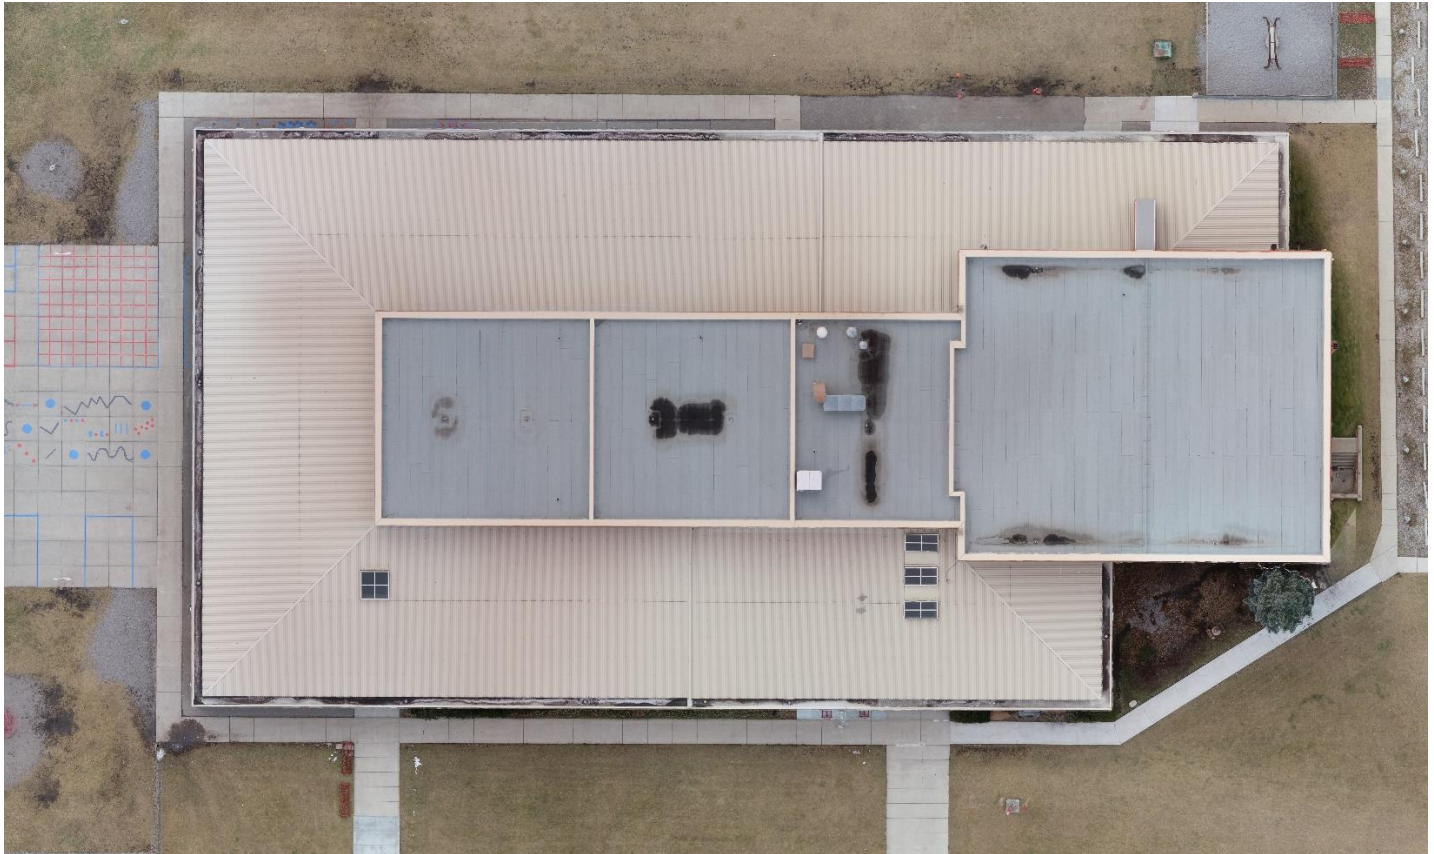
The building is a one and two storey building with a low slope and steep roofing system. The roof consists of several distinct roof sections identified on the figure above. Low slope roof areas are 2 ply SBS, steep slope roof areas are surface fastened metal, fastened with bolts sealed with neoprene seals.

Both roof systems should provide substantial life expectancy.

The sloped metal roof should be monitored for deterioration of the neoprene seals in the fasteners and they should be replaced prior to leakage as that can cause the fastening surface to rot and fasteners will pull out.

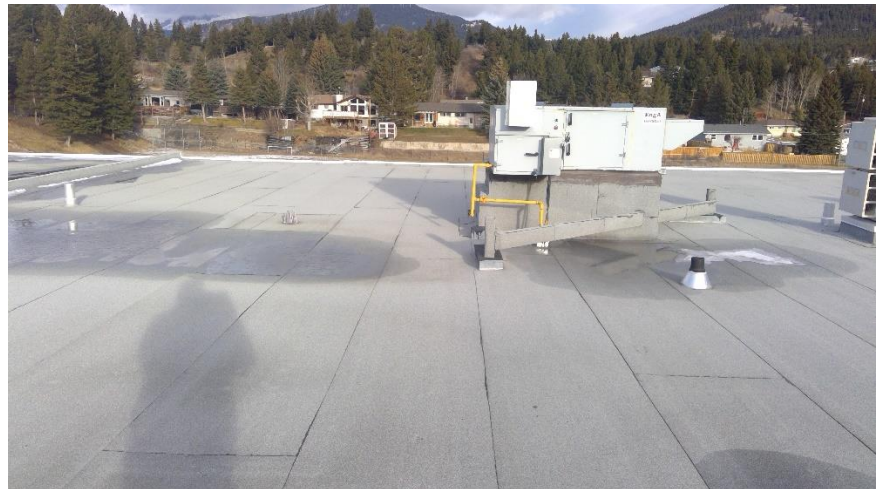
- 6) View to the north of the SBS roof.

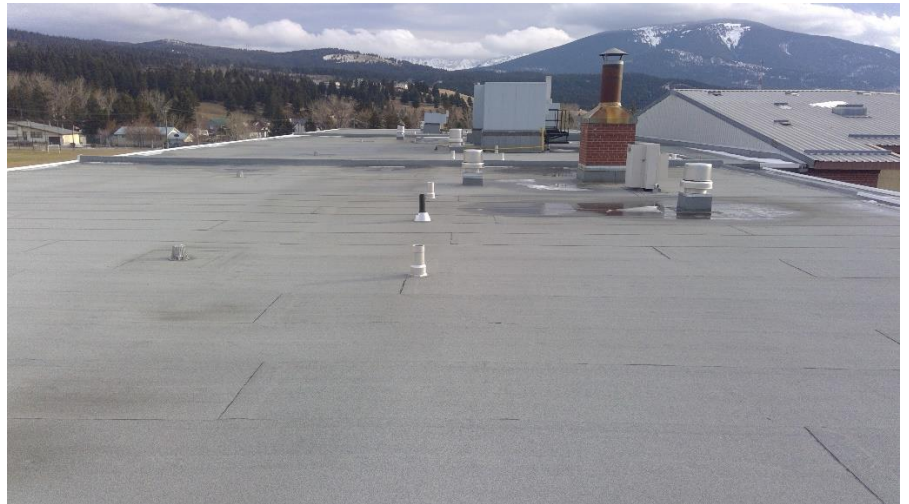
- 7) Overview of the lower roof.

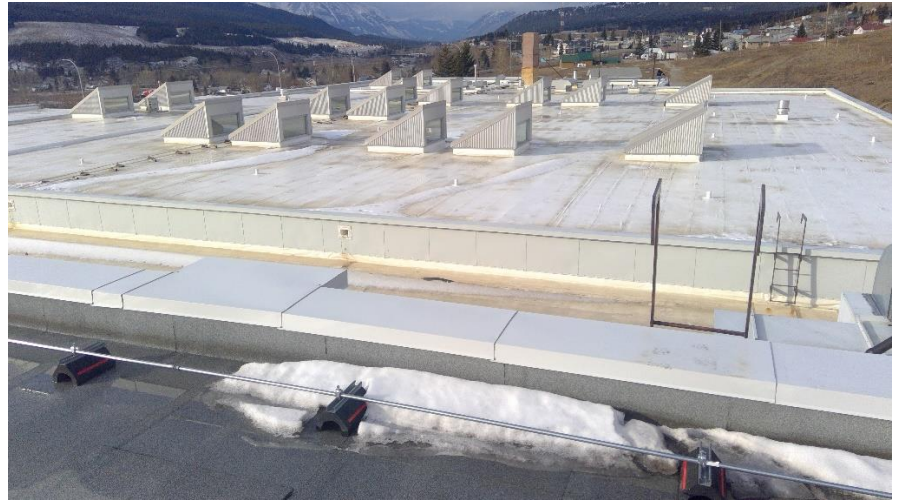
- 9) Overview of the PVC roof areas to the west of the gym roof.

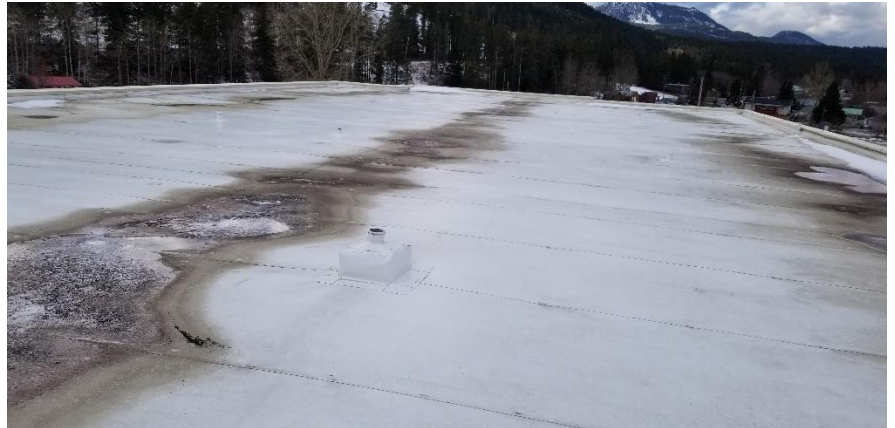
19) PVC roof section to the west.

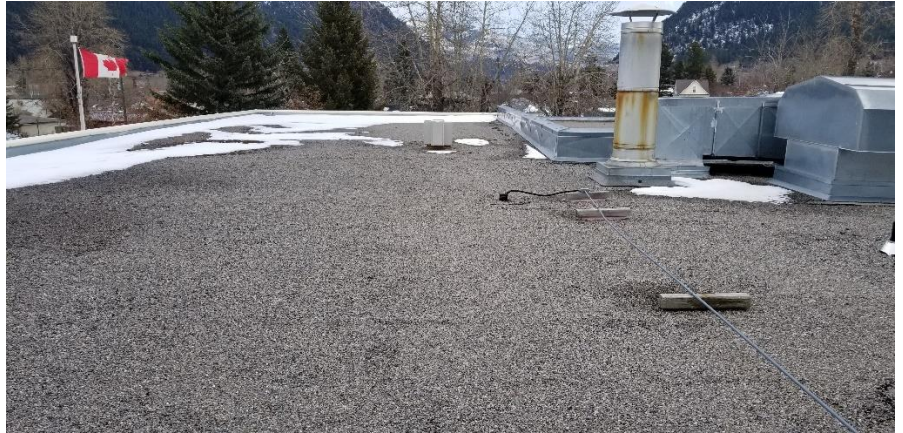
21) Built up roof section to the east.

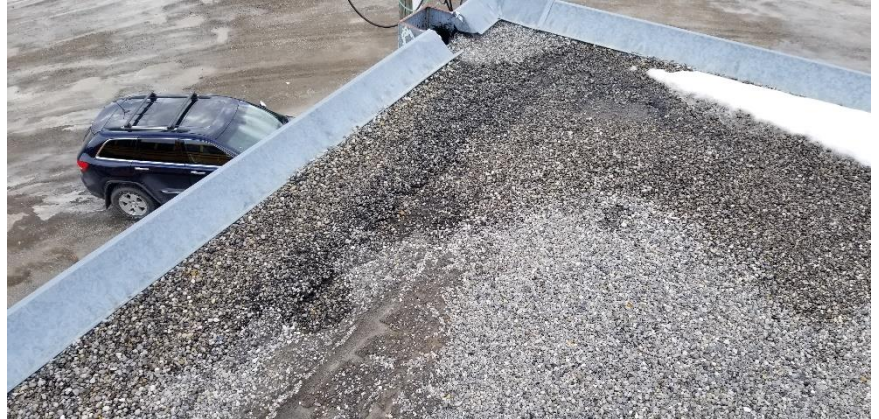
- 23) Felt exposure and evidence of blistering on the BUR roof.

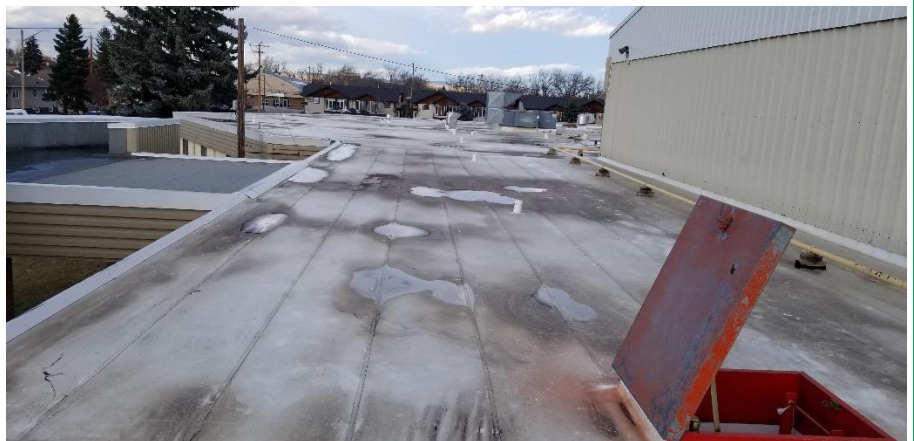
38) PVC roof section to the west of the sloped metal roof.

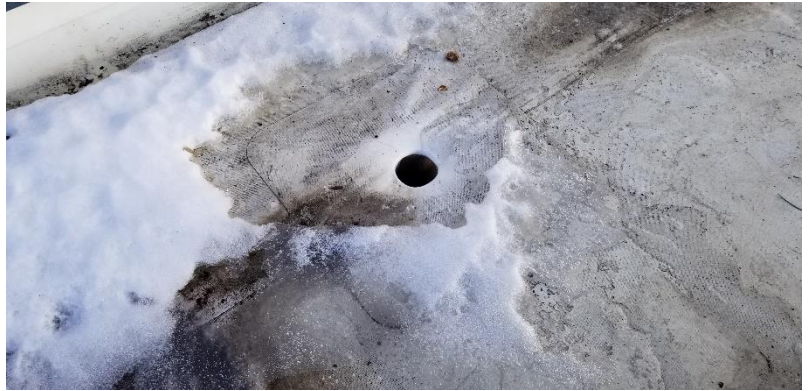
- 41) Drain undersized to provide proper drainage.

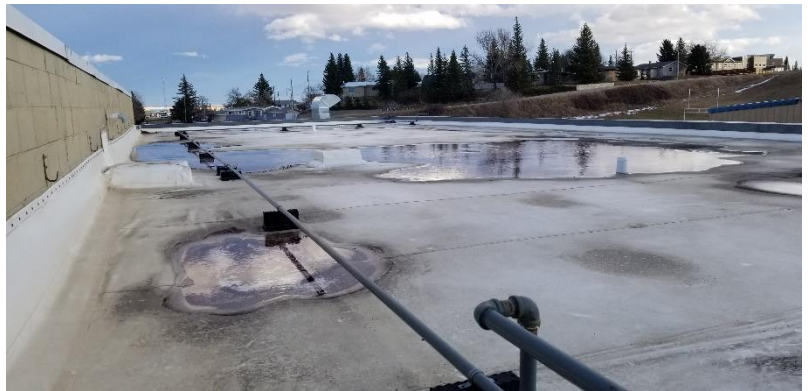
- 42) Severe ponding in some areas, also the wall to the left should have been clad or a gum lip flashing installed.

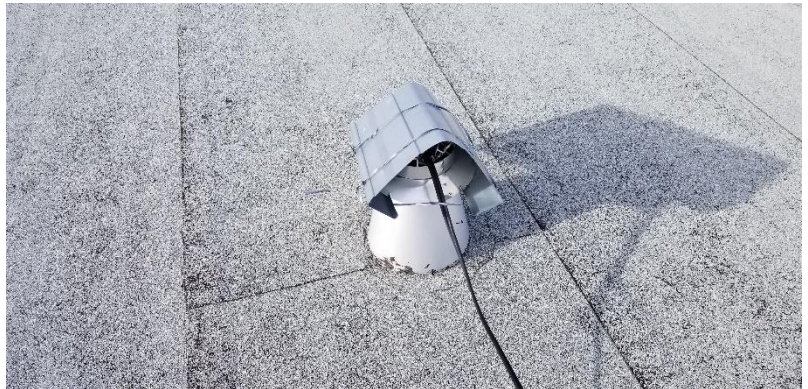
50) Unusual vent.
